Laborer is Killed When Backed Over by Asphalt Milling Machine - Massachusetts

Investigation: # 03-MA-018-01

Release Date: July 8, 2005

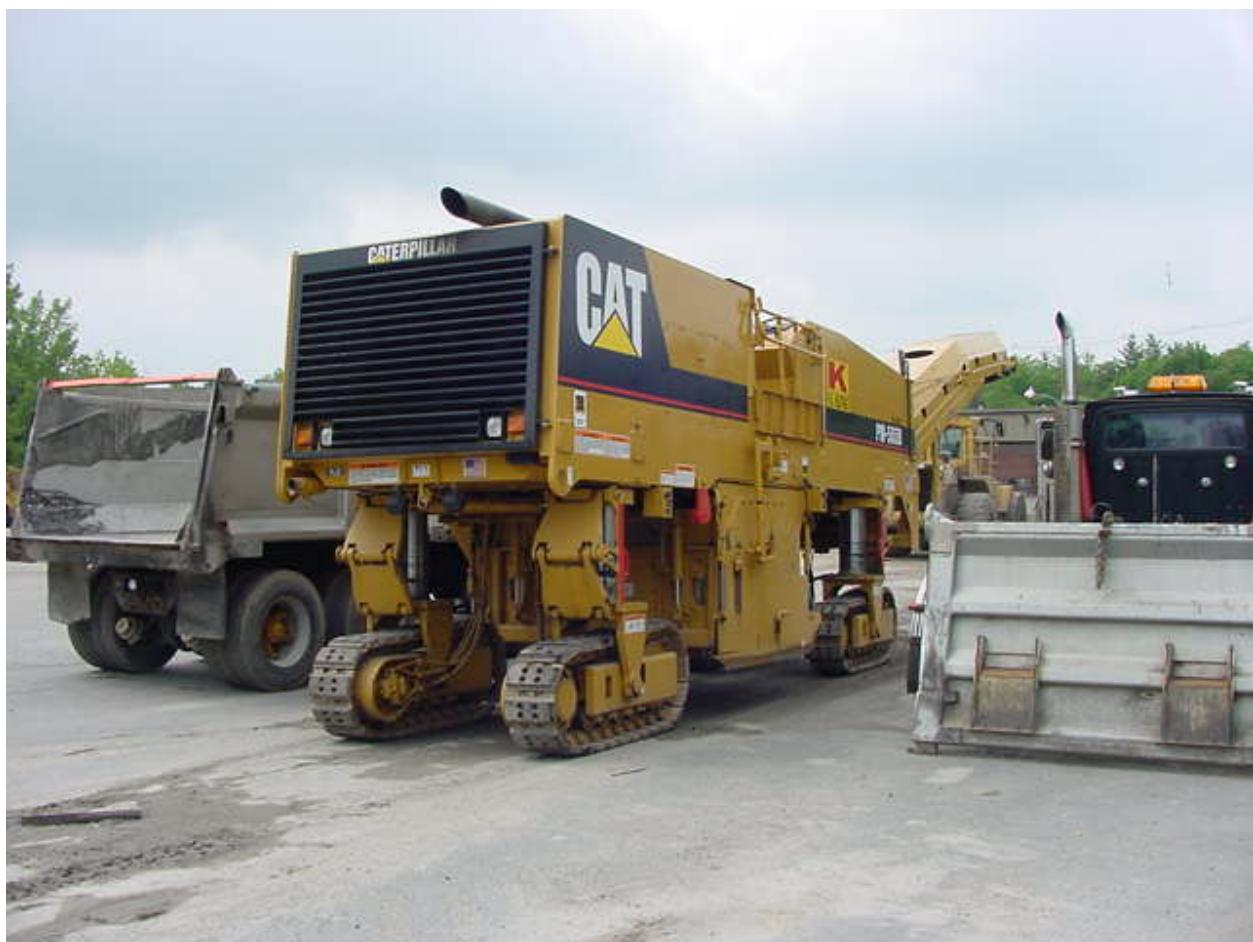
Figure 1 - Rear of the milling machine involved in the incident

The machine involved in the incident was a cold milling machine (Figures 1 and 2) that weighed approximately 85,100 pounds with the water tank full. The machine had a diesel engine and four crawler tracks. The milling machine was designed to remove the top layers of worn or deteriorated asphalt, eliminating surface imperfections such as bumps and ruts. The amount of removed asphalt could be selected by adjusting the drum cutting depth. The machine's cutting width was fixed at 6.9 feet and the length of the milled area depended on the project. During the milling operation, water from the machine's water tank was used to control dust levels.

At the time of the investigation, the company was planning on installing cameras at the rear of the milling machine and monitors at the operator's area. The company had already installed this same type of equipment on a loader at one of its quarry locations and had reported that the loader operator felt that the camera and monitor was very helpful while backing.

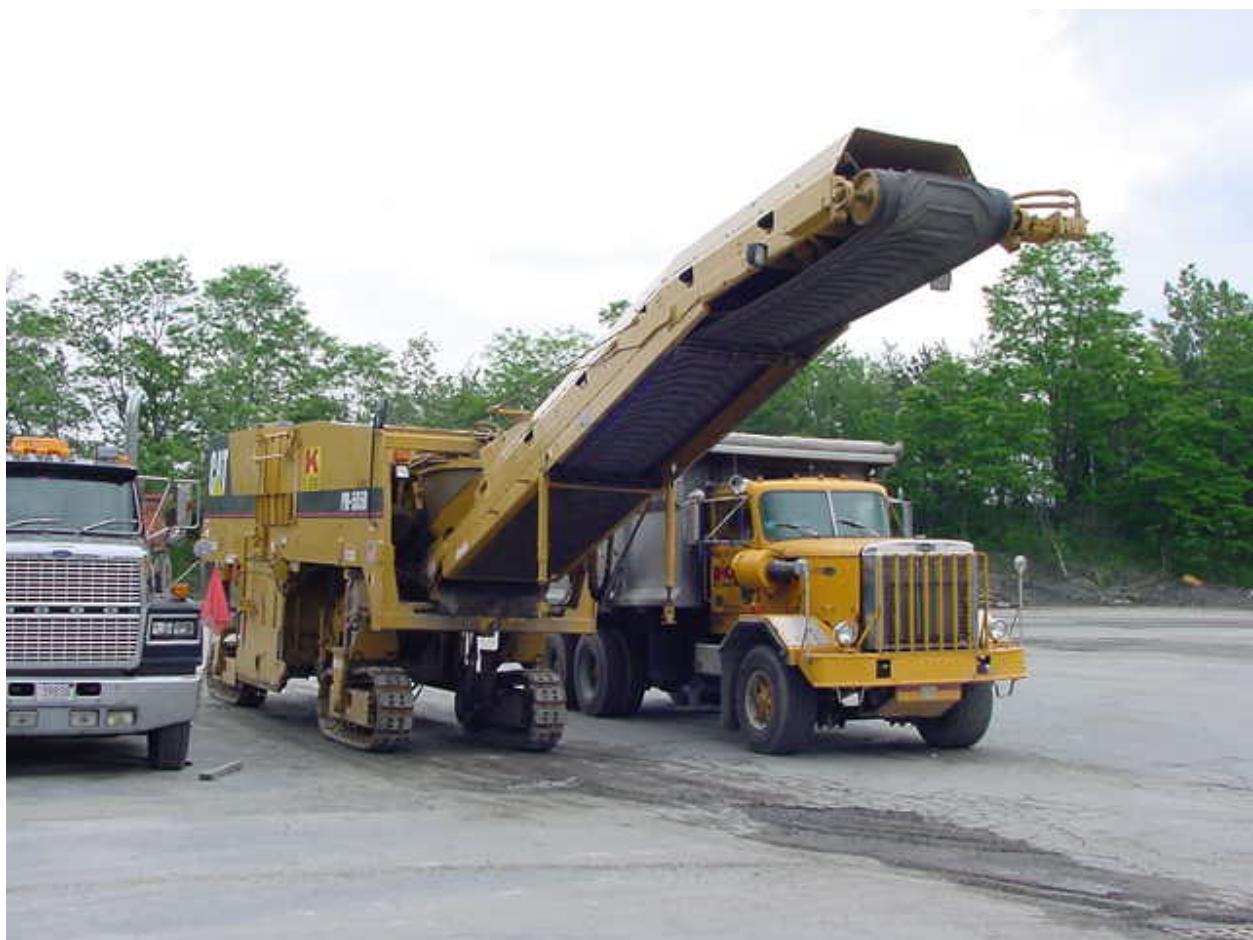
Figure 2 - Front of the milling machine involved in the incident

During the milling process, the removed asphalt is ground up and discharged via a conveyor that is located at the front of the machine. A dump truck is positioned at the end of the conveyor to collect the discharged asphalt (Figure 2). The dump truck is moved along with the milling machine so discharged asphalt from the milling machine's conveyor will continuously dump into the truck.

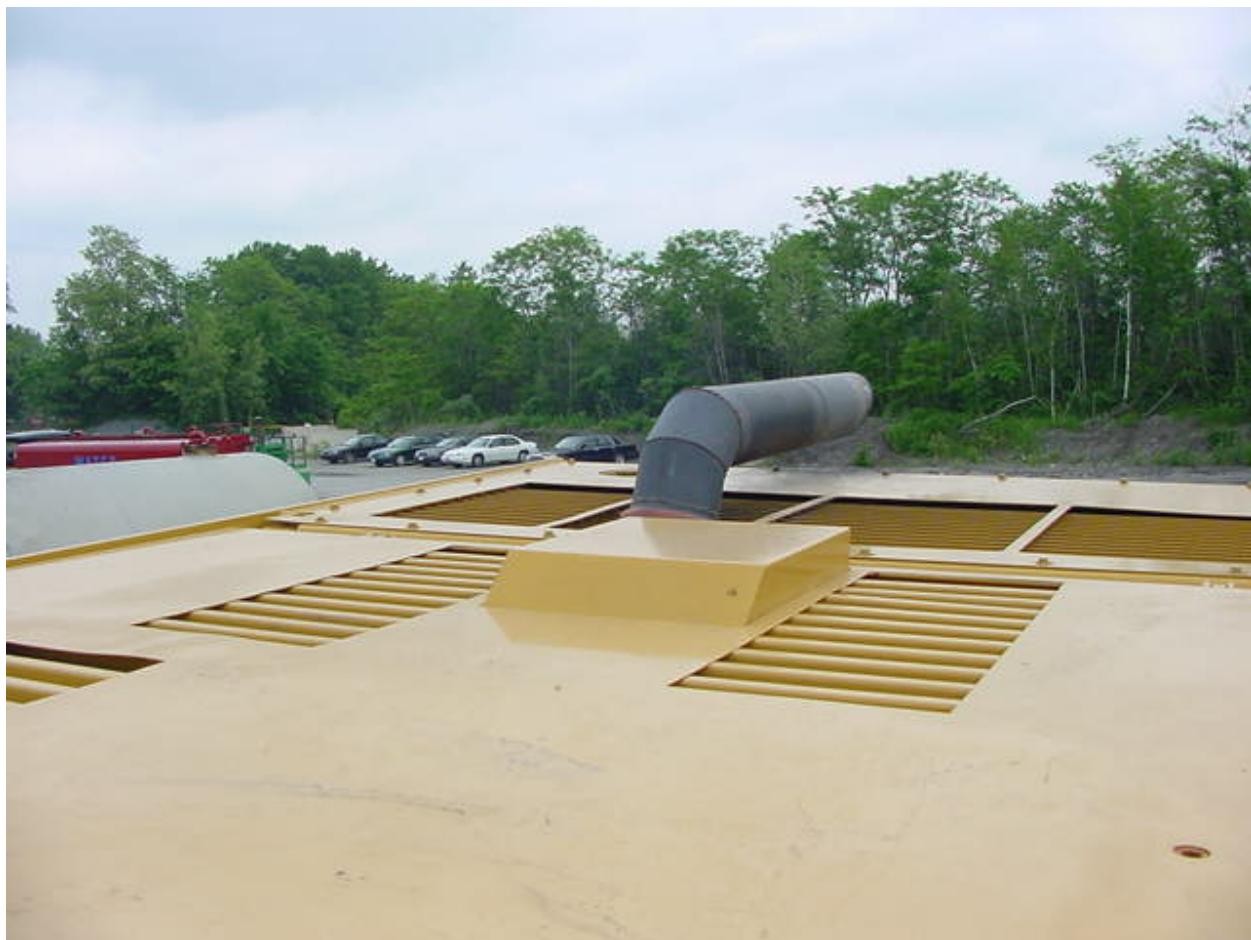
**Figure 3 - View from the operators area
looking to the rear of the machine**

On the day of the incident, the victim and his crewmembers had worked a seven-hour shift that started at 7:00 a.m. and then arrived at the incident work site at 5:30 p.m. for that day's normal scheduled shift, which started at 6:00 p.m. The area to be milled was a triangular shaped section of a parking lot, measuring approximately $\frac{1}{4}$ acre. The company provided lighting at the work area for the nighttime work. The victim's main task during the milling operation was to walk alongside of the milling machine to check on the cutting drum area and to act as a spotter for the operator, due to limited operator visibility (Figure 3) during the milling process and while backing the machine.

Discussion: As represented in Figure 3, the milling machine operator, while located in the operator's area, had very limited visibility of the area immediately around the machine. Designing milling machines to optimize the operator's visibility of these critical areas around the machine would be beneficial to both the operator and workers on foot.

Recommendation #3: Milling machine manufacturers should give increased attention to machine operator visibility when developing machine designs and operational procedures.

In this case, if the operator's area was the highest point on the machine and the surrounding sections of the machine sloped downward away from the operator's area, this could possibly increase the operator's field of vision around the machine while located in the operator's area.

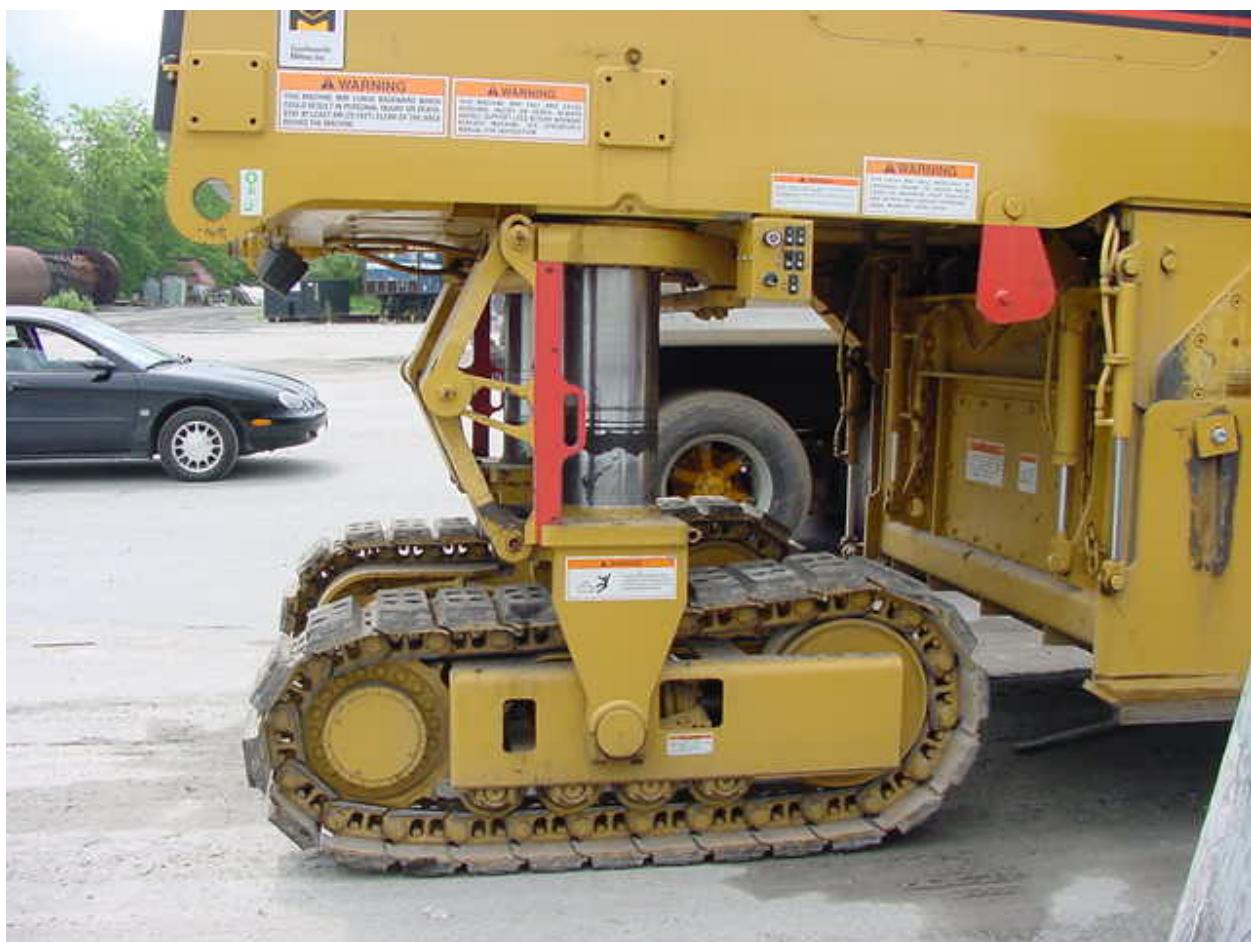
Figure 4 - Right rear track that struck the victim

It is unknown if the victim nodded to the milling machine operator or if the machine operator responded to a nod that was a head movement not intended for the machine operator. It is also unknown, but very possible, that the victim could have tripped causing him to become caught by the milling machine's right rear track.
