STATE OF NEW YORK DEPARTMENT OF HEALTH

FATALITY ASSESSMENT AND CONTROL EVALUATION

Maintenance Mechanic Killed when Improperly Installed Overhead Garage Door Topped Scissors Lift Case Report: 04NY135

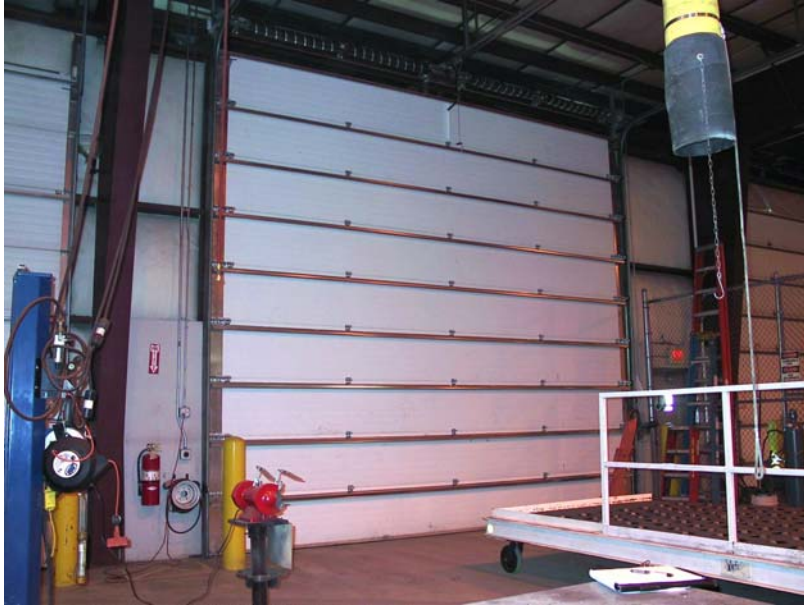
Following installation, the new door did not operate properly and the top door panel was bent in the middle. The victim and a co-worker returned to the cargo building on December 9 to make adjustments. They examined the door and then called the overhead door sales company to discuss the problem. The owner of the garage door company stated that he had several phone conversations with both the victim and his employer. In order to assist in determining a solution, the owner of the garage door company needed to know the door lift type and the size of the lift drums. The victim and his employer told the door company owner that the new door was a high-lift door with eight-inch lift drums; although, in fact, the door was a standard lift door with six-inch lift drums. Based on the incorrect information provided by the maintenance firm, the owner of the overhead door company recommended installing two additional torsion springs to balance the weight of the door. It was also recommended that a piece of angle iron be installed across the bent section of the top panel to straighten the panel and improve the door operation.

Photo 1. The overhead door that was involved in the fatal incident: a standard lift steel insulated door with six-inch lift drums. The door in the photo was adjusted and repaired by a garage door technician after the incident.

The owner of the garage door company went to the cargo terminal building several days after the incident to repair the door for the shipping company. According to the garage door company owner, the facility maintenance firm made multiple mistakes when installing the overhead door: the hinges and the tracks were both installed incorrectly, and the door panels were placed upside down and inside out. If the door had been installed properly, the rollers would have been able to move easily inside the tracks. The incorrectly installed hinges and tracks inhibited the rollers' movement and caused the door to jam. The overhead door was a standard lift door with six-inch drums. The two torsion springs later recommended were for a high-lift door with eight-inch lift drums; this was the door model mistakenly reported to the garage door company owner. It could be reasonably speculated that the force applied by the torsion springs was incorrect for this door. These mistakes may have caused the unbalanced door to spring up after the door was manually released.

Discussion: The installation/service maintenance manual for the overhead door was not available for the workers while they replaced the door parts and serviced the door. When working on overhead doors, employers should ensure that an installation/service manual is available for reference and that workers follow the manufacturer's recommendations.

Discussion: A garage door that does not go up and down smoothly when manually operated most likely has a problem with the track and roller system or a spring system that is out of balance. Overhead door springs are both very powerful and very dangerous and can cause serious physical injury and death, as happened in this case. Maintenance companies should develop a standard safety procedure for overhead door maintenance to address the potential safety hazards involved in working around overhead doors as well as proper safety precautions and protective measures. Employees should receive adequate training before being allowed to work on overhead doors. For problems beyond the scope of the training and experience of the maintenance staff, the employer should hire professional garage door technicians to work on the doors.

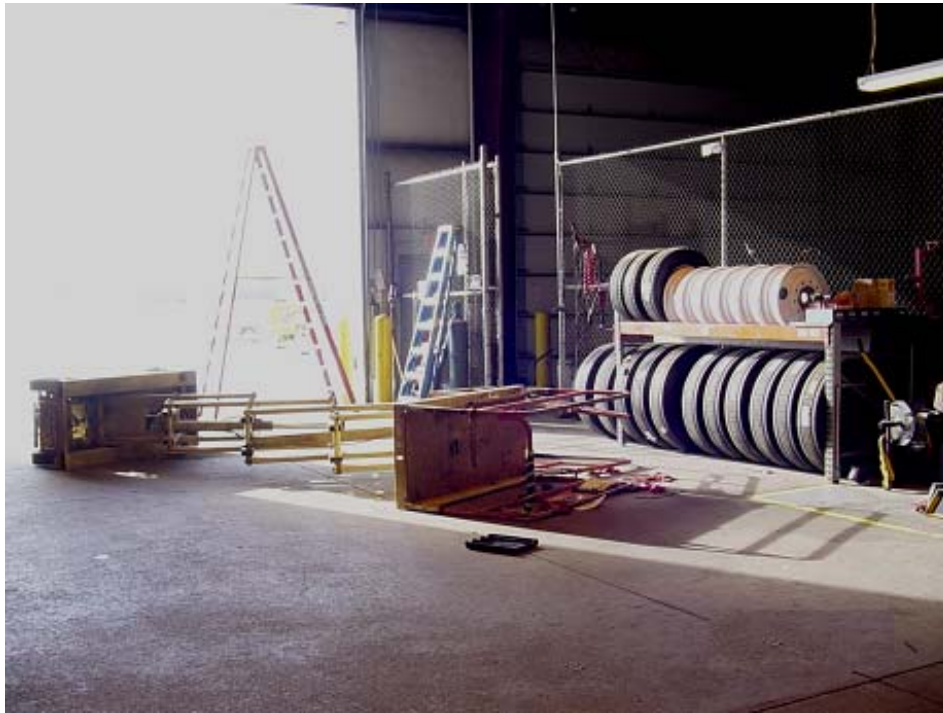
At approximately 7:00 p.m., the victim was working on the platform of a scissors lift that was extended approximately 15 feet above the ground and parked parallel to the door. No additional fall protection was used. Fall protection is not required by OSHA when operating a scissors lift with a standard guardrail system. The victim first tried to manually disconnect the door arm assembly from the track with the emergency release handle by pulling the handle and cord assembly, but it would not release. He then asked for a screwdriver. At this time, the co-worker and a shipping company mechanic were both in the area on the ground. The shipping company mechanic provided a screwdriver to the victim. The victim used the screwdriver to pry the emergency disconnect away from the chain drive assembly. According to the co-worker, both he and the victim anticipated that the door would go down upon being manually released due to its weight. However, the door abruptly sprang upwards to the fully open position, striking the guardrail of the scissors lift, and causing the lift to topple to the concrete floor. The co-worker and the shipping company mechanic ran to the victim who had fallen out of the lift and was lying on the concrete unresponsive. The mechanic called 911. The EMS squad and police arrived within minutes. The victim was quickly transported to a hospital where he was pronounced dead.

Photo 2. Post incident scene: the scissors lift was struck by the garage door after the door was released by the victim, toppling the lift. (Courtesy of OSHA)

According to the post-incident examination, the scissors lift had been operated within the scope of the technique specifications and performance capacity at the time of the incident. There were no known mechanical defects or malfunctioning parts on the scissors lift that may have contributed to the incident.

Discussion: A jammed door may have tremendous potential energy that may be released suddenly when the jam is cleared. Workers should stay clear of overhead door paths. The door path should also be clear of any lift or other equipment that may cause injury if struck by the moving door.
