FATALITY ASSESSMENT AND CONTROL EVALUATION

**Ironworker Foreman Crushed when Bridge Support Element
Broke During Dismantling
Case Report: 05NY013**

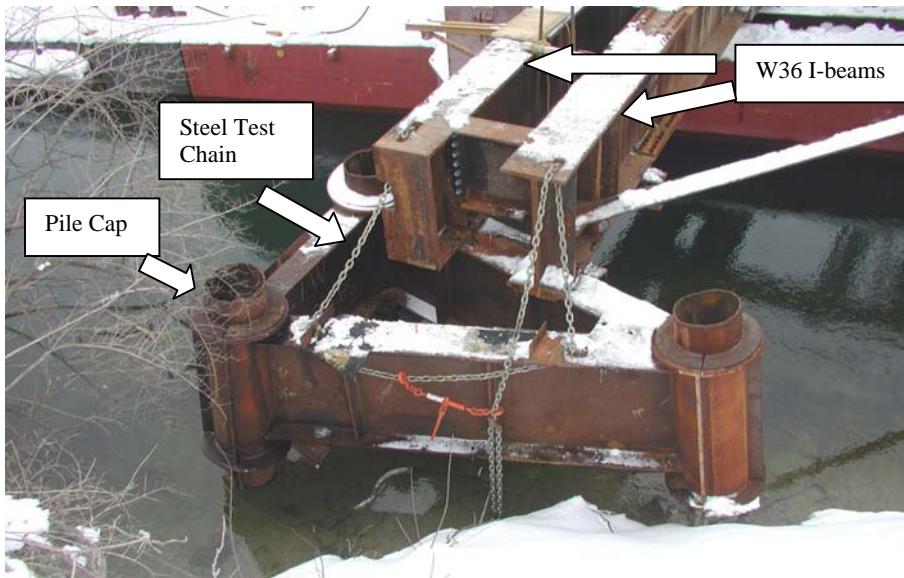
Photo 1. A pile cap that was attached to a pair of W36 I-beams and secured with a 12,000 lb. steel test chain.

The post-incident examination revealed that the cap had been welded to the W36 I-beams with two welds. It appeared that both welds had been partially cut prior to the incident. The company's original engineering plan dictated that all pile caps were to be bolted to the I-beams with four 7/8" A325 bolts and chained to the W36 beams with two 5,000 lb. test steel chains. Later, the job site superintendent proposed to replace the bolts with welds. The company professional engineer (PE) approved the request and specified that each cap should be welded to the W36 beams with four welds and chained to the beams with two 5000 lb. test steel chains. However the cap that was involved in the incident had been welded to the girders with only two welds instead of four, and all pile caps were chained to the W36 beams with a single 12,000 lb. test chain rather than two 5,000 lb. test chains. These deviations were not communicated to nor discussed with the PE. According to the company PE, the two welds on the cap would not have provided a sufficient safety margin to support the weight of the pile cap and the additional loads.

Discussion: Employers should strictly follow project engineering plans and specifications and discuss any intended modifications of the plan with the project engineer (PE). No deviations from the original plan should be allowed unless reviewed and approved by the PE. In this case, the third cap that was involved in the incident was welded to the girders with two welds instead of four, as approved by the PE. Also, the steel chains connecting the pile caps to the girders were different from what was specified by the PE.

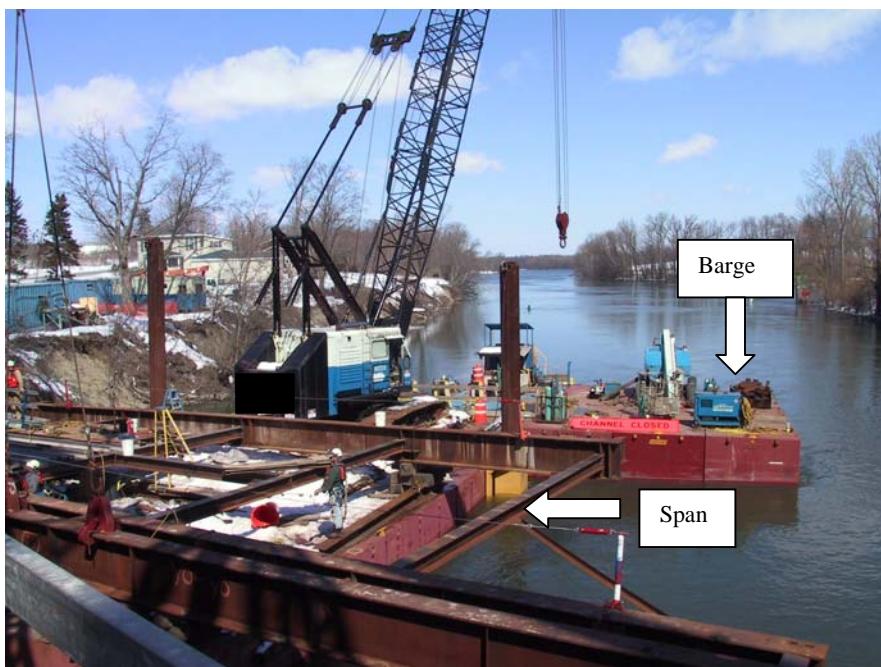
Photo 2. Overview of the barge and workstation where the temporary bridge span was placed and being dismantled.

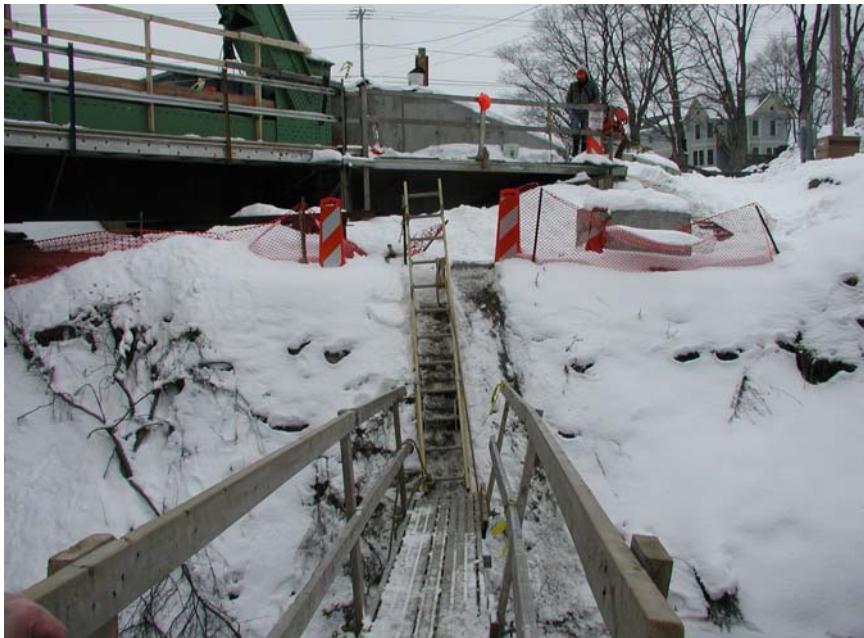
Work started immediately following the crew meeting. Workers entered the work platform on the floating barge through a ladder that was placed against the riverbank and a catwalk (Photo 3). The ladder served as the only access to the barge and was unstable. The top of the ladder was covered with ice and snow at the time of the incident.

Photo 3. The ladder and catwalk that served as the only entrance to the barge.

Discussion: Employers should provide workers with safe access pathways to each worksite. Unsafe worksite access is a potential hazard for workers. In this case, a ladder was placed between the riverbank and the work platform to serve as the only access to the barge. Workers may have fallen while climbing the ladder. Unsafe access pathways may also hinder and delay rescue efforts during an emergency situation. Following this incident, the company removed the ladder and built a catwalk with railings for fall protection for workers to access the barge.

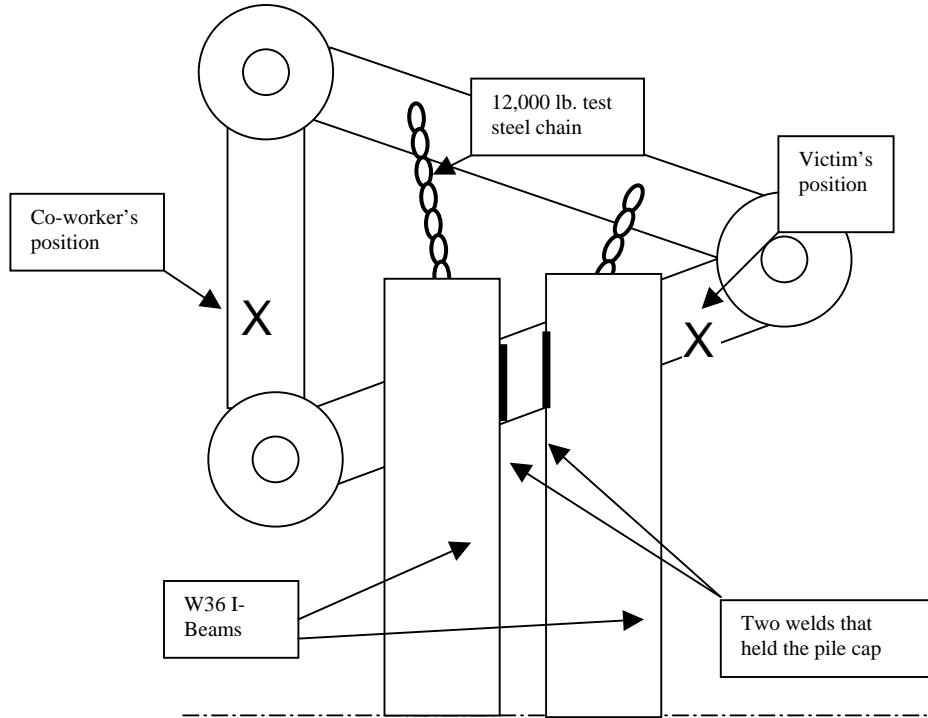
Figure 3. The victim and co-worker's positions on the pile cap at the time of the collapse.

Just prior to the incident, the co-worker got on the cap to assist the victim with rigging. The victim was straddling the two sides of the cap near its tip and the co-worker was standing on the base of the cap (Figure 3). Before they were able to rig the cap to the crane cable, the cap broke apart from the W36 I-beams and swung on the chain towards the ends of the W36 beams. The victim was

Discussion: Immediate employee retraining should be provided in the event of an incident, a near-miss incident, or changes in operational procedures or equipment. The proper procedure for safely dismantling pile caps should be included in the written project plan and reviewed with the crew. The employer should ensure that workers understand the importance of following the dismantling steps in the correct order. Workers should be encouraged to report any unsafe behaviors to the project supervisors and site superintendent. Management should increase supervision to ensure that workers follow appropriate safety procedures.

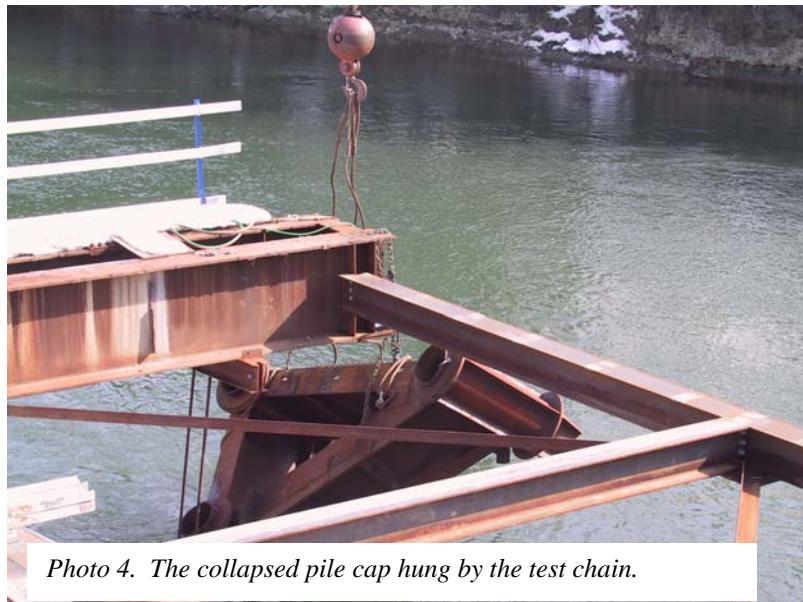
Photo 4. The collapsed pile cap hung by the test chain.

crushed between the swinging pile cap and the ends of the W36 beams. The cap hung on the test chain above the water (Photos 4 and 5) with the victim lying on the pile cap partially submerged in water. The co-worker was thrown into the river and was not injured; he swam to the barge and was pulled out of the water by two workers.

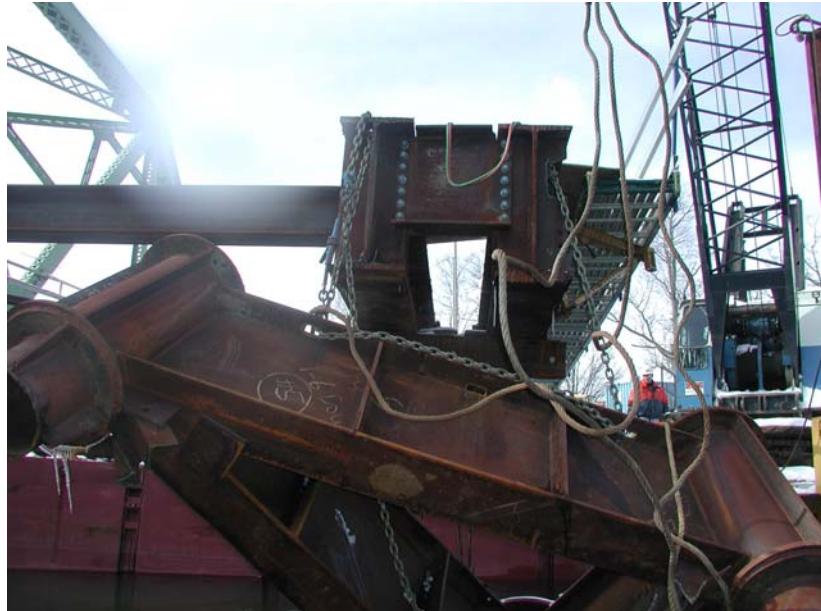
Photo 5. The pile cap hung by the test chains after it broke apart from the W36 I-beams.
