FACE INVESTIGATION: #04WI003

SUBJECT: Laborer Dies when Crushed Between Forklift Cage and Mast

**WISCONSIN FATALITY ASSESSMENT AND CONTROL EVALUATION
(FACE) PROGRAM**

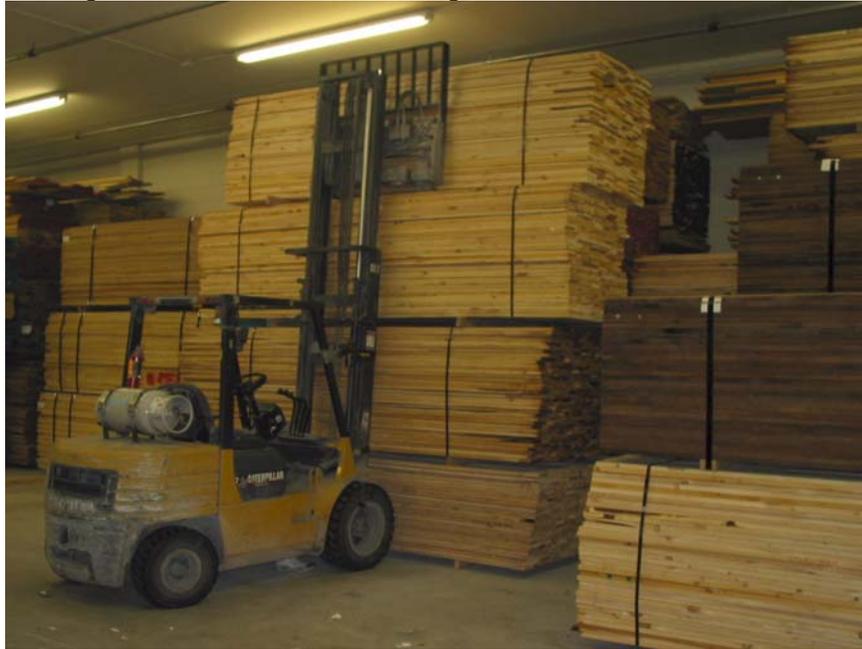
On January 21, 2004, a 41-year-old male laborer (the victim) died when he was crushed between the cage of a forklift and the forklift mast. The victim was using a Caterpillar forklift (powered industrial truck) to unload bundled lumber from a semi-truck in the warehouse of a cabinet manufacturing shop. He had unloaded three bundles of lumber and stacked them against a wall in the building. He was preparing to stack the fourth bundle on top of the third bundle and it is surmised that he noticed one of the spacers on the third bundle, upon which the fourth bundle

would be placed, was missing. (Figure 1.) The victim apparently climbed to the top of the bundle on the forklift to the area where the spacer should have been, and slipped, falling into the forklift controls. This caused the mast to tilt backwards and pin him. He was alone at the time of the incident and was found pinned between the forklift cage and the mast by the semi-truck driver. The semi-truck driver summoned other employees in the

Figure 1. The forklift stacking the fourth bundle of lumber.

On the evening of the incident, the victim unloaded three bundles of lumber and placed them against the wall in the warehouse. He was preparing to stack the fourth bundle on top of the three bundles that had been stacked. The 2" x 4" x 4' spacers were in place on the first two bundles of lumber. The fourth and final bundle was raised and the 2" x 4" x 4' spacer on the left side of the third bundle was in place. However, the 2" x 4" x 4' spacer on the right side of the bundle was missing. It was found on the floor beside the stack of bundled lumber after the incident.

When the victim was found, the load with the fourth bundle on the forklift was raised and in place to be unloaded at a height of approximately 10 feet. Since no witnesses were present at the time of the incident, the following description of what occurred was constructed from the evidence. It is unknown if the spacer fell off the third bundle or if the victim knocked the spacer off the right side with the forklift when he brought the fourth bundle to the unloading area. The victim left the seat of the forklift. He did not lower the load on the forklift, nor did he use the lock knob to put the lock into place on the forklift. It appeared that he tried to climb up the forklift and the bundled lumber to place the right side 2" x 4" x 4' spacer in the correct position on top of the third bundle. He slipped and fell back between the forklift mast and the front of the cage area of the forklift. His lower extremities came in contact with the control levers.

Recommendation #2: Ensure that employees follow safety standards for proper load manipulation, unloading and stacking.

Discussion: If there is a problem with unloading or stacking the load, the load should be lowered and a safe strategy to get the job completed must be identified. In this case, if the load had been lowered, the victim would not have been able to reach the top of the third stack of bundled lumber. Employers should ensure that equipment is available for gaining safe access to

elevated areas. Appropriate ladders, mobile scaffolds and/or lifts used in accordance with OSHA safety standards can be used for this purpose.

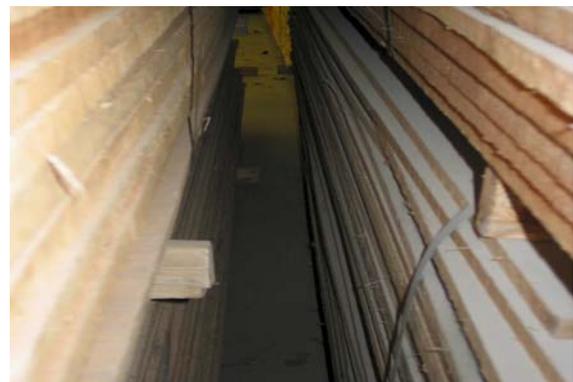
Figure 2. The spacers are stacked edge-wise.

2" x 4" x 4' spacers were placed on each end at the top of the bundled lumber. Following this procedure, the load was transported via forklift to the wall where the bundled lumber was stacked. The load was raised and the bundled lumber was placed in its final position against the wall. This method ensured the 2" x 4" x 4' spacers were in place for the next bundle to be stacked on top of them.

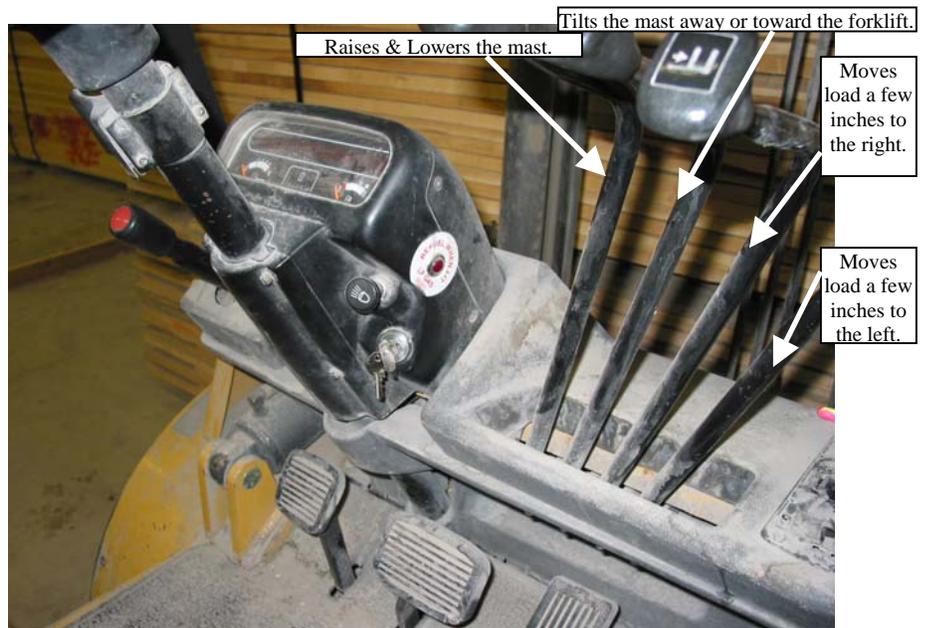
The forklift had four levers to operate the direction of the load. Starting from the left side of the four levers, the first lever on the left raised and lowered the mast. The second lever tilted the mast either away from or towards the forklift. The third lever allowed the operator to move the load a few inches to the right and the fourth lever allowed the operator to move the load a few inches to the left. (Figure 3) It is surmised that when the victim fell between the mast and the front of the cage area, he initiated the second lever which caused the mast to tilt back towards the cage, pinning him between the mast and the cage.

Figure 3. Forklift controls.

Recommendation #1: Ensure that employees follow safety standards for properly dismounting a forklift.

Discussion: OSHA standards for general industry 1910.178 state that when the operator of a forklift is dismounted and within 25 feet of the forklift still in his view, the load engaging means shall be fully lowered, controls neutralized and the brakes set to prevent movement. The Caterpillar Maintenance and Operator's Manual states the following when leaving the forklift or parking it:

- Set the parking brake.
- Put the direction lever in neutral.
- Place the lock knob in the lock position.
- Lower the forks fully to the floor. Tilt the mast forward until the forks are flat.
- Turn off the key.

Hands, feet and all body parts should be kept away from the mast, reach mechanism and other pinch points. Do not climb on any part of the forklift.
