# Fatality Investigation Report

OR 2003-29-1

## Operator killed when bulldozer slides off logging road

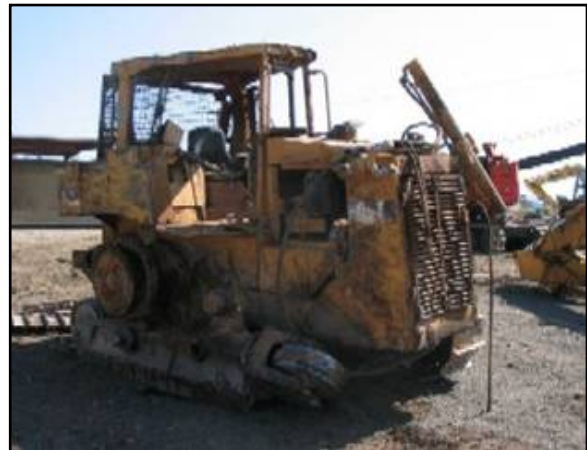
The D6H Caterpillar following the incident shows noticeable damage – missing the front blade, rear grapple, and tracks – but the operator's cage is relatively intact.

The victim was found sitting up, supported by a stump about 50 ft below the main road. He was pronounced dead at the scene. It is believed the victim died from injuries received while being thrown around inside the cab.

### **Recommendation #2. When operating off-road work machines, wear the seatbelt, or utilize some other form of personal safety restraint.**

The victim in this incident is reported to have rarely worn personal restraints while operating heavy equipment. The employer acknowledged this was a risky work practice, but also believed the personal restraints were not designed to meet the demands of the working conditions where the bulldozer was being used. Employees operating heavy equipment with this employer have complained about using personal restraint systems, because they are often bruised or injured by them, even in less demanding circumstances.

In the development of the OSHA standard requiring the provision and use of seatbelts in mobile logging machinery (29 CFR 1910.266 (d)(3)), consideration was given to received comments regarding undue restriction and increased hazard on steep terrain. Reviewing the evidence of machine rollovers, however, showed that all victims were thrown from the cab and crushed by the machine, which might have been avoided by providing and wearing a seatbelt. OSHA considered, but decided not to allow any exceptions to the seatbelt rule. Due to evidence that many operators wear the seatbelt loosely, and that this does not protect the operator in a rollover, OSHA also requires the seatbelt to be securely fastened.

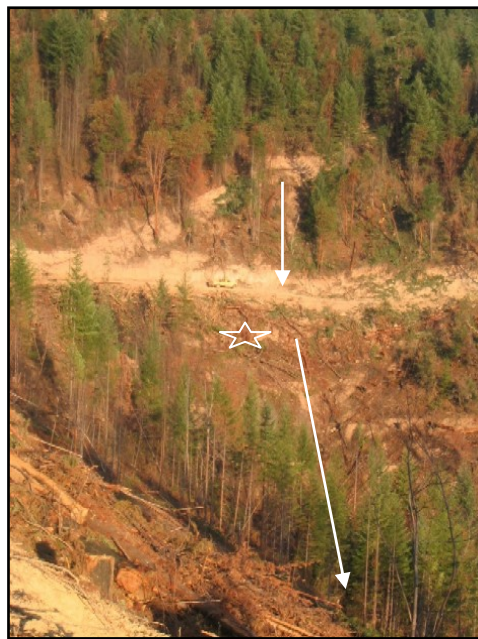
Arrows indicate the path of the Caterpillar as it tumbled off the skid road into the ravine. The star shows where the operator was thrown from the cab.

About 150 ft up the road, a hard layer of sedimentary rock was exposed. The bulldozer's metal tracks lost traction on the slick rock surface, and the 27-ton machine slid off the road, but was stopped by an old madrone tree. The bulldozer was facing uphill at this point. The operator had probably dropped the blade in an attempt to stop the slide off the road, causing the machine to face uphill when it came to rest against the tree. The operator regained control and apparently decided to turn downhill to get off the side of the mountain.

The exact maneuver at this point is not clear, but in the effort to regain the road, the bulldozer slipped off the steep 60-70 degree sidehill and tumbled several times before hitting the main logging road 150 ft below. The impact tore off the blade and the operator was ejected. The bulldozer continued to tumble to the bottom of the ravine another 450 ft farther, leaving a trail of metal debris.

### **Recommendation #4. Drop the blade to help control or stop a slide.**

When faced with a situation where the bulldozer starts to slide, it is best to drop the blade in an attempt to stop the downward progression. Usually dropping the blade is enough to stop sideways motion, though in some circumstances the blade may slide on the hard surface as well. On steep terrain, wherever possible, a bulldozer should face downhill while working to increase the effectiveness of the blade to control a slide.
