## MIFACE INVESTIGATION: #05MI064

### SUBJECT: Farmer Pinned Under Left Rear Tire of Industrial Tractor-Loader With Backhoe

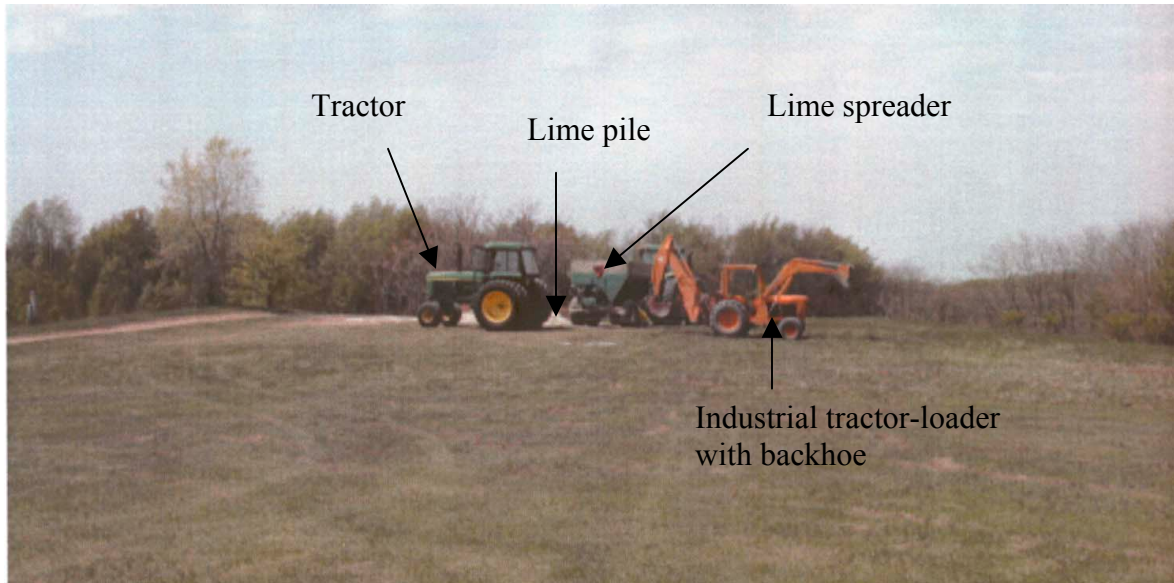
Figure 1. Overview of incident scene showing industrial loader on slight decline, location of lime pile, tractor and spreader

On May 6, 2005, an 82-year-old male farmer was pinned under the left rear wheel of the John Deere 300-B industrial tractor-loader with backhoe. He was in the process of loading lime into a spreader so it could be distributed on his fields. He left the loader bucket in the air, and had not placed the tractor-loader in park. The engine was idling. It is presumed that as he was trying to exit or enter the tractor-loader, it began to roll down a slight incline and he was pinned under the left rear wheel. Neighbors who heard the tractor-loader idling looked out their window with binoculars and saw the victim under the left rear tractor wheel. They called 911. When emergency response arrived, he was declared dead at the scene.

- Practice safe dismount procedures including lowering the bucket and locking the brakes or using the park-lock.
- When parking a machine on a slope, position the machine at a right angle to the slope.
- Do not try to re-enter moving machinery.

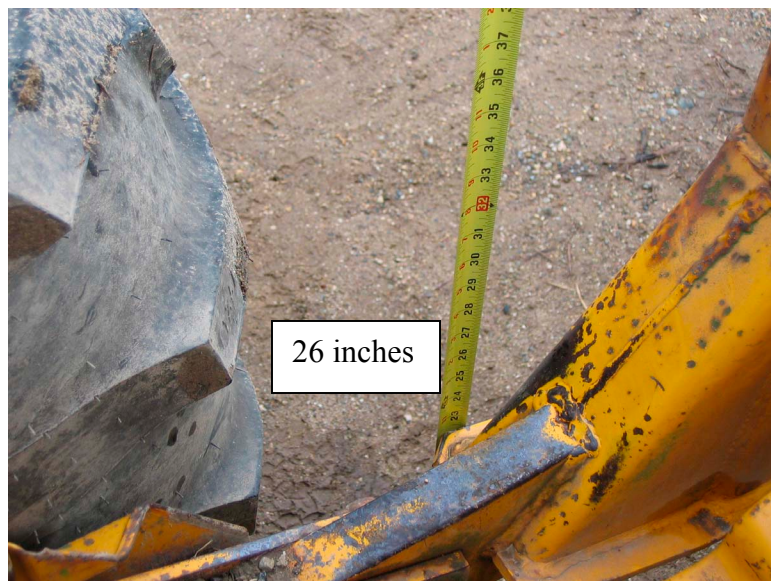
The victim was operating a John Deere 300-B industrial tractor-loader with backhoe. He purchased the equipment new in 1976. The rear tires were 49 inches tall with a tire tread width of 17 inches. The rear tire size was 17.5 L24. The distance between the ground and subframe (top of where you step into the tractor-loader) that carried the loader weight was 26 inches. See Figure 2. The distance between the rear tire and loader frame was 12 inches. See Figure 3. The loader weight was approximately 8,000 pounds.

Figure 2. Height of subframe from ground

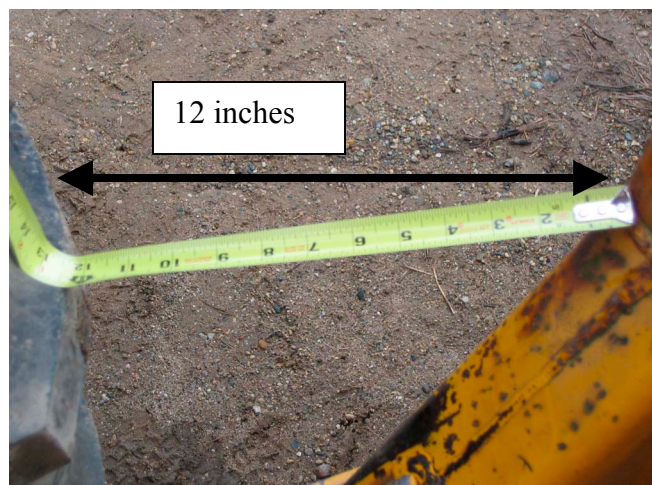
Figure 3. Width between subframe and rear tire

The victim probably placed the right lever of the tractor-loader into a “neutral” shift position (in the middle of the “H”) and left the engine running. The left tractor-loader lever was engaged in the low speed position. See Figure 4. His family members developed the following scenario: The victim noticed that he did not have his work gloves on when he was beginning to load the lime with the 300-B. The tractor-loader was located on a slight incline, estimated at approximately two degrees by his son. Without lowering the bucket or placing the speed gearshift in park, he dismounted the tractor-loader while it was idling to walk to the 8110 to retrieve his gloves. It is unknown when he may have been struck by the left tractor-loader tire; he could have been dismounting or trying to stop the tractor-loader movement while standing on the ground. If the victim had already dismounted, he was probably trying to stop the moving tractor-loader by either reaching between the frame and the fender or by trying to step back into the loader to place the gearshift into park. He had approximately 12 inches between the frame and the bumper to enter the cab (See Figure 3). He either slipped or was caught by the left rear wheel and he was pinned under the wheel.

The fatal injury may have occurred when the victim was attempting to stop the moving tractor-loader, either when reaching between the subframe and the fender or while trying to step into the cab. Operators should not attempt to remount moving vehicles. In this case the tractor-loader would not have caused any significant human or environmental damage. It should have been let go and retrieved once it came to rest.

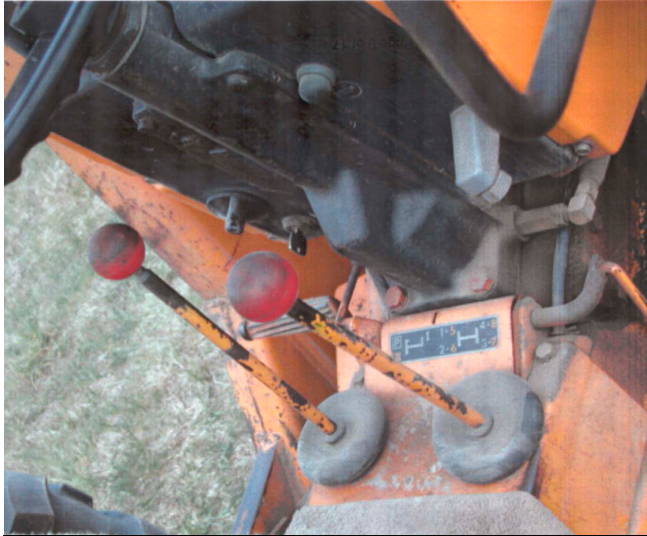
Figure 4. Position of gear levers taken after incident.

- Practice safe dismount procedures including lowering the bucket and locking the brakes or using the park-lock.

Generally, an operator, while sitting in the operator's seat, should stop the machine, lower any attachments to the ground, shift controls to neutral/park and lock (if so equipped), engage the parking brake, stop the engine, cycle all hydraulic controls to relieve system pressures and remove the key. Performing these steps will reduce the likelihood of a tractor or machine unexpectedly moving forward or backward.
