MIFACE INVESTIGATION: #04MI180

SUBJECT: Mill Hand Dies When Drill Was Thrown From Shattered Hardened Steel Tool Extension and Strikes Him In Chest

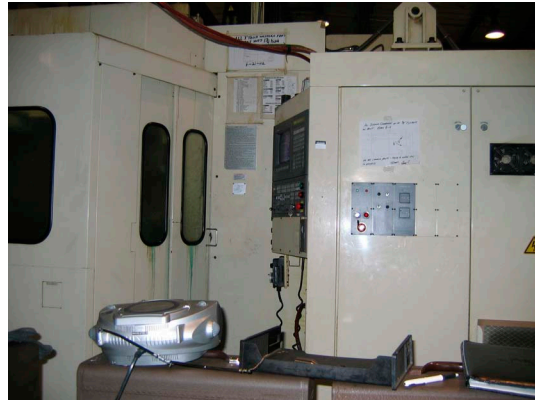
Figure 1. CNC machine involved in incident

The victim was operating a MC-600-H CNC machine with a spindle capability of 5000 rpm. The machine was purchased new in 1997. See Figure 1. The CNC machine was equipped with automatic tool loading. The machine's tool magazine contained many drilling tools, and due to the various milling operations required, it was often necessary to change from one drilling tool to another in the same milling program. The tool used was mounted in a spindle and could move as needed to perform whatever cutting operation was required. The material machined was held steady in a fixture or precision vice on a table. The table was moveable, and the computer controlled the movement. The emergency stop button was clearly identified and accessible on the machine the victim was operating.

MIOSHA examined the CNC machine after the incident. An interlock switch on the doors at the CRT position was out of adjustment. This interlock would prevent the machine from operating if the doors were opened. This non-interlock was not a factor in the incident. It was possible to see damage on the automatic tool change arm. The tool changer swing arm assembly above the machine spindle was dented. Also the dent’s distance from the machine’s “face” appeared to “line up” with the bent tool extension.

- Employers should ensure equipment is maintained according to manufacturer instructions.

Although not a factor in this incident, an interlock switch on the doors at the CRT position was out of adjustment. An out-of-adjustment interlock switch could be a contributing factor in a future injury/fatality. Newer machines have a program override to ensure that doors may not be open when machining is being performed.

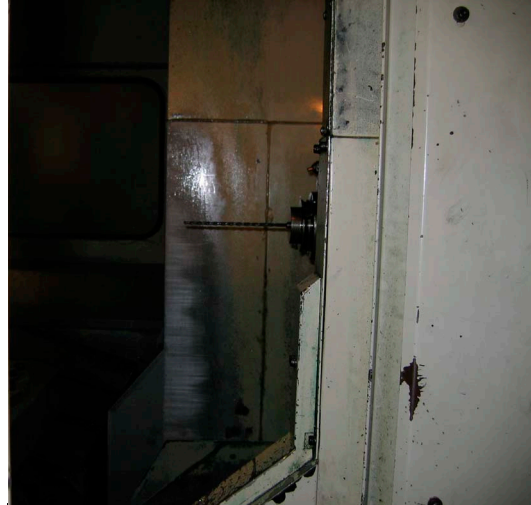
a purchased six-inch long, one-inch O.D. hardened steel tool extension. The hardened steel tool extension had a 1/2-inch internal diameter thread that was connected to an in-house manufactured soft steel tool extension that was 10-inches long and had a one-inch O.D. Two inches of the soft steel tool extension was inside of the tool holder. The victim attached this tooling to the tool holder and pressed the “clamp” button on the computer console. The overall extended tool length was estimated at 24 inches. Figure 2 shows a sample tool (not the tool involved in the incident) placed in a tool holder within the CNC machine with the machine’s doors in the open position.

Figure 2. Example of tool in holder within the CNC machine with doors open

The spindle speed force exertion caused the soft steel tool extension to bend to an approximate 90-degree angle. The bending caused the hardened steel tool extension to strike part of the automatic tool changer. The hardened steel tool extension shattered and released the drill. The drill shank bent approximately 10 degrees. Both the shattered extension pieces and the thrown drill struck the victim. The extension pieces struck the upper side of his cheekbone, his jaw and neck. The drill entered the victim’s body below the left collarbone point first. The programmer hit the emergency stop button. The supervisor who heard the bang went to the location, attempted first aid measures and tried to stop the bleeding. Emergency response was called and the victim was taken to the hospital where he died.

- Employers should consider reviewing their standard operating procedures to include keeping machine doors closed when possible.

The victim was observing the tooling rotation through open doors. It is unknown if this was a common practice. It is also unknown that if had the doors been closed whether the extension and drill airborne paths would have been deflected or slowed to a degree that may have avoided or caused a lesser injury to the victim. Employers should review machine operation standard operating procedures to determine if what protective measures, such as closing the machine doors during testing procedures can be identified and are appropriate for the operation.
