## MIFACE INVESTIGATION: #04MI107

### SUBJECT: Engineering Technician Dies When Backed Over by Cement Mixer

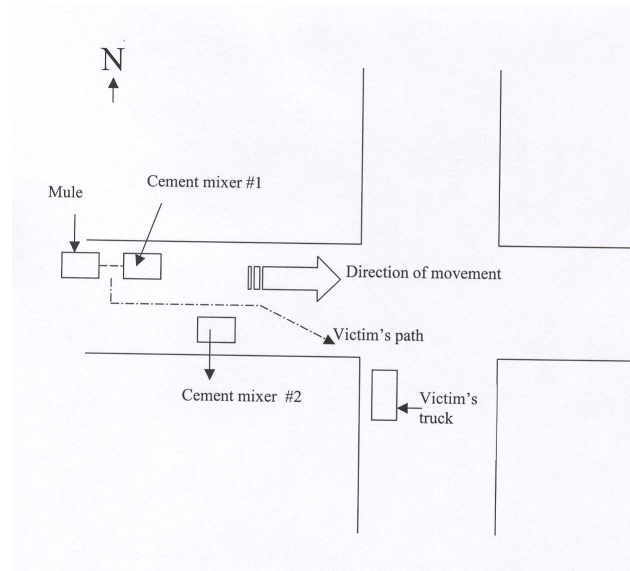
Figure 1. Drawing of incident scene

On July 29, 2004, a 40-year-old male engineering technician was struck and killed on a road-building project by a cement mixer that was traveling in reverse. The road surface was compacted aggregate and crushed limestone and had a slight incline. There were two cement mixers in the immediate vicinity. Cement mixer #1 was unloading cement into a curb-paving machine ("mule"). Cement mixer #2 had already completed unloading its cement into the mule and was being washed out by the driver. To determine if the mixer #1's concrete was within specifications, the victim took a sample that weighed approximately 600 pounds from chute and loaded the concrete into a wheelbarrow. The victim pushed the wheelbarrow past the driver side of mixer #1, and as he came to the rear of mixer #2, he turned sharply south, to his right to get to his truck. The victim's back was facing mixer #2. At approximately the same time, the driver of mixer #2 finished washing out his mixer, entered the cab, activated his backup alarms and began to move in reverse to leave the job site. See Figure 1. It appears that the victim heard the backup alarm from mixer #2 because a witness stated that he increased his pace to attempt to get out of the way of the mixer. It appears that the victim either tripped or lost control of the wheelbarrow and was struck and backed over by mixer #2. The victim was transported to a local hospital where he was declared dead.

- Employers should ensure that workers on foot remain clear of moving equipment by developing and utilizing an "Internal Traffic Control Plan" for each highway and road work zone project.
- Ensure appropriate communication methods for workers on foot and equipment operators; equipment operators should use trained spotters.
- Review options for equipment-warning devices for both construction equipment and employees.

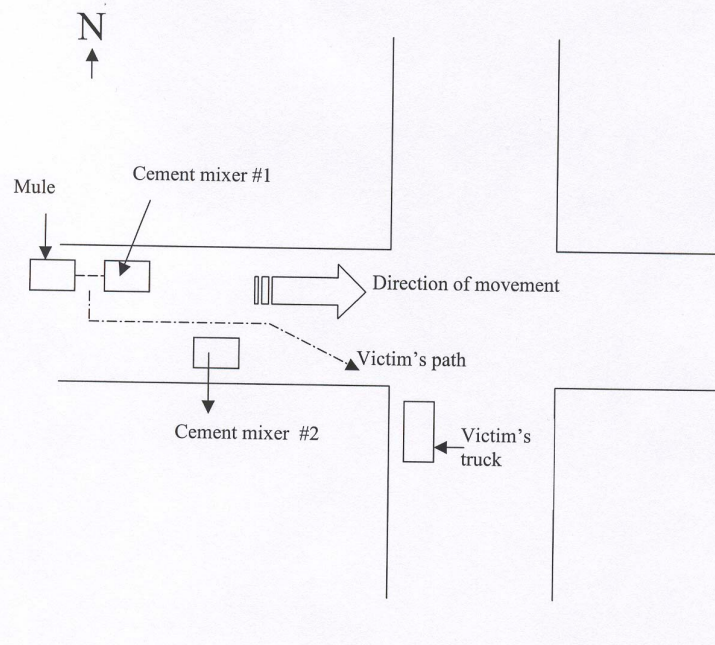
Figure 1. Drawing of incident scene

Curbs were being laid by a slip form paving machine or "mule." This machine is an extrusion-type of machine, and does not use a permanent form for the concrete. Concrete is discharged from the mixer via the chute directly into the mule. The mule lays the curb at approximately 2000 feet/day and must stay moving. Therefore, when a cement mixer is empty, it moves out of the way and another mixer takes its place. The mule and mixer #1 were laying curb on the north side of the road. They were moving east – this required mixer #1 unloading the cement into the mule to be traveling in reverse. The backup alarm was operational. A cement mixer that had previously unloaded its cement, cement mixer #2, had moved to the south side of the road and was being washed out by the driver.

The incident occurred around 11:00 a.m. The victim parked his truck on the southwest corner of the existing crossroad, at the base of the incline of the road under construction. This allowed him to push the empty wheelbarrow up the incline and take the full wheelbarrow down the incline. He took the wheelbarrow to cement mixer #1 and asked for the load ticket. After he gathered the information, he unloaded approximately 600 pounds of concrete from the chute. The victim proceeded back to his truck so he could conduct the quality checks. See Figure 1. The victim pushed the wheelbarrow past the driver side of the mixer #1, and as he came to the rear of mixer #2, he turned sharply south, to his right, to get to his truck. At approximately the same time, the driver of mixer #2 finished washing out his mixer, entered the cab, activated his backup alarms and began to move in reverse to leave the job site.

The driver of cement mixer #2 stated he looked in both mirrors and backed up very slowly with his foot on the brake. All safety features of mixer #2 were in good operating order. According to the police report, a witness thought that the victim heard the backup alarm because he quickened his pace in what looked like an attempt to get out of the way of the mixer. The victim either lost his balance or tripped and fell toward the wheelbarrow. The passenger side rear tire of mixer #2 struck the victim on his right side, and ran over him and the wheelbarrow.

- Employers should ensure that workers on foot remain clear of moving equipment by developing and utilizing an "Internal Traffic Control Plan" for each highway and road work zone project.

Due to the size of the road area, it would have been difficult for the driver of mixer #2 to pull forward and turn his mixer around so that he could drive out of the area instead of back out of the area. Although there was an alternate route that would have allowed him to drive out instead of back out, possibly due to construction vehicles in the way, the mixer driver did not take it.

Equipment operators should take special care when backing out to ensure the area behind them is clear. MIFACE recommends that, prior to backing out, (a) the operator walk around his vehicle before entering the cab to determine the conditions around the vehicle and, (b) recruit a trained "spotter".
