## **Vibratory Hammer Operator Killed when Crushed Between a Crane Superstructure and its Left Rear Track - Massachusetts**

**Investigation: # 03-MA-006-01**

**Release Date: January 26, 2005**

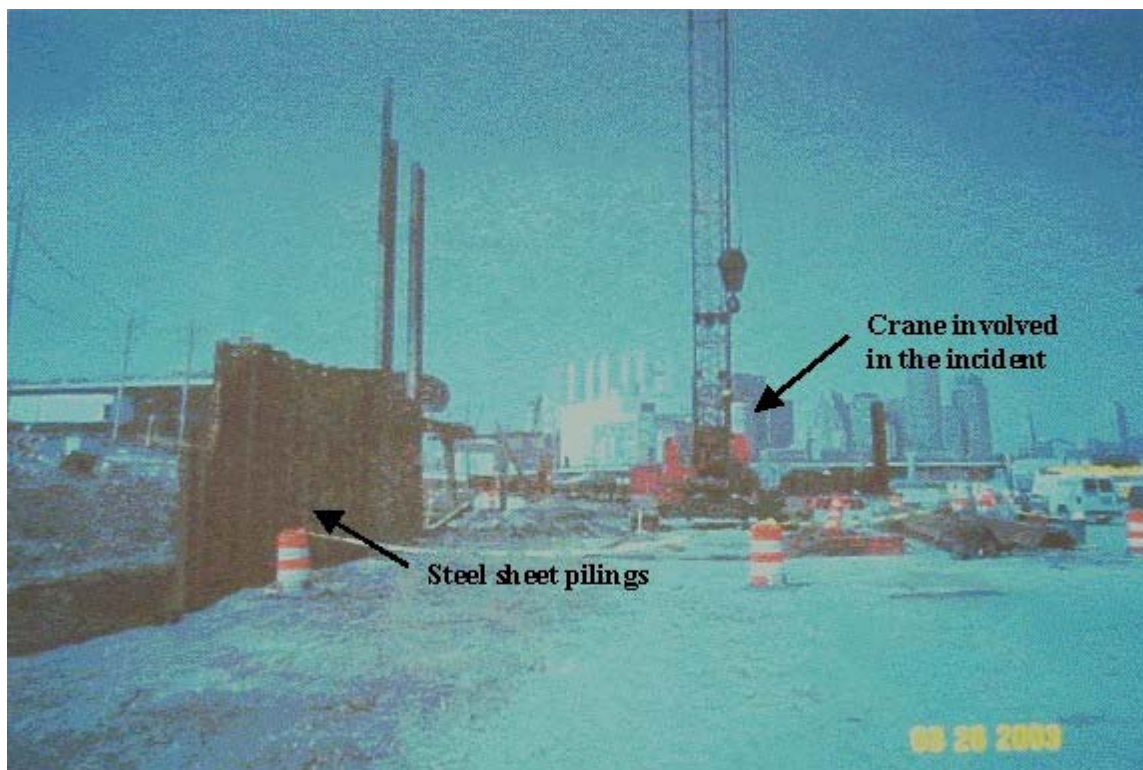
The crane involved in the incident was a 70-ton lattice boom crawler, manufactured in 1975. The company had purchased the crane approximately one year prior to the incident. A vibratory hammer rigged to the crane was being used to install the steel sheet pilings (Figure 1). The vibratory hammer was powered by a power pack, which consisted of a diesel engine that provided the energy required by the hydraulic motors and hammer clamps.

**Figure 1 - Crane involved in the incident and some driven sheet pilings**

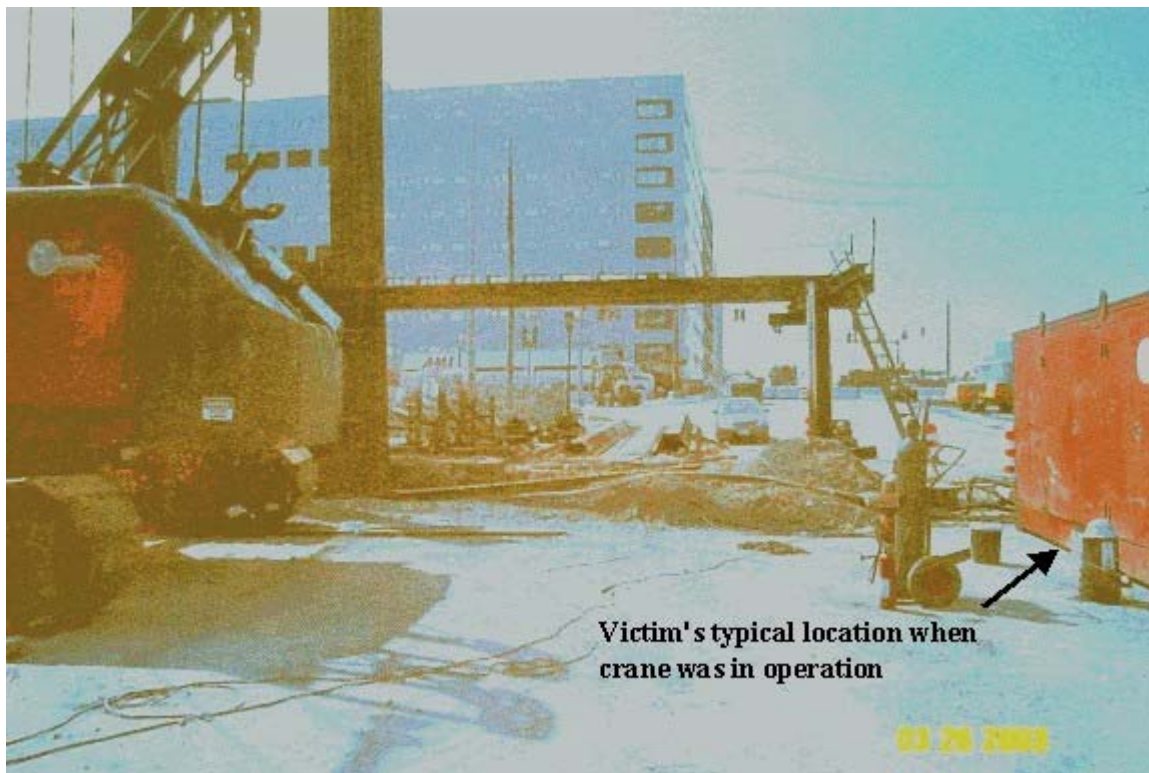
sheet piling allowing it to be driven down into the soil. When the vibration is stopped the soil returns to its former load bearing condition. The victim's main task was to operate the vibratory hammer's hand held controls, mainly turning the vibratory hammer on and off. The victim's typical location during the steel sheet pile driving task was next to the power pack and outside of the crane's swing radius (Figure 2).

**Figure 2 - Victim's typical work location during  
the crane operation**

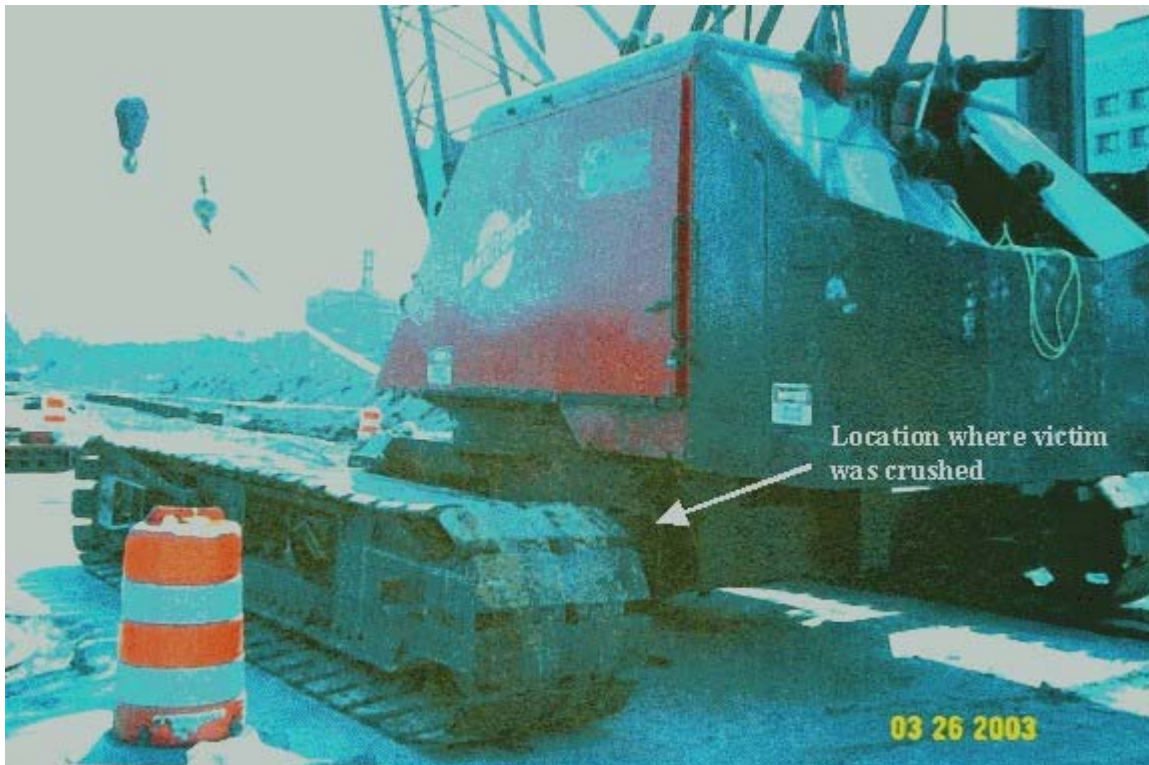
The incident occurred at approximately 9:30 a.m., immediately following the coffee break, when the crew started an unscheduled task because the steel sheet pile driving task was still on hold. The unscheduled task was welding together the already driven sheets. The welding task was not part of the victim's nor the crane operator's job duties, and while the rest of the crew was performing the welding task, the victim and crane operator had additional downtime. During this downtime, the victim walked over to the crane, which did not have a swing radius barricade around the rear of the rotating superstructure. While standing inside the crane's swing radius, between the left rear track and the crane superstructure, the victim was out of the crane operator's line of sight. Without advance warning, the operator moved the crane and swung the superstructure to the right crushing the victim between the left rear track and the superstructure (Figure 3).

The employer reported that it is not known why the crane operator moved the crane and swung the superstructure at that time, but it could have been to reposition the crane to get it ready for when the steel sheet pile driving task could be resumed. In addition, the company stated that the victim might have accessed the swing radius location also to prepare for resuming the steel sheet pile driving task by retrieving a grease gun to grease the hammer. The task of greasing the hammer is typically performed once every two days. The grease gun for this task was stored in the engine compartment at the back of the crane, which is inside the swing radius.

In this case, the rear swing radius of the crane's superstructure was not barricaded. A barricade, either temporary, such as three-inch caution tape, or permanent, such as cement barriers, will help prevent employees from accessing the swing radius and being struck or crushed by the crane. In addition, no one, including vibratory hammer operators and oilers, should ever enter a crane's work area without notifying the crane operator.

**Figure 3 - Location where victim was crushed, between the left rear track and the superstructure.**

**Recommendation #1: Employers should ensure that the swing radius of each crane has been barricaded to prevent employees from entering the swing radius.**

**Discussion:** The OSHA standard 29 CFR 1926.550, *Cranes and derricks*, specifically states "accessible areas within the swing radius of the rear of the rotating superstructure of the crane, either permanently or temporarily mounted, shall be barricaded in such a manner as to prevent an employee from being struck or crushed by the crane."
