# **Dump Truck Driver Dies After Unintentional Release of Asphalt**

**Incident Number: 05KY036**

## **Kentucky Fatality Assessment and Control Evaluation (FACE) Program**

**Subject:** Dump Truck Driver Dies After Unintentional Release of Asphalt

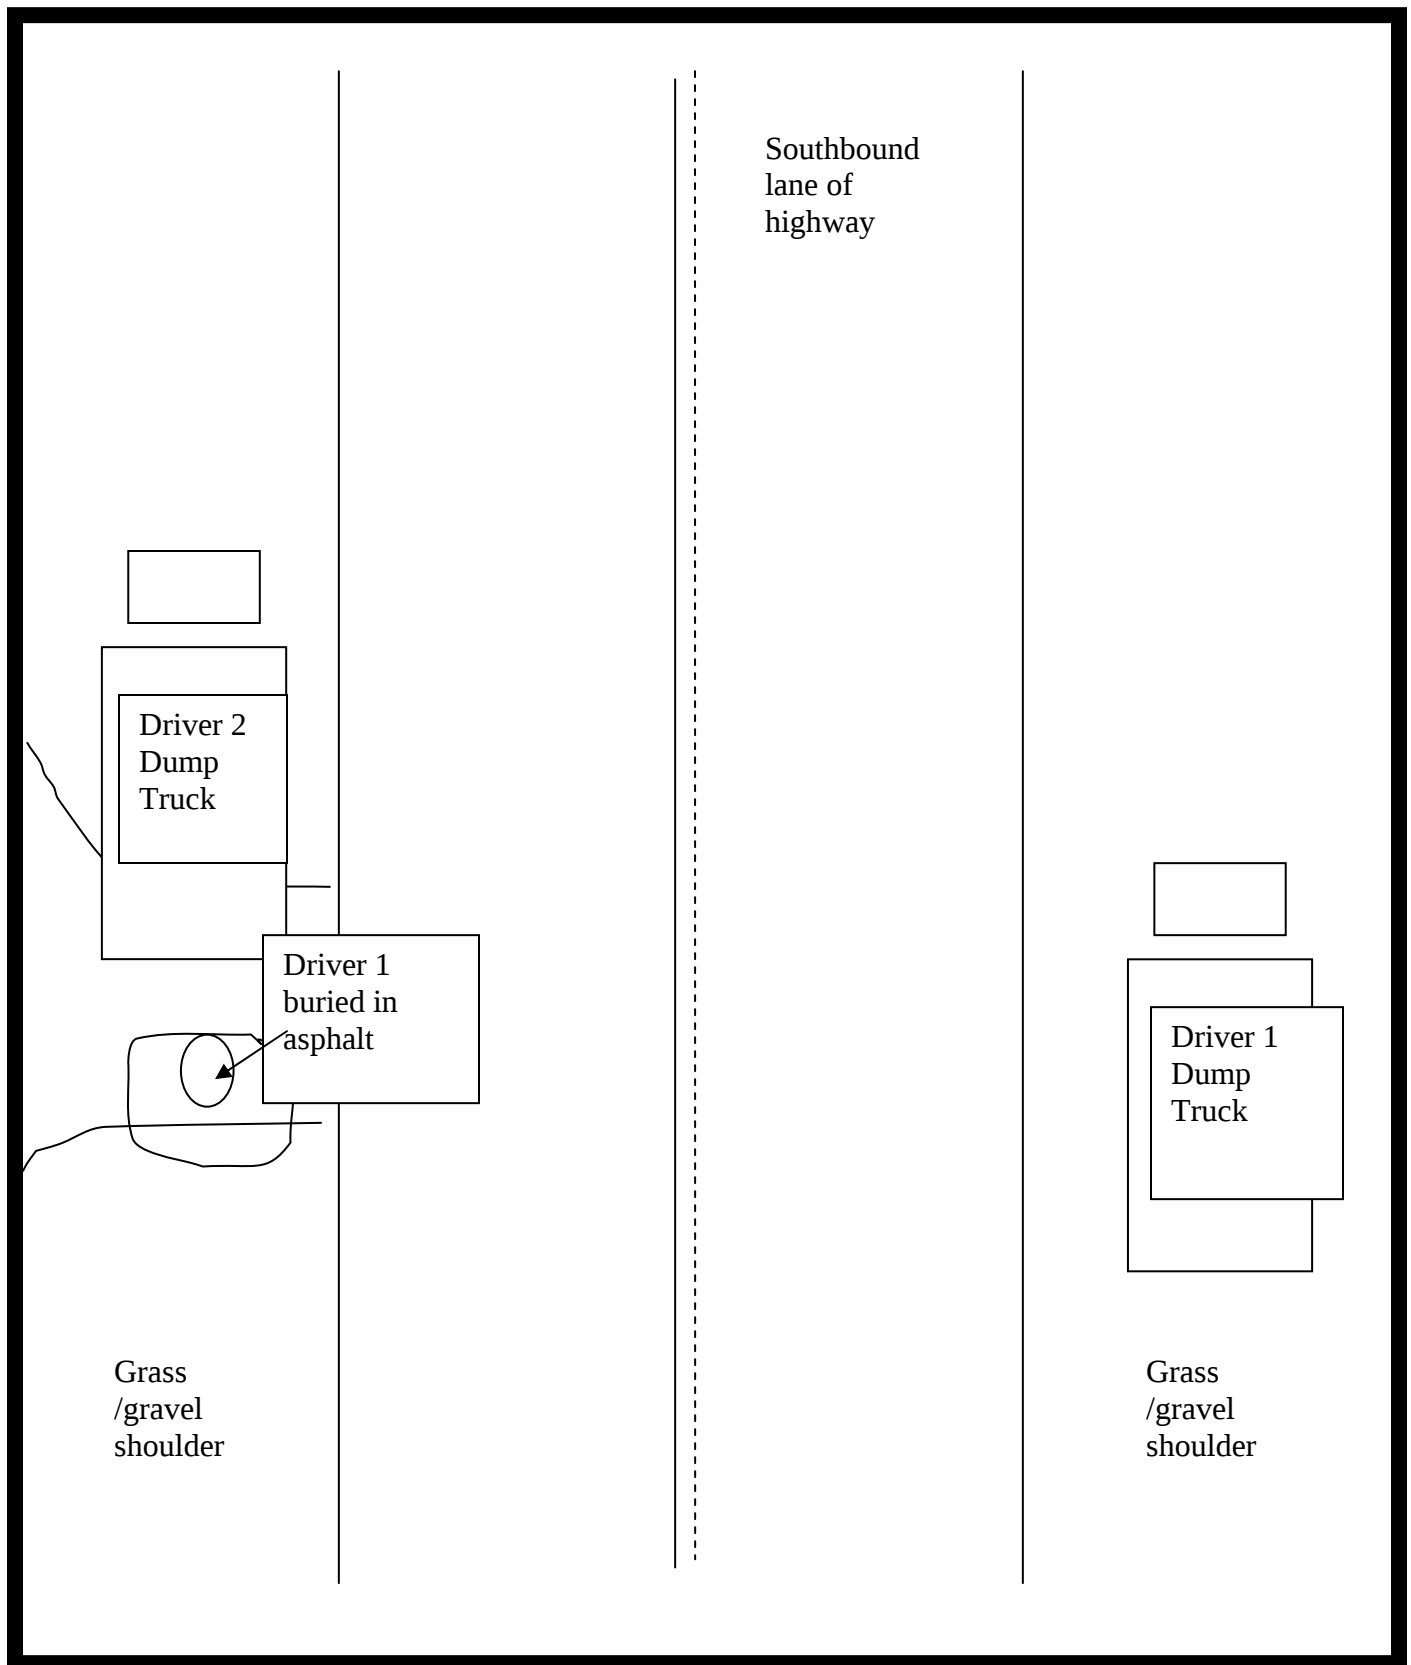
Diagram 1: Diagram of scene. Not to scale.

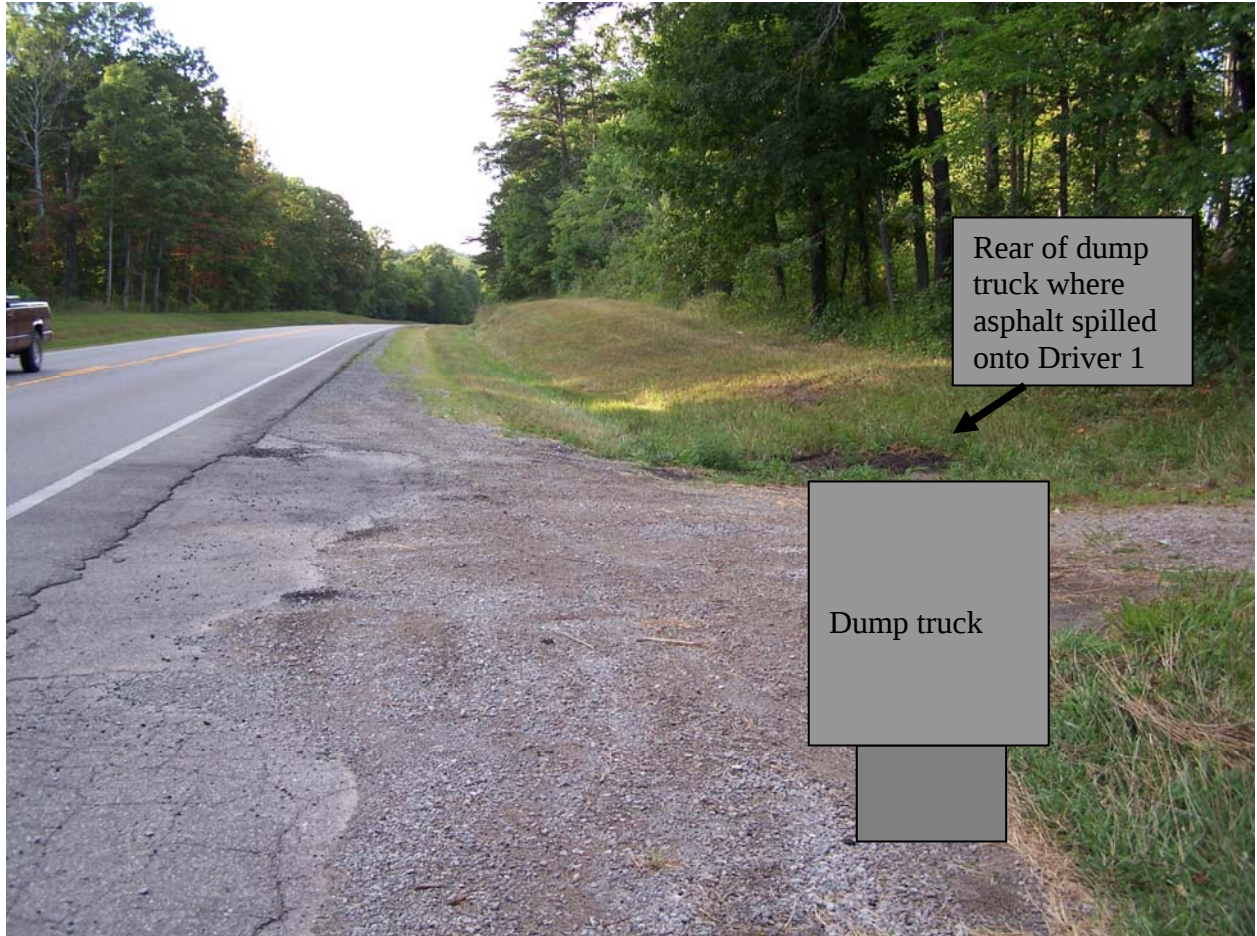
Photo 2: Northbound shoulder where Driver 2 parked dump truck. The dump truck was facing south.
