Nebraska FACE Investigation NE-2005-12

Construction Worker Struck by Falling Steel Roof Beam

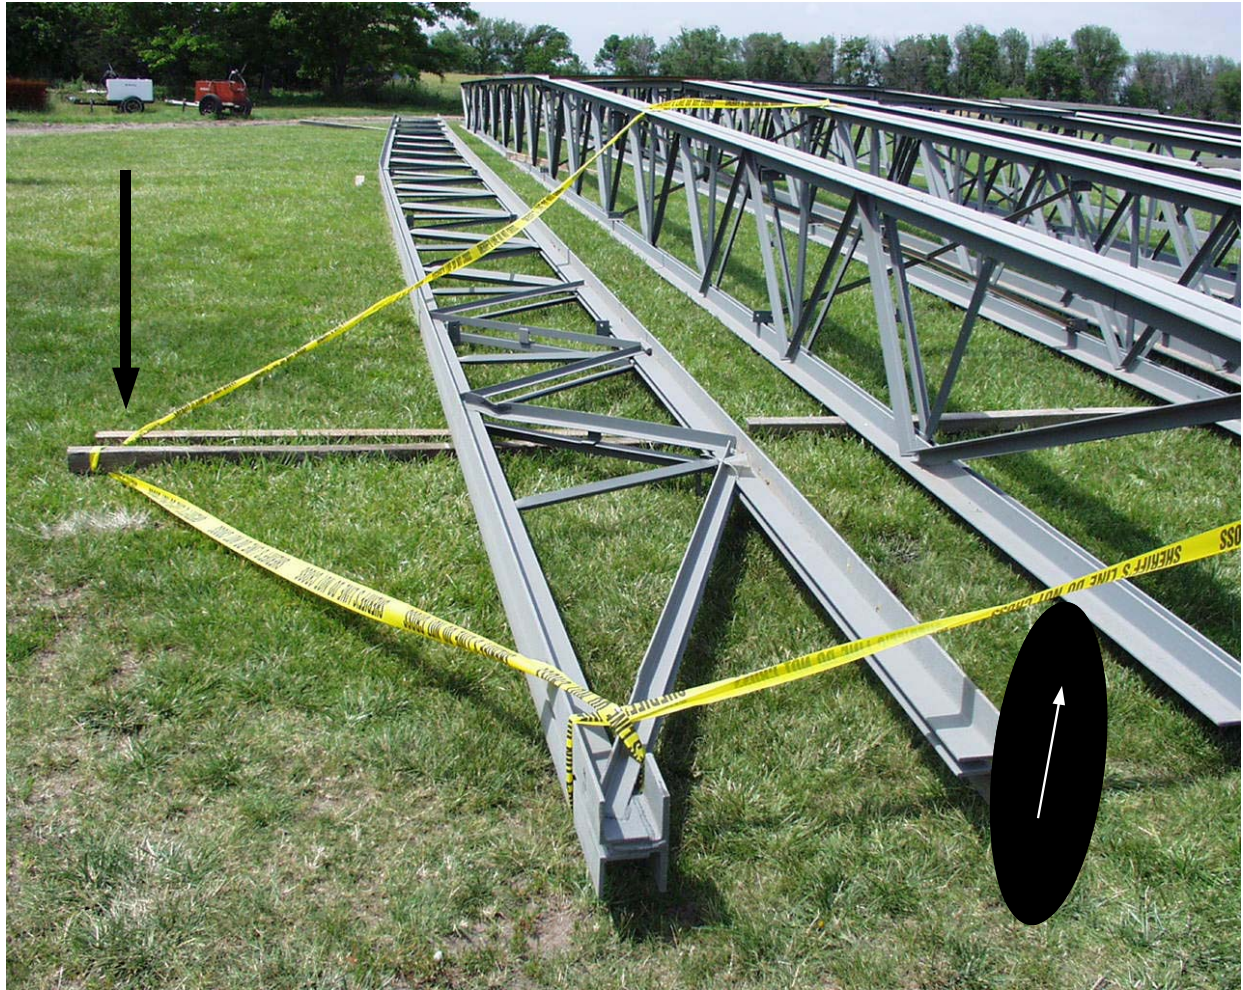
Attachment 2. Picture of incident steal roof beam showing victim's position and location of 4x4s.

This picture was taken the day after the incident looking north. This is the single beam that fell from the forklift tines. The black oval indicates the approximate location of the victim's body after being struck by the beam, which was in a crouched position. The black arrow points to the two 4x4s that this end of the beam was to rest on. It is believed that the top 4x4 was not centered properly and the victim darted underneath the raised beam end to align the boards. The victim was struck by the beam, but was not trapped between the single beam and the paired beam to the right.

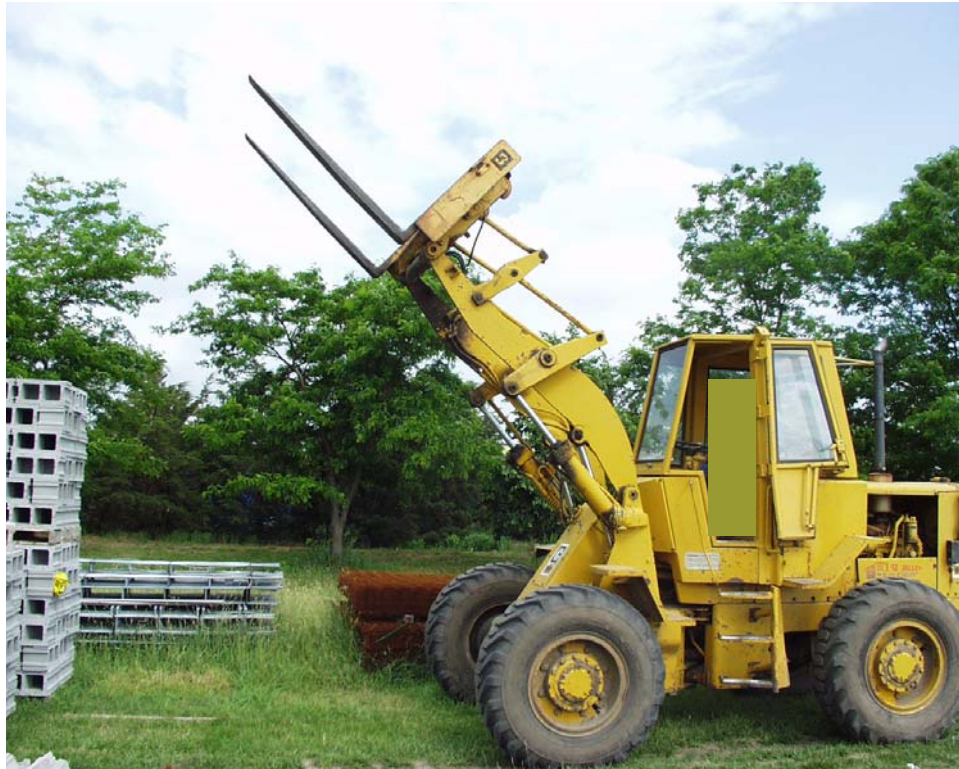
Incident forklift in the maximum raised position necessary to clear concrete blocks.

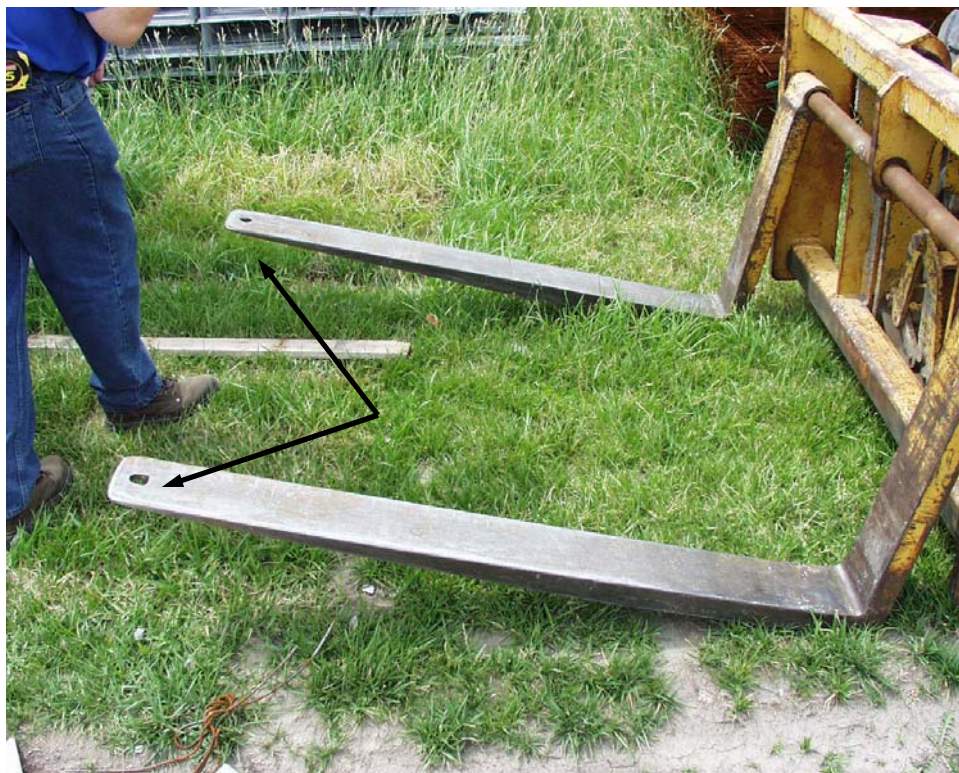
Attachment 3.

Discussion: A single hole, approximately 1 ½" round, had been cut into each forklift tine by a cutting torch. This had been done since the company bought the equipment. The applicable OSHA standard states: *No modifications or additions which affect the capacity or safe operation of the equipment shall be made by the customer or user without the manufacturer's written approval. If such modifications or changes are made, the capacity, operation, and maintenance instruction plates, tags, or decals shall be changed accordingly. In no case shall the original safety factor of the equipment be reduced.*

Arrows indicate holes cut into forklift tines.

- **Recommendation #3: Do not make any modifications or additions to equipment unless authorized by the original equipment manufacturer.**

Reference: 29 CFR 1910.178(a)(4); 29 CFR 1926.602(c)1(ii)
