A plumber repairing a water line in a trench in Texas died when he was struck by the bucket of a backhoe.

Investigation # 99TX39001

Release Date: January 18, 2001

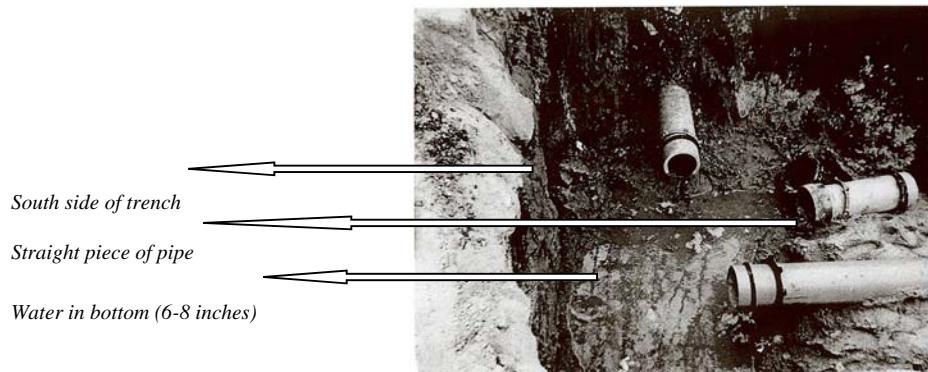
Picture 1: Area of Incident

to 7 feet where the pipe was located. About 6 to 8 inches of water was on the bottom of the trench (*see Picture 1 and Diagram*). There was no shoring, shielding, or sloping of the trench walls.

Recommendation #3 - Employer should ensure that workers are protected from cave-ins by an adequate protective system.

Discussion: Discussion: 29 CFR 1926.652 (a) (1) states that "each employee in an excavation shall be protected from cave-ins by an adequate protective system." A protective system designed for the soil conditions found in this excavation could have included a trench shield (also known as a trench box), shoring, or a combination of shoring and shielding. Employers should consult tables in the appendices of the OSHA Excavation Standard that detail what is required depending upon the type of soil and environmental conditions present at the site. Employers can consult with manufacturers of protective systems to obtain detailed guidance for the appropriate use of these products. In this incident, no protective system had been placed at any point in the 31 foot long trench. Although the victim in this incident was not killed because of a trench cave-in, protective systems should always be used in trenches greater than 5 feet deep (4).

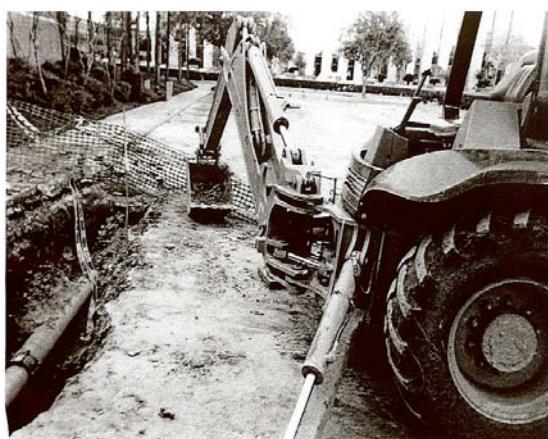
Picture 2: Bucket and Boom of Backhoe

At 11:20AM the "L" pipe had just been placed in the bucket by the victim and apprentice plumber when, unexpectedly, the 255 lb. bucket with the approximately 40 lbs of pipe swung swiftly to the left and struck the victim in the left arm and upper chest, shoving him about six inches and pinning him into the south trench wall. The apprentice plumber yelled at the operator

The operator told the police investigator that when he released all controls, the bucket swerved quickly to the left. Nobody witnessed the operator's movements during the incident.

Recommendation #1 - Employers should ensure that backhoe operators shut down backhoes according to the manufacturer's directions and direct workers to remain an adequate distance from operating backhoes

Discussion: According to the apprentice plumber, the backhoe was running with its bucket positioned about four feet down in the trench directly in line of contact with the victim. If the backhoe had been shut down properly and had workers been directed to remain an adequate distance from the backhoe the fatality may have been averted.

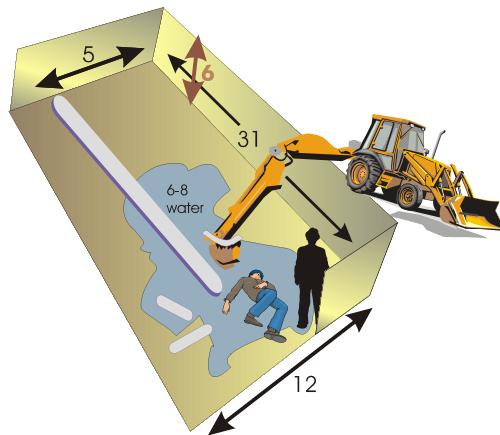
Diagram

The bucket of the backhoe was positioned about four feet down in the trench close to the pipe line. The victim was facing east about one foot directly to the left and in the line of contact with the bucket. The apprentice plumber was also to the left of the bucket but out of its reach and was facing west looking at the victim. (*See Diagram*)
