The foreman for an electrical construction and maintenance company in Texas was electrocuted after grabbing energized bayonet fuse in a live front transformer.

Investigation # 99TX20201

Release Date: 1999

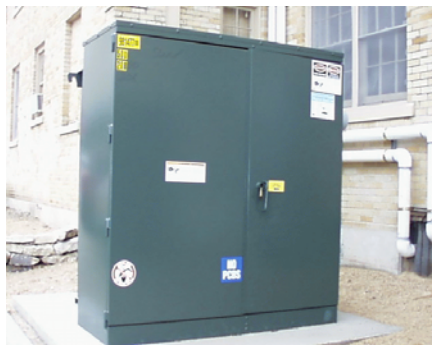
Picture 1

A crew foreman (the victim) and his crew of 4 linemen under contract with the local electrical utility company were changing submersible transformers to single phase pad-mounted dead front transformers in an apartment complex. Live front transformers have energized parts when the doors are opened. Dead front transformers have no energized parts exposed when the doors are opened. The pad-mounted transformers measured 43" wide, 48" high, and 48" deep (see *Picture 1*). On the day of the incident the crew was working on a loop of 12 transformers and was changing units Nos. 7, 8, and 9 (dead front transformers). The transfer had been completed on two transformers (nos. 7 and 8) and they had just changed No.9 and were in the process of re-energizing the loop of transformers. In order to isolate No. 9 to work on it, the transformer's links to the primary cable were disconnected to de-energize the sections of underground voltage lines from No. 8 to No. 9 and from No. 9 to No. 10 (live front transformer). Bayonet fuses inside the transformer doors of Nos. 8 and 10 continued the circuit for the primary cable and were removed to isolate power from reaching No. 9.

PAD-MOUNTED TRANSFORMER

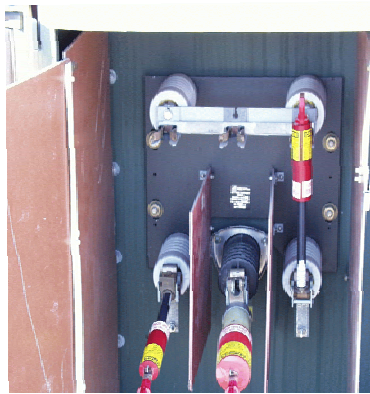
Picture 2

The crew was returning things back to normal on No. 10 by reinstalling the bayonet fuse between two switches (see *Pictures 2 and 3*), which would re-energize the primary cable to No. 9. It was written company policy that an 8 foot, insulated, fiberglass shotgun or hot stick was to be used when making energized connections within a pad-mounted transformer. When the victim approached No. 10, he noticed the lineman having trouble “cocking” the bayonet fuse to insert it into the top switch. “Cocking” is the process of grabbing the middle of the bayonet fuse and sliding the sleeve covering down to reveal the metal contact collar at the top. This metal contact collar was then to be hooked into the top switch to complete the connection and fully energize the system. The fuse would be “hot” at this point. The victim told the lineman to remove the hot stick. The victim then walked three feet to the transformer, leaned his left hand on the top edge of the transformer, and with his left forearm touching the left transformer door, grabbed the electrically energized fuse with his unprotected, bare right hand. This completed the electrical path to the ground, and he was electrocuted by 7200 volts. The resulting flash caused his clothing to catch on fire.

De-energized

BAYONET FUSES INSIDE LIVE FRONT TRANSFORMER

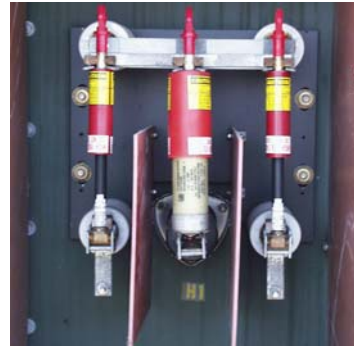
Picture 3

Energized (Hot)
