Occupational Fatality Report

A farm worker on a family run farm in Texas died when he was crushed by the basket of a cotton stripper as he stood in the engine compartment of the cotton stripper.

Investigation: #99TX02001

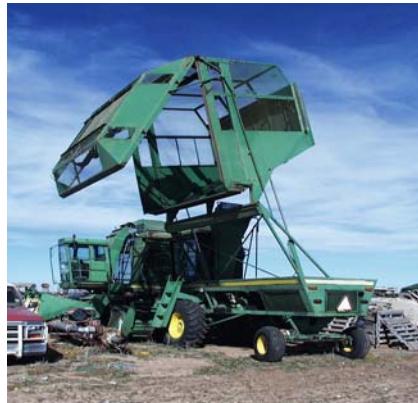
#1: Raised over center

Recommendation #1 - Employers should ensure workers never enter the top of the engine compartment unless the basket is raised over center.

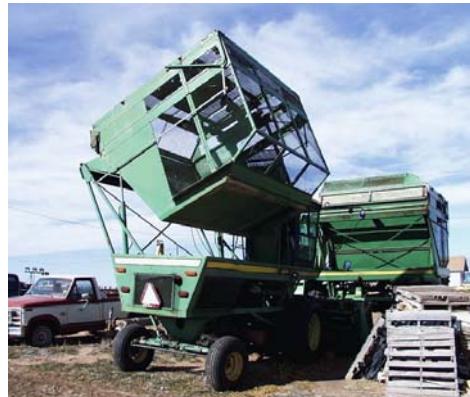
The victim started to strip cotton from one of the fields. When he had a full basket, he proceeded to a module builder to dump his load. A module builder packs the cotton down and prepares it to be transported by truck to a cotton gin. After he dumped his load, he exited the operator's compartment and for an unknown reason stepped into the area above the engine compartment. He was able to get into this area because the basket was still in the raised position but not over center (see photo #2)

While he was in this area, the basket of the cotton stripper slowly descended due to a hydraulic leak. (When the basket is not raised to the over-center position, the weight of the basket is not transferred to a safe position. When the basket is pushed over center, it requires use of the hydraulic system to pull it back and lower it.)

#2: Basket descending

Recommendation #2: Employers should ensure that machinery is checked periodically for leaks or other mechanical defects

Discussion: It is unlikely that this incident would have occurred had the leak been repaired. The victim was the sole operator and he performed maintenance as required. It is unknown if he was aware there was a hydraulic leak. The operator's manual requires the hydraulic oil level be checked every 10 hours. Checking the hydraulic oil level at regular intervals would alert the operator to a possible leak. Also, any hydraulically elevated components without locking detents must be supported by jacks or heavy timber supports.

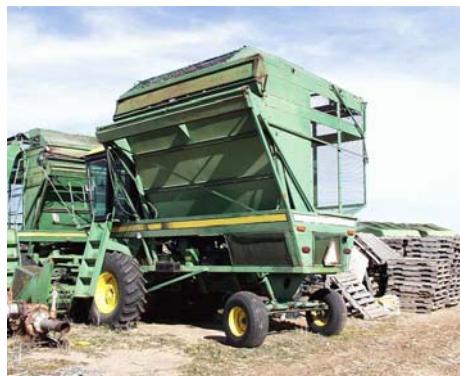
The victim was unaware the basket was slowly descending. Before he could move from beneath the basket, he was pinned between the bottom of the basket and the top of the engine compartment (see photo #3)

#3: Closed basket position

The Justice of the Peace report stated the victim died from suffocation resulting from the tremendous pressure put on his chest from the weight of the cotton basket.
