A laborer for a framing subcontractor in Texas died when he fell from a wooden trash box being lifted by a forklift.

Investigation # 98TX31001

Release Date: May 18, 1999

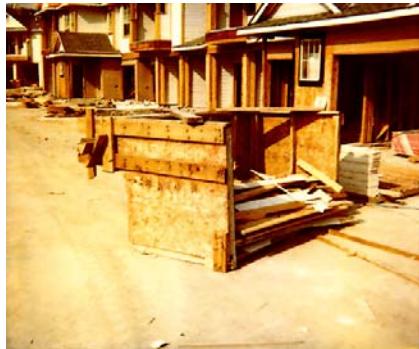
Photo #1

The trash boxes were four feet by eight feet and were made at the job site (see Photo #1). On the sides were the words "for trash only" in both English and Spanish. They were designed to stay on a forklift's forks when their contents were dumped into a larger refuse container. This was accomplished by attaching a bar made of two 2x6's to the back of the box. There was a 17-inch space between the bar and the back of the trash box. The forklift operator would position the face of the forklift's carriage between the wooden bar and the back of the trash box (see Photo #2). The operator could then raise the box and tip it forward to empty refuse into a larger container.

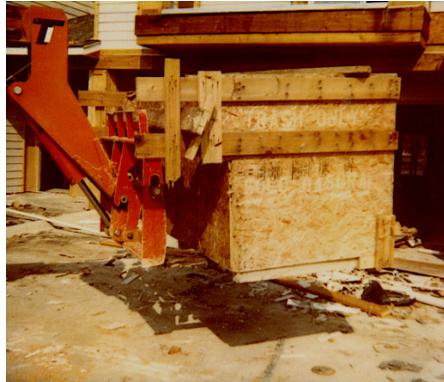
Photo #3

The coworker picked up the trash box without correctly positioning it on the forks. He did not place the face of the forklift's carriage between the bar and the back of the box. Instead, he placed the face of the carriage against the back of the wooden bar (see Photo #3). This caused the front of the box to extend at least 20 inches over the tips of the forks. (Note: The forks were 47 ½ inches in length and the box was 48 inches deep. The space where the carriage is supposed to be positioned plus the thickness of the two 2x6's add an additional 20 inches to the width of the box.)

When the coworker came back with the forklift, he raised the trash box so it was close to the opening on the second floor. The victim stepped into the trash box and told the coworker to reposition the forklift so he could nail up the last piece of sheeting. The forklift was on uneven hard packed dirt. When the coworker attempted to reposition the forklift, the movement caused the box to wobble and the victim fell out of the box to the ground. The box fell off the forks and struck the victim in the head.

Recommendation #2: Employers should ensure that rough terrain forklifts used for lifting personnel, when no other practical means are available, are equipped with stable lifting platforms and fall protection devices.

Discussion: The American Society of Mechanical Engineers in their standard ASME B56.6-1992, Safety Standard for Rough Terrain Forklift Trucks¹, recommends rough terrain forklift trucks not be used to lift people unless there is not other practical option. If a rough terrain forklift truck must be used to lift people, the following precautions should be taken. For the full list see ASME B56.6-1992, para.5.15 (a)-(y).
