SUBJECT: A driller died after falling through an opening in the oil rig floor.

SUMMARY

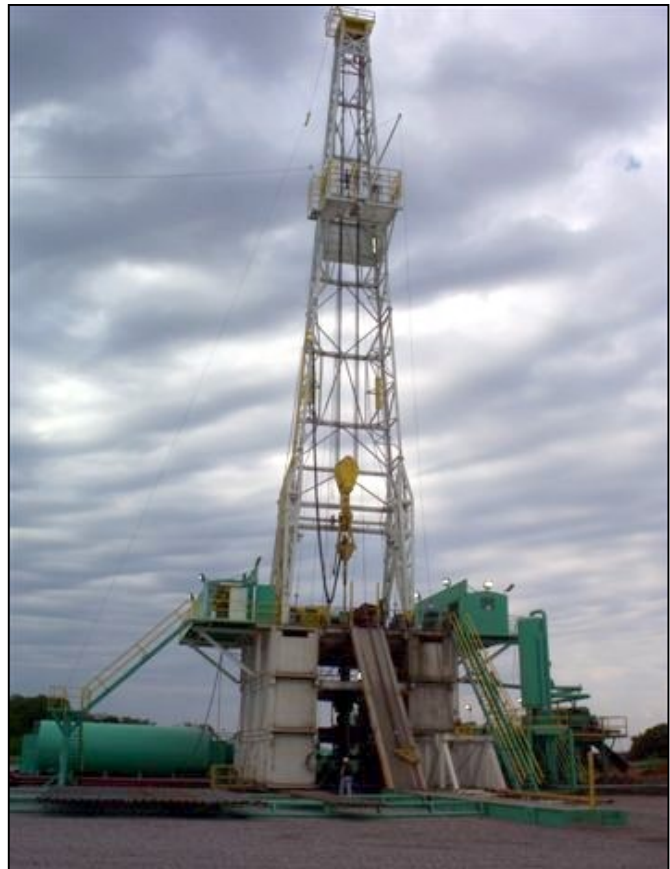
Figure 1. Oil rig

Incident Scene: The incident occurred on a well site during the assembly process (rigging up). The employer had recently obtained the rig being used (Figure 1). The electric drilling rig had been renovated, modified, and upgraded by the company using new and reworked components and had been inspected by a third party inspection contractor. A practice rig up had been conducted in the company yard before a trucking contractor delivered the rig to the site. The ground surface of the well site was firm and level. The derrick floor was approximately 27 feet above the ground. Since the incident occurred while the rig was being assembled, not all walking and working surfaces had been equipped with the required guardrails and handrails. However, all appropriate warning signs

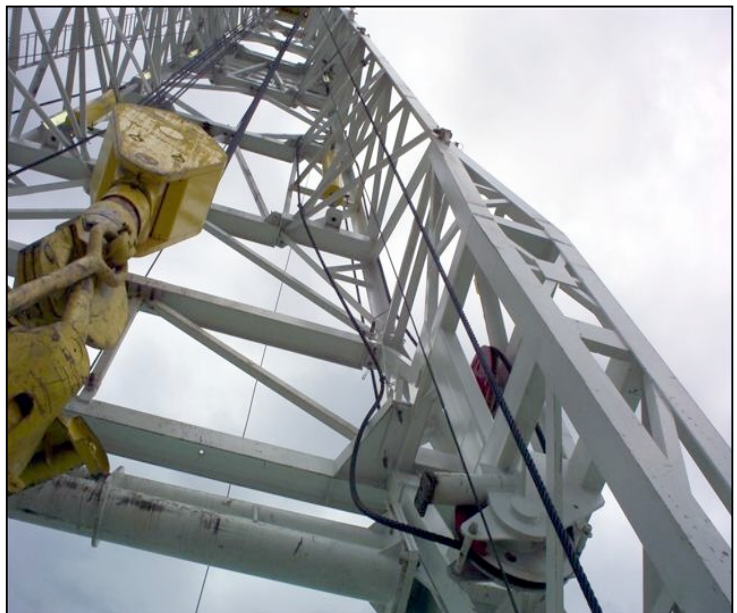
Figure 2. Oil rig cable and hoisting mechanism

In order to install the air hoist, the bridle line had to be disconnected first. The bridle line, a 1.75-inch heavy wire rope used to raise and lower the assembled derrick, was in two sections with each end connecting to a derrick leg. The sections were connected with a socket assembly—an open and closed socket and a connecting pin. The decedent and another employee were on one side of the drilling floor coiling the bridle line as it descended, and three other employees (including the injured worker) were on the other side coiling the other section. One of two toolpushers, the most experienced operator on site, ran the drawworks, the machine used to reel in and out drilling line and lower the bridle line. Some employees were standing in the coils as they wrapped the legs of the line on the floor. Approximately, three 6-foot diameter coils had been made on each side. In the

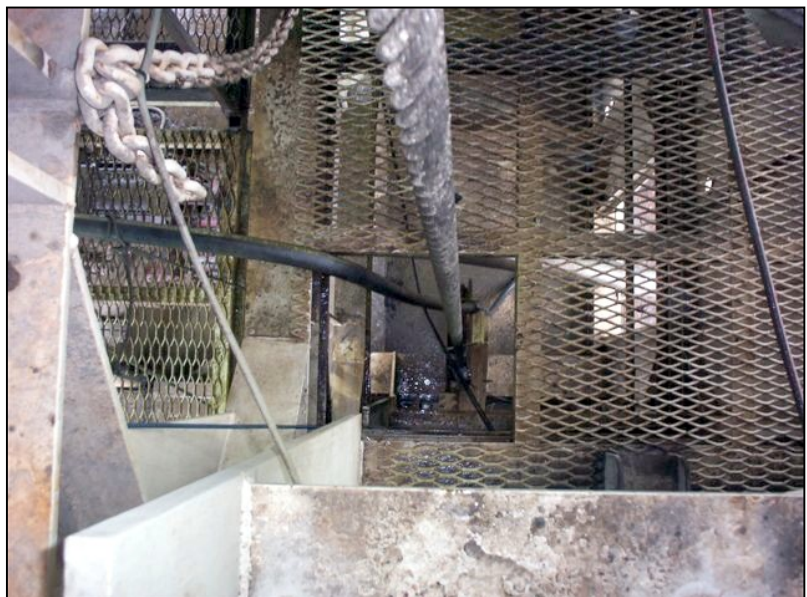
On the day of the incident, the decedent and his co-workers were beginning the third day of rigging up. A trucking contractor brought the rig's components to the site; however, there was a miscue in the sequence of events. Four floor plates were to be installed on the rig floor while it was on the ground and the trucking company's cranes were available on site. However, the floor plates were delivered late, after elevation of the rig floor. Also, the mobile crane that was used to lift various parts in the assembly process left the site before the floor plates arrived. Unless the floor plates were put properly in place, the rig could not be operated safely. Without a means of installing the plates on the elevated rig floor, the derrick had to be erected so that the air hoist could be used (Figure 2). The hoisting mechanism on the derrick itself was routinely used to lift and lower equipment and materials throughout the drilling process. The derrick was ready to be erected at 11:30 a.m. and the process was completed without any problems around 12:00 p.m. Three employees using body harnesses and lanyards pinned the derrick to the legs; however, no fall protection was used by any other employees on the drilling floor during any of the rig up processes because additional equipment was not available. The three employees with harnesses did not have them anchored to a safety line once back on the drilling floor. Three supervisors were on site, had been on the drilling floor, and were aware of the situation (missing floor panels and lack of fall protection).

Figure 3. Unguarded floor opening where victim fell

- Ensure that all employees working at elevated heights are provided with and utilize proper fall protection equipment and are not exposed to unguarded openings or other hazards without adequate protection.
- Develop, implement, and enforce a comprehensive safety and health program that includes safe operating procedures for all drilling operations.
- Ensure that all employees are trained properly and possess the skills necessary to recognize and control hazards for all operations in which they participate.
