Tractor Owner Dies After Being Pinned by Tractor Attachment Which Fell on Him During Disassembly in West Virginia

Case: 03WV044-01

Release Date: March 7, 2004

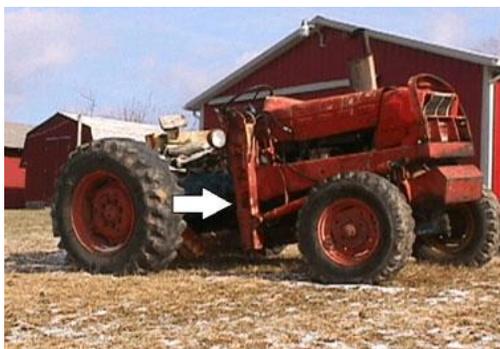
On December 28, 2003, a 79-year-old male tractor owner (victim) died of injuries sustained when the tractor component he was removing fell on him fatally pinning him to the ground. The victim was in the process of removing the tractor's front-end loader in order to replace it with a newer one (see [Figure 1](#)). At the time of the incident, the victim was unbolting the rear points of attachment which were located under the left and right rear axles (see [Figure 2](#)). He had first removed all of the nuts on the left side, and was in the process of removing the last nut on the right side. He had positioned himself under the right rear part of the attachment without supporting it (see [Figure 3](#)). Upon removing the nut which anchored the attachment to the bottom of the tractor's right rear axle, the component, being supported solely by the front of the tractor, dropped to within 6-8 inches of the ground compressing the victim's chest (see [Figure 4](#)). The victim's wife came out to check on her husband and found him pinned under the component. She called EMS, which arrived shortly thereafter and found no signs of life. The body was extricated and transported to the local funeral home.

Figure 1. The arrow points to the component being removed at the time of the incident.

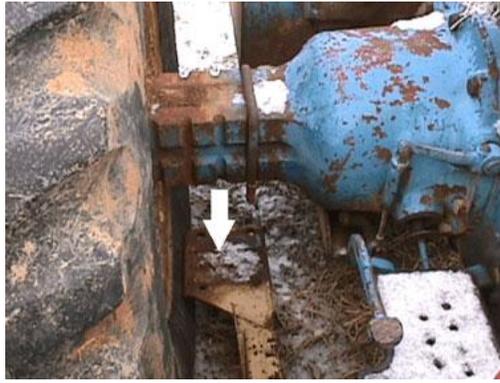
Figure 2. Photo shows the right rear attachment point. Arrow points to component which fell.

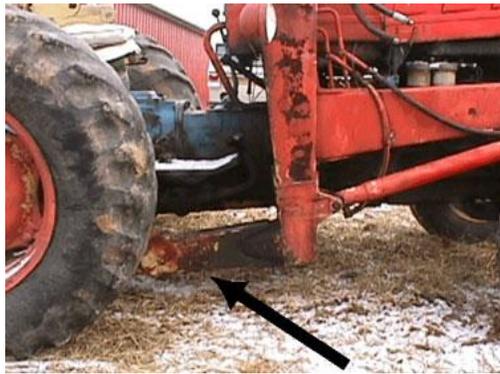
Discussion: In this incident, the victim was working under an elevated load which was unsupported. It is unclear why the victim chose not to block or support the component as it was reported he had done in very similar situations in the past. Correctly chocking or blocking the attachment on both sides with timber or jack-stands prior to removing any of the nuts would have prevented this incident by supporting and/or arresting the energy source before contacting the victim.

Figure 3. The arrow represents the victims position while removing the last nut located under the right rear axle. He was on his back with his chest directly below the component identified by the arrow.

Recommendation #1: Tractor owners and equipment mechanics should ensure that prior to inspecting, adjusting, repairing, or removing elevated components, a strong positive means of support be used before placing any part of the body under an elevated load.

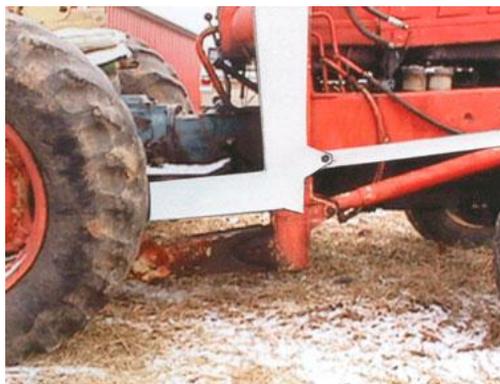
The cause of death was listed as compression asphyxia as well as chest trauma.

Figure 4. The white silhouette represents the component's original position prior to dropping to within 6-8 inches of the ground pinning the victim.
