Part-time Farmer Dies Following a Tractor Rollover in West Virginia

Case: 02WV003-01

Release Date: June 10, 2002

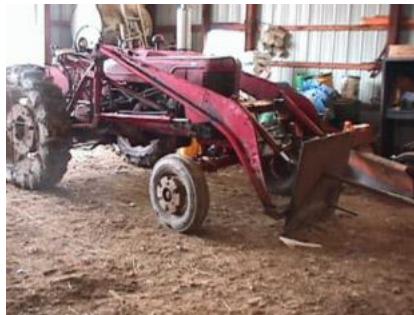
On January 26, 2002, a 57-year-old male part-time farmer (victim) died of injuries sustained when the tractor he was driving rolled over while transporting a round hay bale. The victim was using a 1939 FarmAll Model M tricycle front-end configured tractor (see [Figure 1](#)). The tractor was equipped with a front-end loader and a round bale spear attachment (see [Figure 2](#)). The attachment was estimated to have weighed 400 pounds. Just prior to the fatal incident, he was moving a large round bale from the storage area. The bale was estimated to have weighed an additional 800 pounds. He elevated the bale and began to transport it to a feeding ring whose current location required traversing a hillside. It was reported that the victim usually transported the bale within a few feet of the ground. The speed of transport was unknown. He was traversing a 40% graded slope (22 degrees) with his left rear wheel on the downhill side (see [Figure 3](#)). When he got within 25 feet of the feeding ring, the victim apparently began to further elevate the load, to clear the top of the ring. As the total load, now weighing approximately 1,200 pounds, was elevated the tractor's center of gravity (C.G.) shifted forward and downhill (see [Figure 4](#)). This shift placed the C.G. outside of the tractor's stability baseline, causing the tractor to roll downhill to the left and to land on the victim (see [Figure 5](#)). The tractor did not have a rollover protective structure (ROPS) or a seat belt. The land owner came out to the field to check on the victim and found him lying on the ground. He called the victim's wife, who in turn called emergency services. The EMS, county sheriff, and medical examiner arrived and found no signs of life. The medical examiner estimated that the victim had died immediately after tractor impact.

Figure 1. 1939 FarmAll Model M tractor with bale spike.

Note: This photo was taken after repairs and wide front-end conversion.

Recommendation #2: Convert tricycle-configured tractors to a wide front-end configuration.

Discussion: The victim was using an older tricycle-configured tractor. Tricycle-configured tractors are inherently less stable and have stability baselines which leave little room for error. This inherent instability is amplified when dealing with elevated front end loads, such as round hay bales. These types of loads raise the C.G. and move it forward toward the tip of the stability triangle. These changed dynamics caused by the load and the hillside's terrain left little room for changes in the elevated load. When the tractor's load was elevated to clear the feeding ring, the tractor's C.G. was pushed beyond the stability baseline causing the tractor to roll over towards the downhill side. Given the fact that the task being performed involved a front-end elevated load in conjunction with sloped terrain, use of a wide front-end configured tractor may have allowed the C.G. to remain within the stability baseline and therefore prevented rollover.

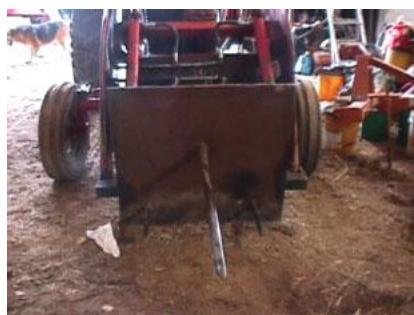
Figure 2. Front end-loader attachment and fabricated bale spear.

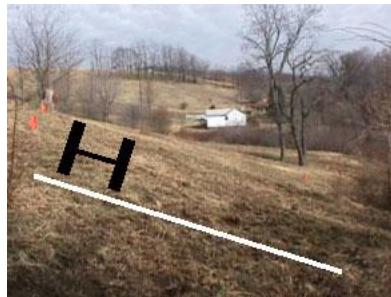
Discussion: Often to prevent damage to the field by the cattle feeder rings are relocated. This particular ring was placed on the edge of the field. Accessing the ring required the victim to traverse a 40% graded slope (22 degrees). Slopes this extreme leave little room for error and should be avoided, especially when transporting loads. A careful evaluation of the path the tractor would have to travel, prior to feeder placement, may have given the person placing it the opportunity to identify and avoid potential hazards. Upon realizing how sloped the path actually was, they may have decided to choose another location. Feeder rings should be located in areas which are as level as possible.

Figure 3. The line represents the measured 22 degree grade. The tractor was driving toward you. This is from the feed ring's perspective.

Recommendation #3: Prior to their placement, evaluate the location of feeding rings for hazards which can compromise a tractor's stability during bale transport.

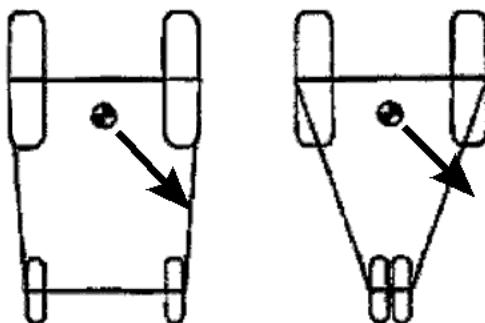
Figure 4. This illustrates the normal C.G. and the shift which occurred due to a combination of sloped terrain and elevated front-end load. The tractor on the right is similar to the one which rolled in this incident. Once the C.G. left the smaller stability baseline of the tricycle configured tractor, the tractor rolled.

Note: A wide front-end tractor will also roll easily when transporting elevated loads on sloped terrain.

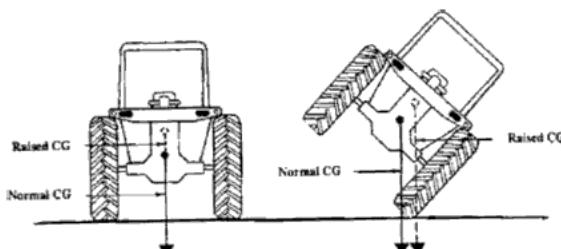
Figure 5. The tractor on the left is operating on a level surface. The tractor on the right is traversing a hillside much like the tractor was in this incident. When transporting an elevated front-end load on level ground there is no C.G. shift to the side and the C.G. remains within safe limits. When transporting an elevated front-end load while traversing a hill, the C.G. is more prone to leave the safe limits of the tractor's stability baseline. Once this happens the tractor begins to roll. The higher and heavier the load, the less the land needs to be sloped for a rollover to occur.
