# Livestock Farmer Dies Following a Tractor Rollover in West Virginia

Case: 01WV060-01

Release Date: April 30, 2002

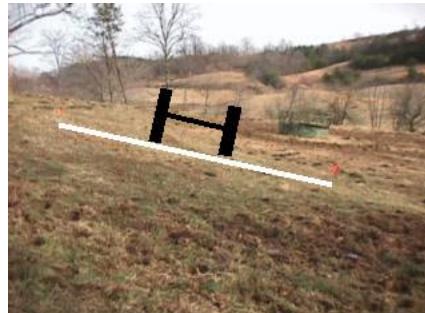
Discussion: The terrain along the victim's chosen path of travel was irregular as well as transversely graded. As the tractor traveled over the irregular surface, the tractor's C.G. shifted forward and downhill. In essence, this surface irregularity turned a fairly predictable surface into a uneven and highly one. The uneven surface caused the C.G. to be in a constant state of change.

**Figure 1. The line represents the measured 16 degree grade. The tractor was driving away from this perspective.**

Evaluating the tractor's travel zone prior to material handling activities may have given the operator the opportunity to identify and avoid the hazardous path of travel. Upon realizing how irregular the path actually was, he may have decided to use the usual road and not attempt the short-cut.

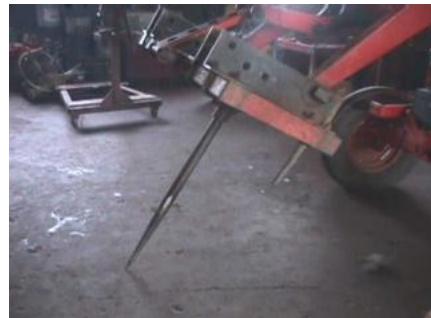
Figure 2. Factory installed end-loader attachment and after market bale spike.

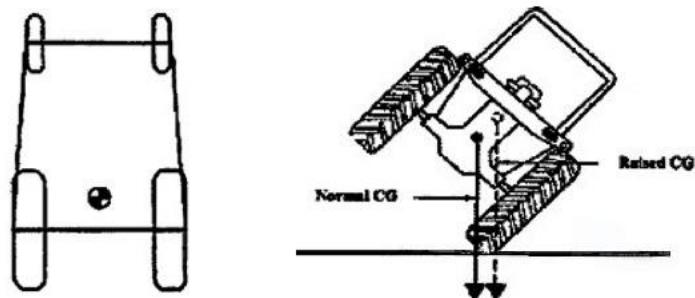
Discussion: Instability is amplified when dealing with elevated front end loads. Elevated loads, such as round hay bales, can pose problems. This type of load not only move the C.G. forward toward the tip of the stability baseline, it also raises the C.G. (see [Figure 3](#)). A forward and raised C.G. on a tractor traversing a hillside leaves little room for even small changes in the tractor's attitude. When traversing a hill, the C.G. will automatically shift closer to the down hill side of the stability baseline. Changes in attitude can quickly swing the C.G. further down hill and outside of the tractor's stability baseline, causing a tractor to roll. In addition, a tractor's rate of speed can greatly influence how quickly and how extreme the C.G. shift will be, especially when traversing a hillside. Although the speed of transport of the victim's tractor was unknown, it is possible that the rate of speed may have been increased in an attempt to complete the task, get out of the cold, and join his wife. It is also possible that the rate of speed used during the fatal incident was the same speed the victim routinely used when transporting bales over the normal road path which had little side-to-side grade. Given the fact that the task being performed involved a front end elevated load in conjunction with sloped terrain, using extreme caution and a slower rate of speed may have allowed the C.G. to remain within the stability baseline and thereby prevent the rollover.

Figure 3. This illustrates the tractor's CG movement as a result of elevating a front end load while traversing a hillside.
