# Maintenance Supervisor Dies After Being Pinned Between Dump Body and Truck Frame During Troubleshooting Inspection West Virginia

Case : 00WV011-01

Release Date: September 8, 2000

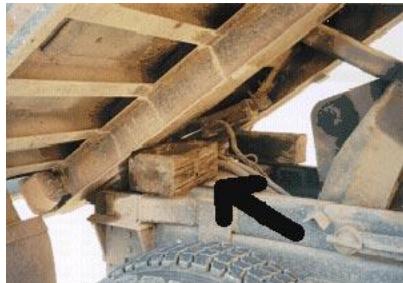
Figure 1. The arrow points to the method of blocking which would have been used had the victim waited.

**Recommendation #1: Employers should ensure that before making inspections, adjustments, or repairs, strong, heavy, positive supports are used to hold the dump body from inadvertently lowering.**

Discussion: In this incident, the victim was working on a truck whose dump bed was elevated and then placed himself under the elevated dump bed without protection. OSHA Regulation 29 CFR 1926.600(a)(3)(i) requires that dump bodies and similar equipment shall be fully lowered or blocked when being repaired or when not in use.<sup>1</sup> Additionally, OSHA Regulation 29 CFR 1926.601(b)(10) requires that trucks with dump bodies shall be equipped with positive means of support, permanently attached to the truck.<sup>1</sup> (see [Figure 4](#)). Correctly chocking or blocking the raised bed would have prevented this incident by supporting and/or arresting the energy source before contacting the victim. Having had a convenient permanently attached body prop would not only have eliminated the need for his coworker to obtain cribbing, but would have eliminated the time period the victim placed himself under the elevated dump bed while he waited.

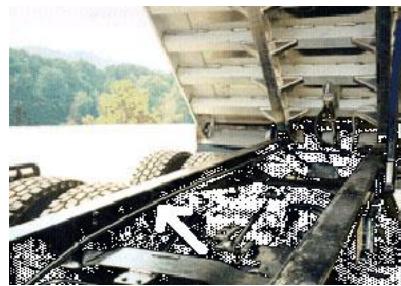
Figure 3. The arrow points to a properly installed and enclosed pull-off cable.

**Recommendation #3:** Employers should ensure that replacement pull-off cables are identical to the original equipment and installed as per the manufacturer.

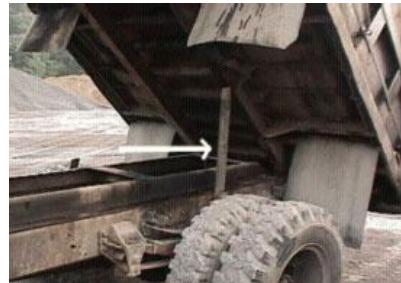
Figure 4. The arrow points to the convenient and permanently attached body support installed after the incident as per OSHA's recommendations.  
The support folds when not in use.
