Dairy Farm Worker Dies Following a Tractor Rollover in West Virginia

SUMMARY

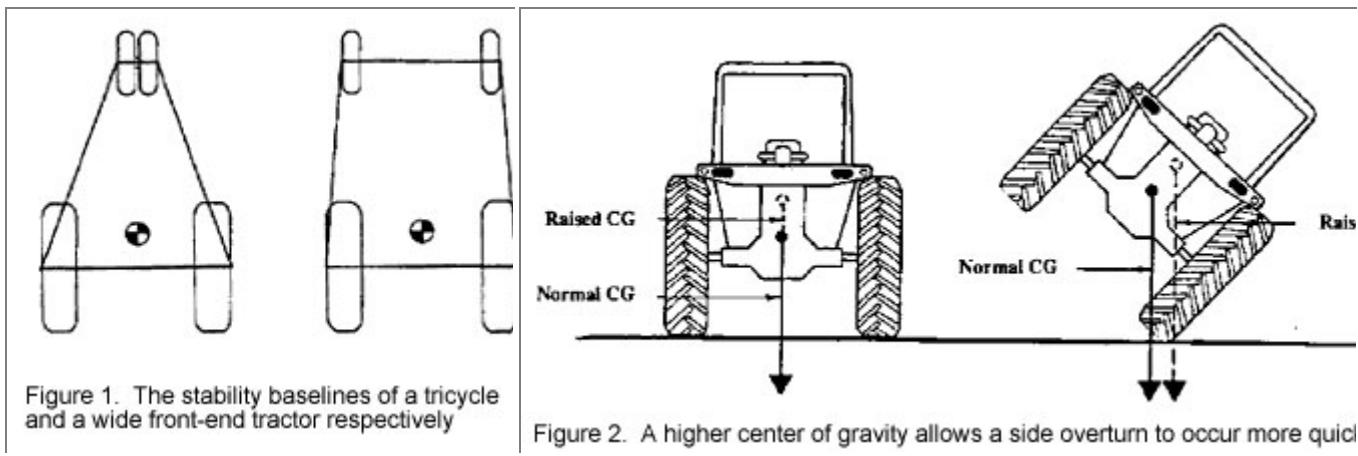
Discussion: The victim was using an older tricycle configured tractor. Tricycle configured tractors are inherently less stable and have stability baselines which leave little room for error (see [Figure 1](#) below).

This inherent instability is amplified when dealing with elevated front end loads, such as round hay bales. These types of loads not only move the center of gravity forward toward the tip of the stability triangle, they also raise the CG (see [Figure 2](#) above). A forward and raised CG on a tricycle tractor traversing a hillside leaves little room for abrupt changes in the tractor's attitude. When the tractor's uphill rear wheel abruptly ran over the small clump of hay within its path, the tractor's CG was pushed beyond the stability baseline causing the tractor to roll over towards the downhill side. Given the fact that the task being performed involved a front end elevated load in conjunction with a sloped terrain, use of a wide front end configured tractor may have allowed the CG to remain within the stability baseline and therefore prevented rollover.

Recommendation #2: Convert tricycle configured tractors to a wide front end configuration.

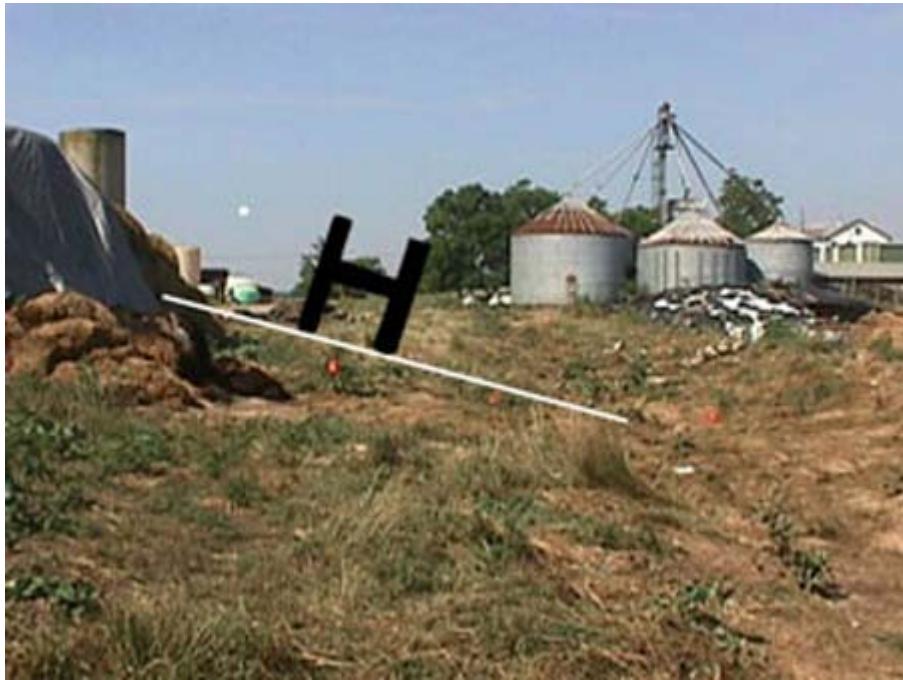
Discussion: The bale was being moved from the farm's designated round bale storage area which was located next to a drainage ditch. The bales were stored parallel to the ditch. This configuration allowed for a non level travel/work zone area on the ditch side of the bales. In fact, the measured grade was 15 degrees. Establishing a storage area whose travel/work zone has a 15 degree slope, places the tractor operator at greater risk for CG shifts. This risk is increases when the work zone activity involves elevated loads. Positioning the storage area on level terrain would have facilitated easier access to the bales and lowered the risk for CG shifts leading to rollover.

Image 1. The line represents the measured 15 degree slope down towards the drainage ditch.
The tractor was driving away from this perspective.

Recommendation #4: Evaluate the location and its terrain prior to establishing round bale storage areas.

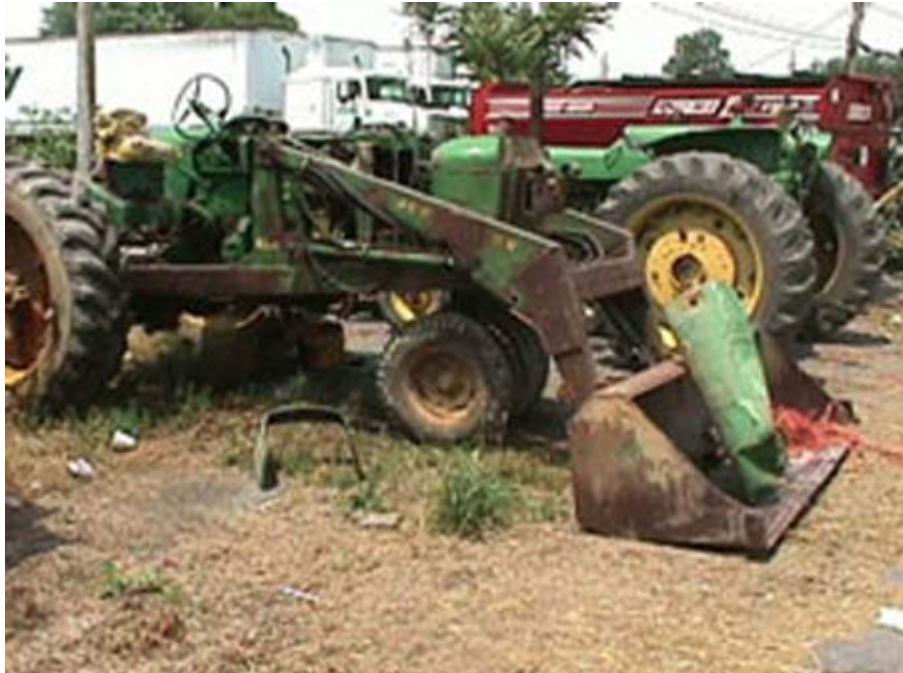
Image 2. Tractor involved in fatal rollover.
Note the tricycle configured front end and the end loader attachment.

Recommendation #1: Equip all tractors with rollover protective structures (ROPS) and a seat belt. [Owners of older model tractors should contact their county extension agent, equipment dealer or

equipment manufacturer to determine if retrofit ROPS and operator restraint systems are available for their equipment. Such systems should be installed by the manufacturer or an authorized dealer].

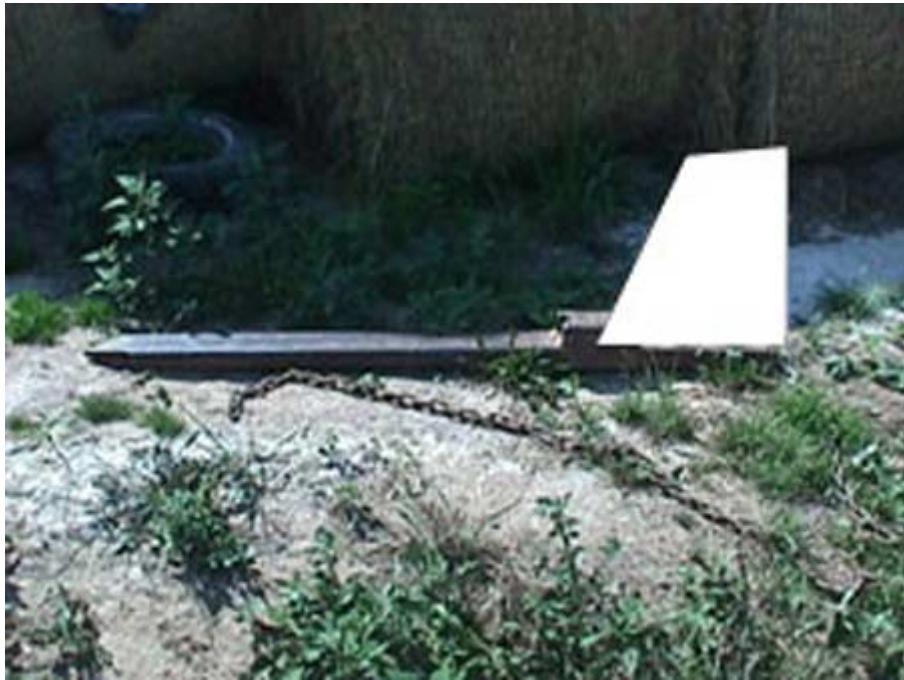
Image 3. This is one of two forks which was attached to the tractor's end loader bucket permitting bale removal.

The white box represents the end loader bucket.
