Dump Truck Driver Dies in West Virginia After Being Pinned Between Dump Body and Truck Frame During Trouble Shooting Inspection

SUMMARY

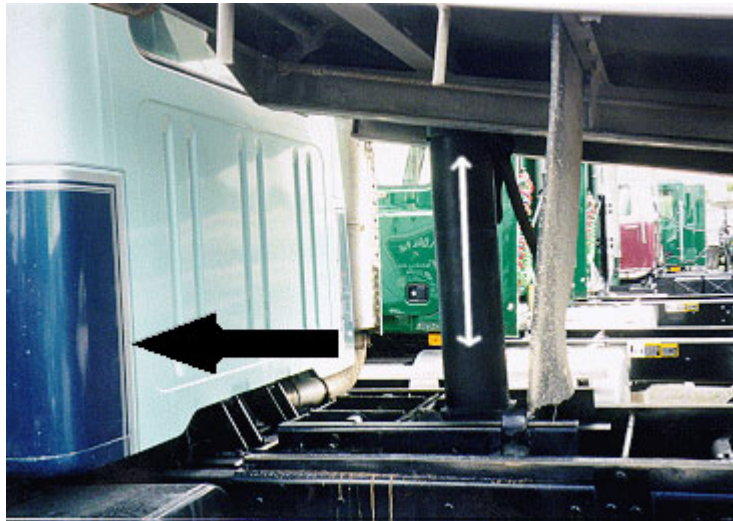
fluid to drain from the hydraulic cylinder back into the fluid reservoir. Hydraulic hoist cylinder and fatal injury site were located directly behind the truck's cab. **See figure below.**

Hydraulic hoist cylinder located directly behind the truck's cab.

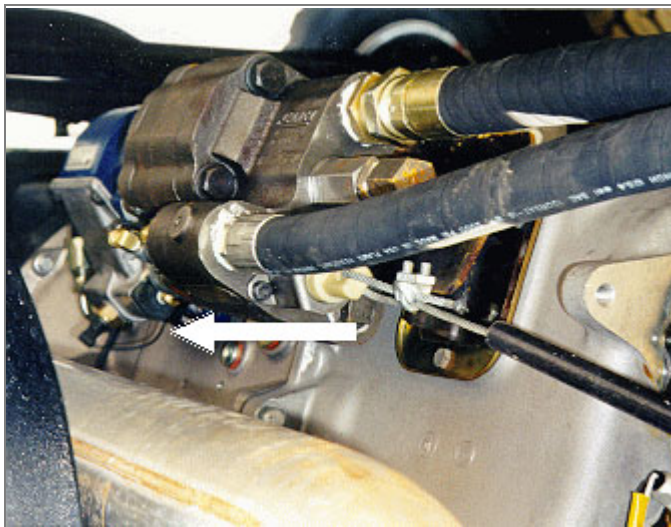
Pneumatically controlled hydraulic valve

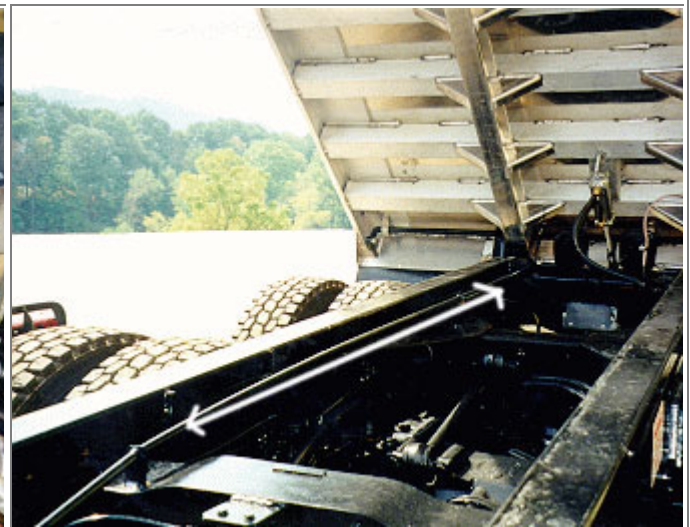
Pull-off cable running along the truck's frame

lead to binding, thereby causing the dump bed to stick during empty bed operations such as lowering after unloading. In addition, raising loaded dump beds beyond 45 degrees can lead to possible vehicle up ending. This vehicle no longer had the pull-off cable intact. The employer was unaware that it had been equipped with one.

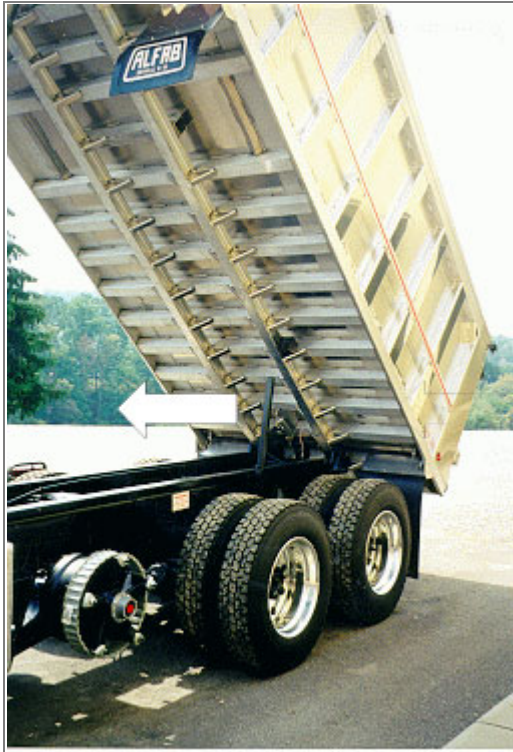
View of the body in an elevated position

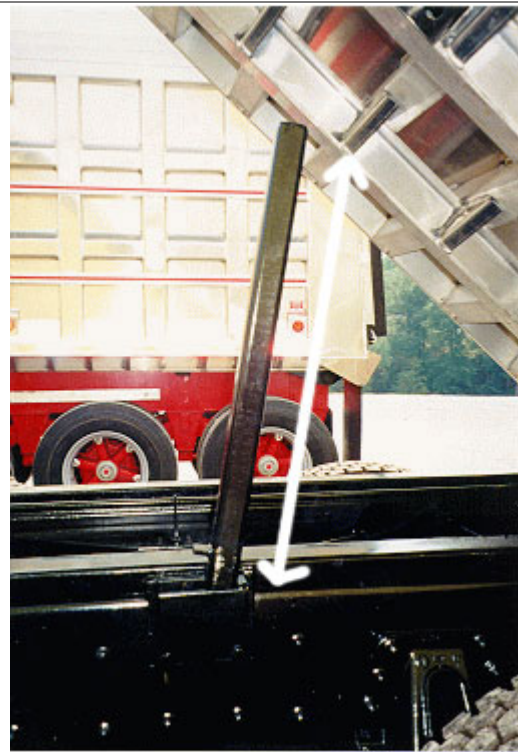
Close-up of the safety body prop when body is in an elevated position

The safety body prop was present, but not used, during this fatal incident. It was reported that on prior occasions the empty elevated dump body stuck in the elevated position. Earlier that day, the victim needed assistance from an end-loader in order to lower the empty dump body which had stuck in the raised position. The end loader bucket was lowered in the back of the dump body to force it down.

Recommendation #1: Employers should ensure that before making inspections, adjustments, or repairs, strong, heavy, positive supports are used to hold the dump body from inadvertently lowering.

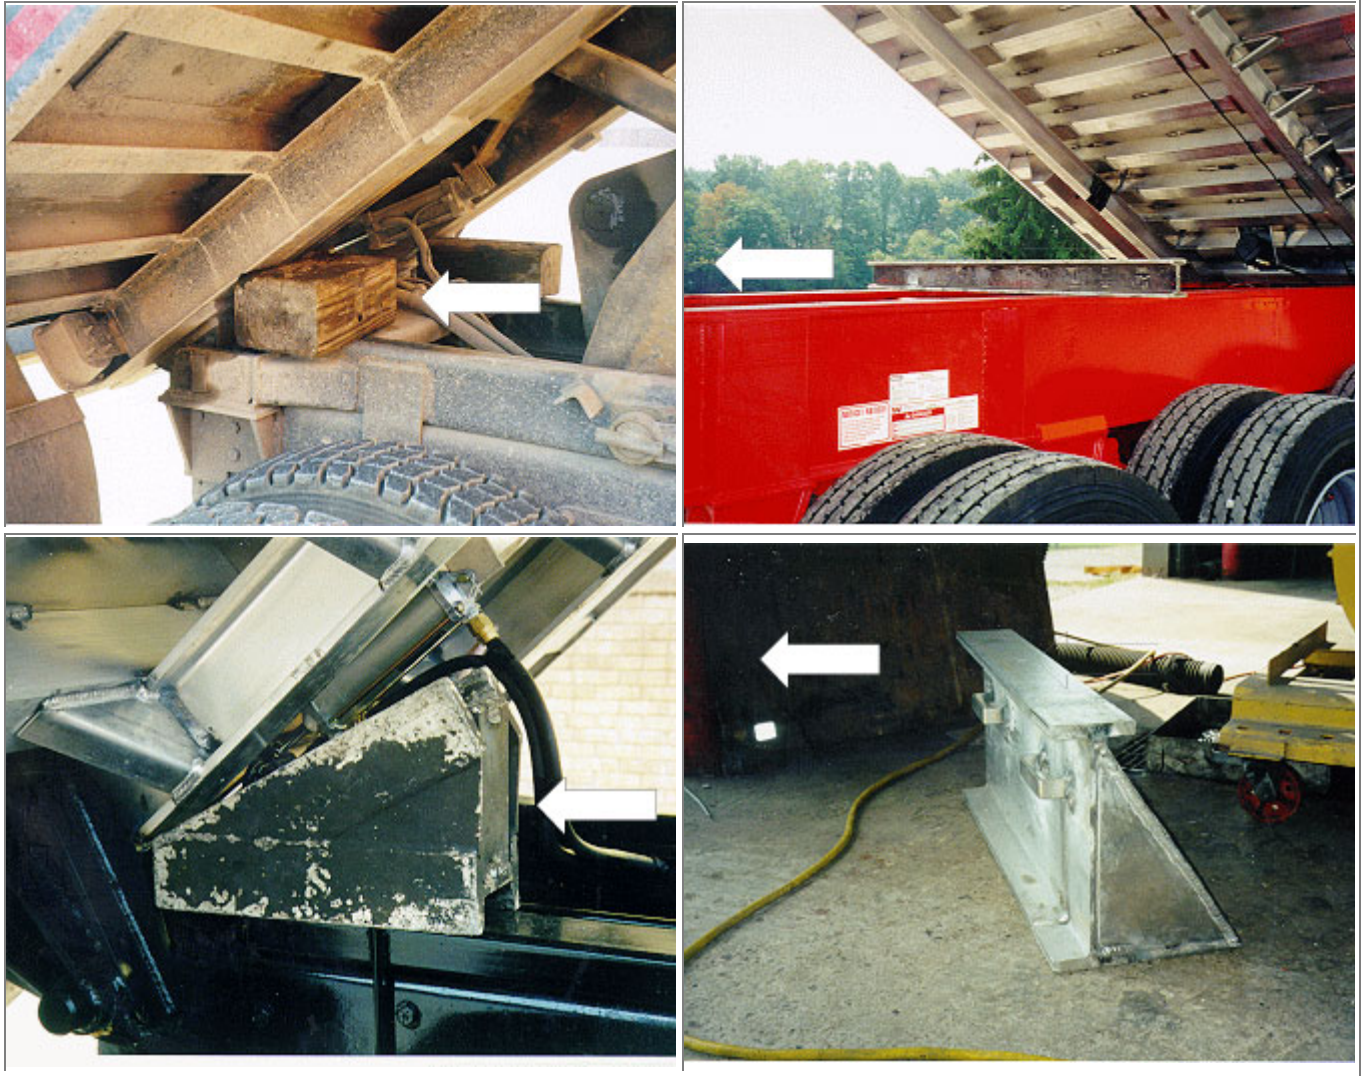
Discussion: Strong, heavy, positive supports are provided by dump bed manufacturers in the form of body props. Body props are non-adjustable and will support the dump body at one position only, which is close to maximum elevated dump angle. Therefore, the need to inspect and/or work on the dump bed at an angle other than the one provided by the body prop places the burden of design and implementation of alternative protection on the employer and the person doing the work. **See figures below.**

The above methods and materials represent various after-market attempts to provide protection.

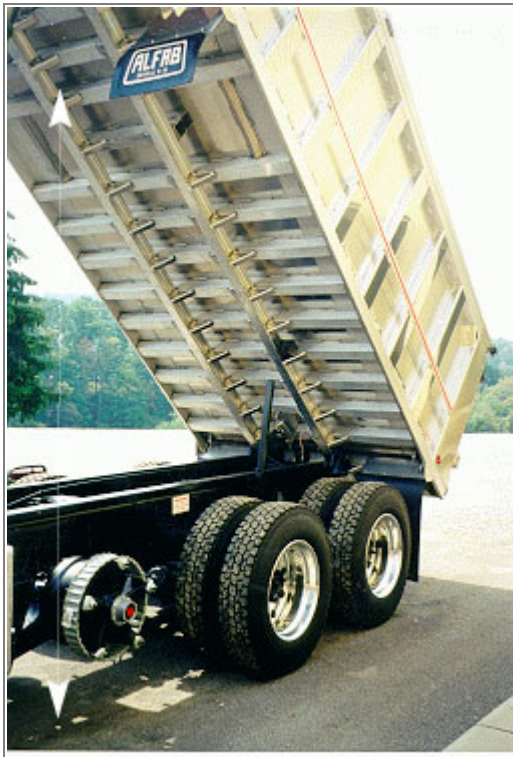
It should be noted that those distributors and repair shops contacted during the investigation indicated that the body props are often not used and commonly found rusted in the position of storage. This may in part be due to the fact that many necessary procedures are out of the body prop's scope of application. For example, one hoist manufacturer recommends that the plunger end pin mountings located in the upper portion of the dump bed body be greased regularly.² These mountings would be close to 15 feet above the ground when using the body prop as provided. **See figures below.**

**Distance of the end pin mountings
when body prop is used**

As was stated earlier this may have been in part why the victim placed himself under the elevated dump bed without protection. Manufacturers should consider adjustable body props and/or positioning an additional prop located closer to the cab thereby allowing a greater range of integral protection. Having had the ability to conveniently prop the bed at any point during the inspection process may have prevented the fatal energy from contacting the victim.

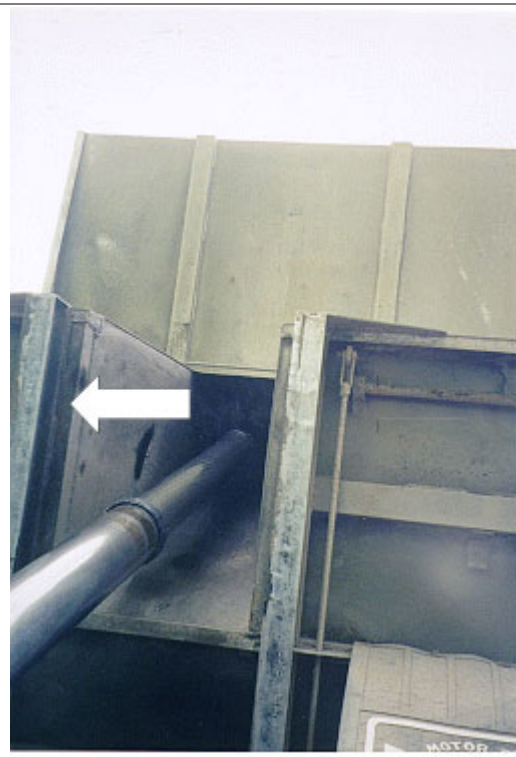
**Close-up of the hydraulic hoist
cylinder**
