Logging Company Owner Dies After Being Struck by Log That Fell From Logging Truck in West Virginia

SUMMARY

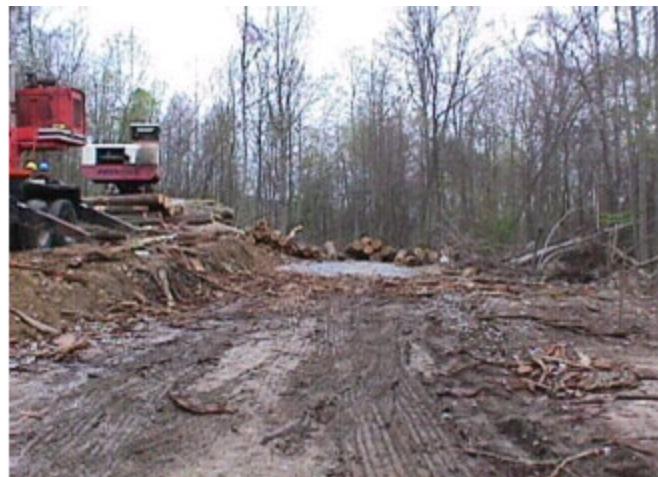
Figure 1. Clear, open, and level landing area.

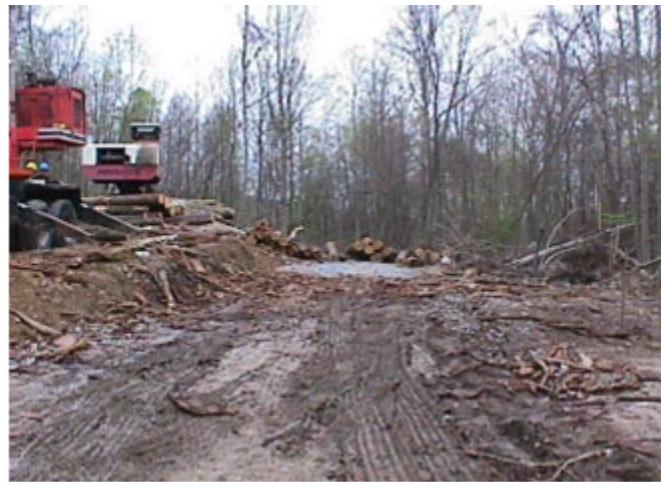
On Saturday April 24, 1999, the co-owners of a logging company met at their operation's landing site for a short term, non-routine Saturday morning loading operation. The operation began at approximately 8:00 a.m. It was a clear and cool day. A total of four individuals were present the morning of the incident. The two co-owners were loading their company's log truck while a truck under contract, its driver, and a friend waited for their turn. The landing area was clean, open, and level (see [Figure 1](#)). The logging truck was loaded using a knuckle boom loader. The victim had assisted his partner who was loading their truck. After their truck was fully loaded, the victim's partner left the loader and climbed into the truck's cab. He then asked the victim to direct him as he backed the loaded truck out of the loading zone. The fully loaded truck, which was moved prior to securing the load, was being relocated to make room for the truck in waiting (see [Figure 2](#)). At approximately 8:45 a.m., as the victim's partner

Figure 2. Arrow in foreground represents area where truck was loaded. Arrow in background indicates area where fully loaded unsecured truck was moved to and approached by victim.

Recommendation #2: Employers should ensure that stacked logs are secured immediately after the loading operation is complete prior to moving the truck.

Discussion: In this incident, the truck and its unsecured load had been moved approximately 100 feet. Unsecured log loads are inherently unstable and more so when moved. CFR 1910.266 h(6)(iv) requires that each log be placed on a transport vehicle in an orderly manner and tightly secured ([2](#)). Securing the load at the time the loading operation was completed might have prevented this fatal injury from occurring. Securing the logs as soon as possible and prior to moving shortens the duration of time that potential log movement and employee exposure can exist.

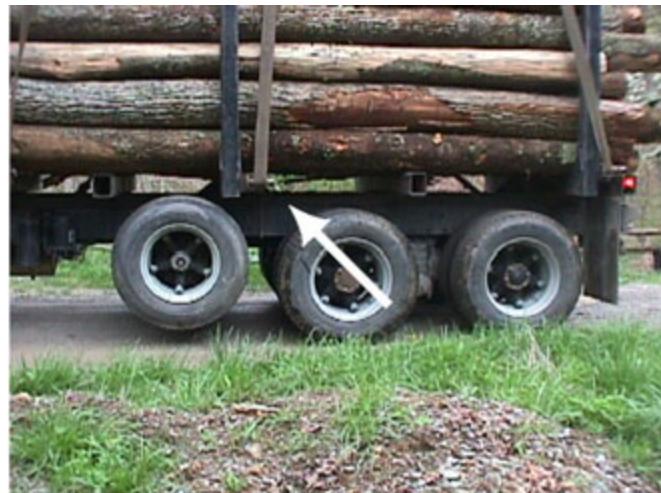
was parking the truck, the victim approached the truck to begin securing the load. He approached one of the binding straps located on the side of the truck (see [Figure 3](#)). As he did, a log rolled off of the truck pinning him to the ground (see [Figures 4&5](#)). An individual who accompanied the empty truck's driver to the site was standing on the landing and witnessed the incident. The bystander ran to the victim's partner to inform him of the incident. The partner ran to the victim. It was reported the partner removed the log from the victim's body by hand. The empty truck's driver ran to the residence of the land owner and called 911. The victim had experienced multiple traumatic injuries as a result of being struck by the falling log. EMS transported the victim to a local hospital where, at 9:35 a.m., he was pronounced dead.

Figure 3. Arrow indicates binder being accessed when log struck victim.

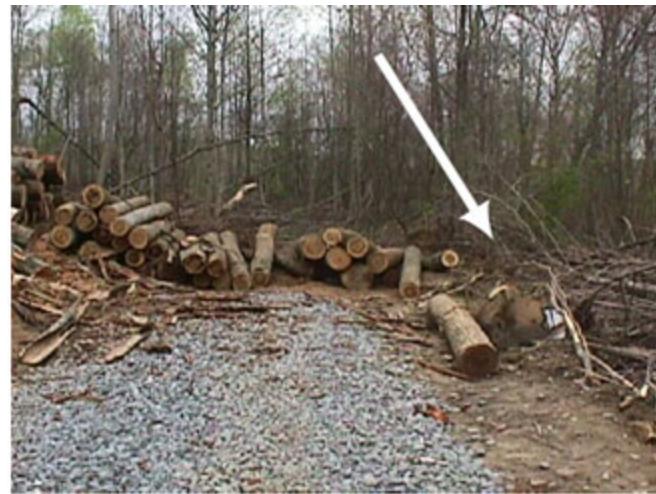
Figure 4. Truck was backed into this area.
Arrow represents path and points to fatal
energy source.

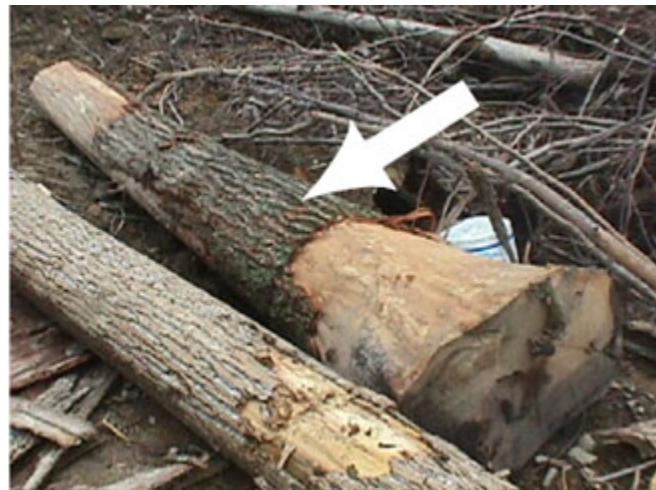
Figure 5. Arrow points to fatal energy source.
Log was 12 feet long and estimated to weigh
1,000 pounds.

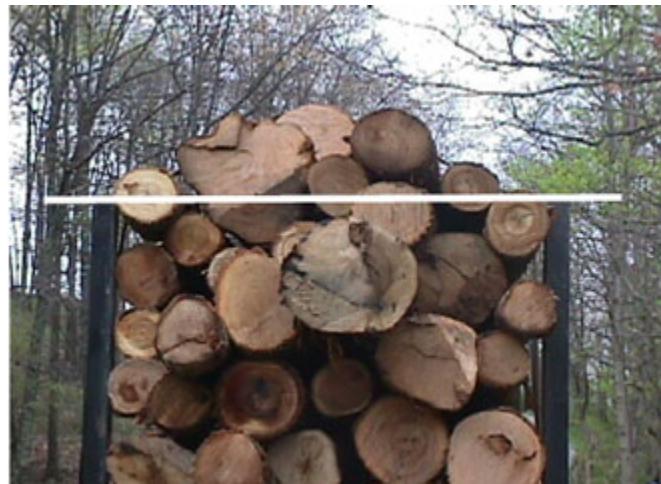
Discussion: In this incident, the victim approached a truck whose load was stacked higher than the vehicle's stakes or standards (see [Figure 6](#)). Loads which have logs resting above the truck's stakes are inherently unstable. Stacking the load higher than the truck's standards also bypasses the vehicle's integral safety device (the standards). OSHA Regulation 29 CFR 1910.266(h)(6)(v) requires that the load shall be positioned to prevent slippage or loss during handling and transport ([2](#)). Loading the truck within its safe limits would have prevented this incident by allowing the truck's standards to prevent or arrest the movement of the logs.

Figure 6. This is the rear view of the same truck loaded the day of the investigation. White line represents the plane created by the top of the standards. Note the height of logs above the line.

Recommendation #1: Employers should ensure that the height of the stacked logs does not exceed the height of the standards on the truck.

Recommendation #4: Manufacturers and employers should consider manufacturing and/or retrofitting log trucks with retention stakes high enough to adequately secure anticipated log loads.

Discussion: Although the majority of the loads placed on logging trucks fall within acceptable state and federal height and weight parameters, they often exceed the height limitations of the truck's retention stakes. In this incident, a log rolled off the top of the load which was above the top of the stakes. Retention stakes which extend above the top of the logs during maximum capacity loads--assuming the stakes are properly constructed--would help to secure the load during all phases of load handling.
