Tree Cutter Dies After Being Struck by Log That Fell From Logging Truck in West Virginia

SUMMARY

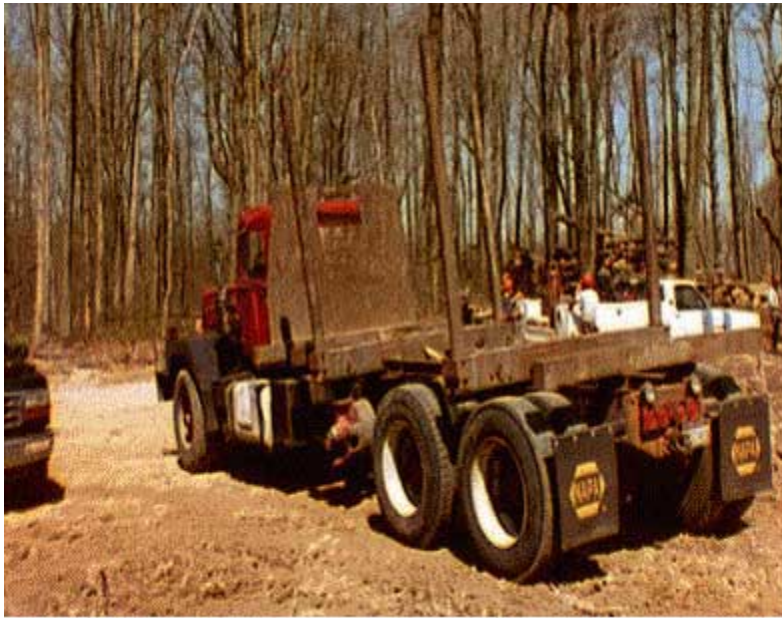
Discussion: In this incident, the victim approached a truck whose load was stacked higher than the vehicle's stakes or standards. Loads which have logs resting above the truck's stakes are inherently unstable. Stacking the load higher than the truck's standards also by-passes the vehicle's integral safety device (the standards). OSHA Regulation 29 CFR 1910.266(h)(6)(v) requires that the load shall be positioned to prevent slippage or loss during handling and transport. ⁽²⁾ Loading the truck within its safe limits would have prevented this incident by allowing the truck's standards to prevent or arrest movement of logs.

Discussion: Although the majority of the loads placed on logging trucks fall within acceptable state and federal height and weight parameters, they often exceed the height limitations of the truck's retention stakes. In this incident, a log rolled off the top of the load which was above the top of the stakes. Retention stakes which extend above the top of the logs during maximum capacity loads-assuming the stakes are properly constructed- would help to secure the load during all phases of load handling.

Figure : The above photograph shows the truck involved in the fatal incident. At the time of the incident, the load extended approximately one foot above the standards. Although this is not the exact location of the incident, the final relationship between the truck, victim, and fatal energy source are represented.

Recommendation #1: Employers should ensure that the height of the stacked logs does not exceed the height of the standards on the truck.

Recommendation #5: Manufacturers and employers should consider manufacturing and/or retrofitting log trucks with retention stakes high enough to adequately secure anticipated log loads.
