FATALITY ASSESSMENT AND CONTROL EVALUATION

Department Store Employee Crushed In a Baling Machine Case Report: 04NY013

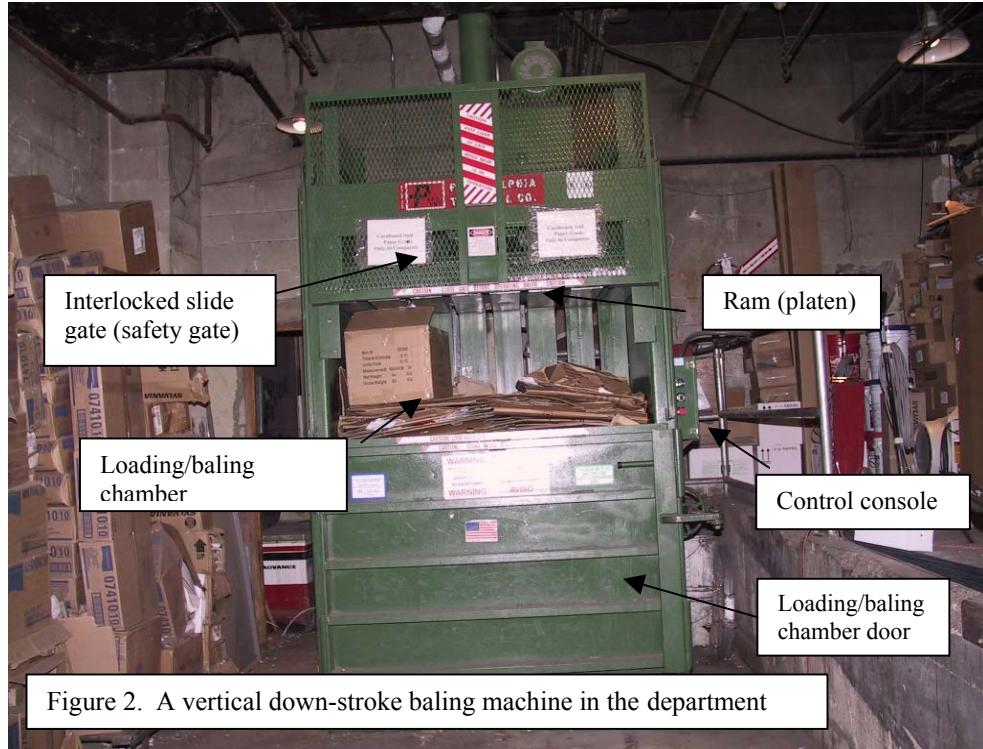
The baling machine was a vertical down-stroke baler (Figure 2), consisting of a ram (platen), an interlocked slide gate (safety gate), a loading/baling chamber, and a control console. The baler utilized hydraulic pressure generated by a 10-horsepower electric motor and a hydraulic pump to compress materials. The completed bales, measuring 60 by 30 by 48 inches, weighed between 850 and 1100 pounds. The control console (Figure 3), located at the right side of the baling machine, had a key switch for turning the machine on or off, a push button for moving the ram up or down, and an emergency stop button.

The baler was equipped with safety devices designed to meet the American National Standards Institute's (ANSI Z245.5) requirements for Baling Equipment-Safety. Specifically, the machine was equipped with a safety proximity switch located in the middle of the lower side of the vertical sliding safety gate. The safety switch was interlocked with the power to the motor and hydraulic pump so that when the gate was fully down and shut, the interlock would engage allowing operating power to the motor and the hydraulic pump. When the door was up and open, the interlock switch cut the power to the motor and the hydraulic pump which immediately stopped the ram from moving.

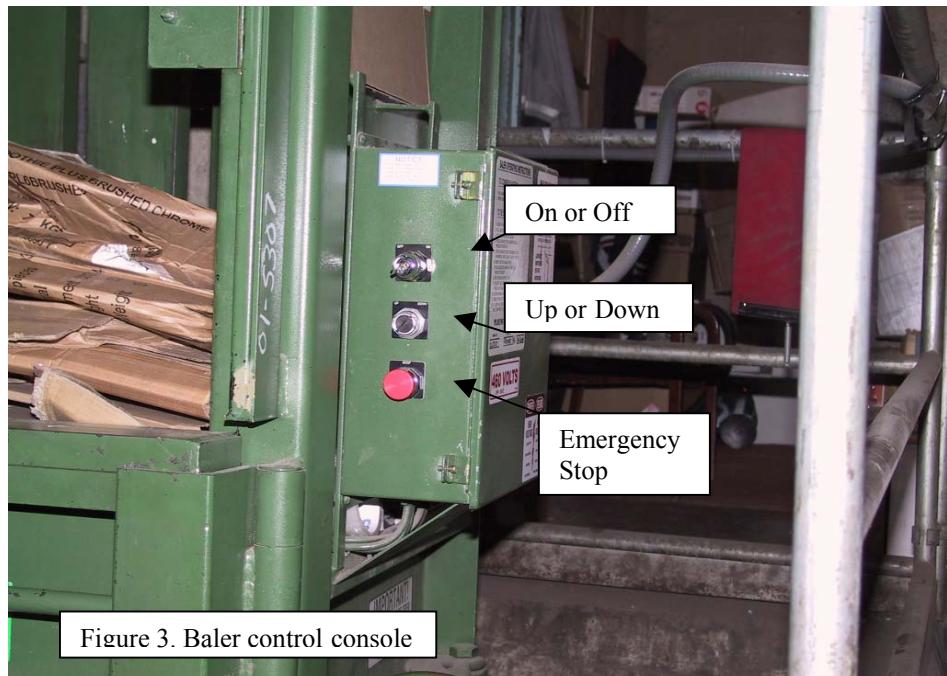
An OSHA compliance officer observed a broken key in the baler's "On or Off" key switch on the day of the incident. A post-incident baler examination found that the electrical wiring had been altered to bypass the "On or Off" switch, and the gate safety switch had been short-circuited by a piece of two-inch wire. By doing so, power was always supplied to the machine and the baler could operate with

the safety gate up. It could not be determined during this evaluation who modified the baler's electrical circuit, when these alterations were made, and what the intent was.

Discussion: Although the company conducted storewide safety inspections twice a month, the inspections did not identify the bypassed safety devices on the baling machine. The safety switches and interlocks on baling machines are designed to protect operators from being injured by the movement of the ram. Bypassing these safety devices increases the potential risk for severe injuries such as crushing or amputation, and in this case, resulted in a fatality. To help ensure operator safety, employers should inspect all baling and compacting machines periodically to ensure safety features are working properly. A baler inspection checklist with specific instructions on how to perform safety device checks should be developed. The results of each inspection should be documented and the records maintained. Balers with malfunctioning safety devices should be removed from service immediately until repairs are completed.
