# STATE OF NEW YORK DEPARTMENT OF HEALTH

## FATALITY ASSESSMENT AND CONTROL EVALUATION

### Flagger Dies after being Struck by a Pickup Truck in a Highway Work Zone Case Report: 04NY012

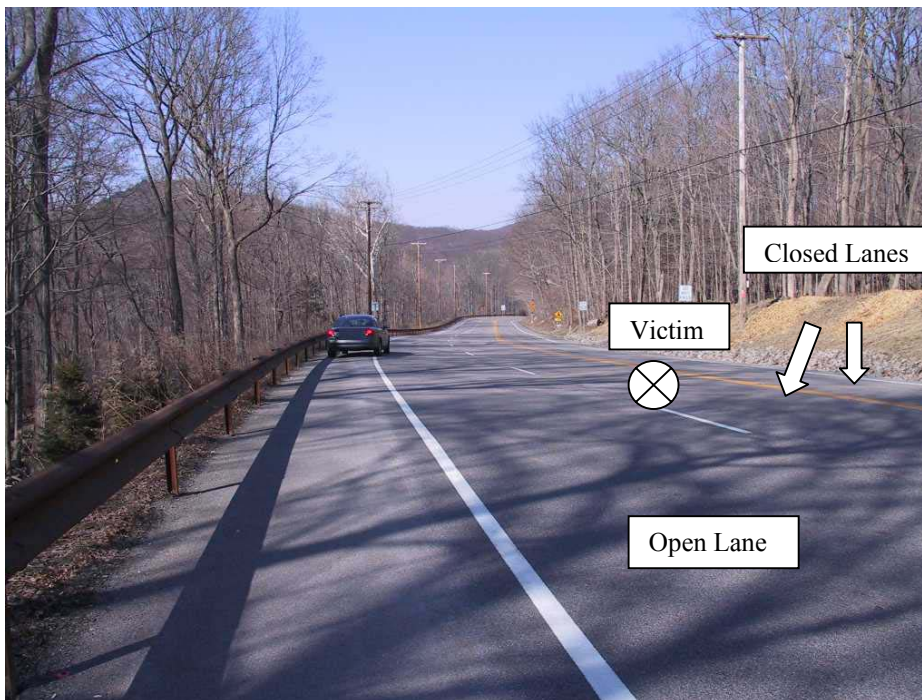
On the morning of the incident, the victim and the other flagger reported to the foreman at the work site at approximately 7:30 a.m. The crew worked on the east side of the highway. They closed two of the three lanes, leaving only one southbound driving lane open to all traffic, both northbound and southbound (Figures 1 and 2). The work zone was approximately 300 feet long. Three warning signs were placed ahead of the work zone at each end including a "flagger", a "man working", and a "one lane road" sign. At the north end of the zone where the victim was stationed, the warning

Figure 1. Incident site including lane closures and victim's position.

At the time of the incident, the victim was standing at the north end of the work zone in the closed southbound passing lane behind a line of traffic cones. He was directing the flow of the southbound traffic with a "Stop/Slow" sign. The victim communicated visually with the other flagger at the south end of the work zone. At approximately 9:05 a.m., the southbound traffic was slowly approaching the work zone. According to the travelling motorists who witnessed the incident, a black Ford F350 Super Duty Pickup truck suddenly pulled out of the traffic into the closed passing lane. The vehicle passed several vehicles that had slowed down in the open driving lane, and accelerated into the work zone. The victim ran towards the northbound lane to avoid the rapidly approaching vehicle. According to the NYSP collision reconstruction report, the pickup truck began braking at this point and then swerved into the northbound lane and struck the victim. The reconstruction report calculated the minimum speed of the vehicle at the time of the collision as approximately 58.20 mph. The victim was thrown in the air by the impact and landed on the northbound shoulder approximately 30 feet from the collision point. A NYSP investigator happened to be travelling in the southbound traffic and witnessed the incident. He immediately called 911 and informed the state police. The emergency squad and NYSP arrived within minutes. The victim was taken to a hospital trauma center where he died on March 4<sup>th</sup> from the injuries sustained in the collision. The driver of the pickup truck was arrested for multiple traffic violations. NYSP tests of the driver for alcohol and drugs were negative.

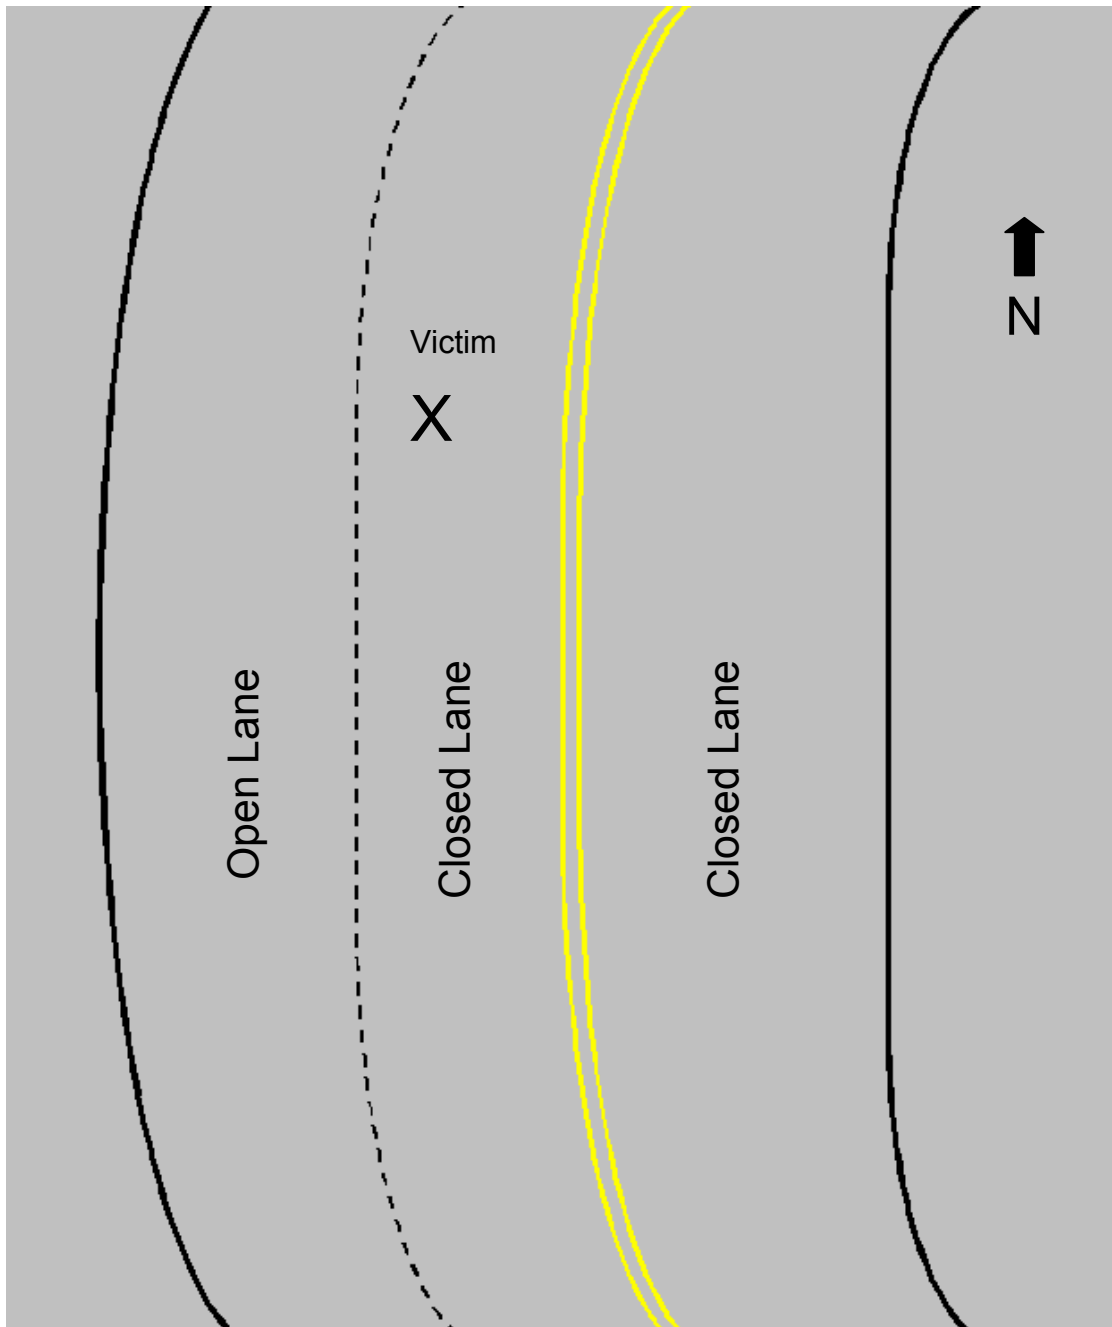
**Figure 2. Diagram of Incident.**  
Locations are not exact and diagram not drawn to scale.
