STATE OF NEW YORK DEPARTMENT OF HEALTH

FATALITY ASSESSMENT AND CONTROL EVALUATION

Contractor Run Over by Front-end Loader at City Salt Stockyard Case Report: 04NY002

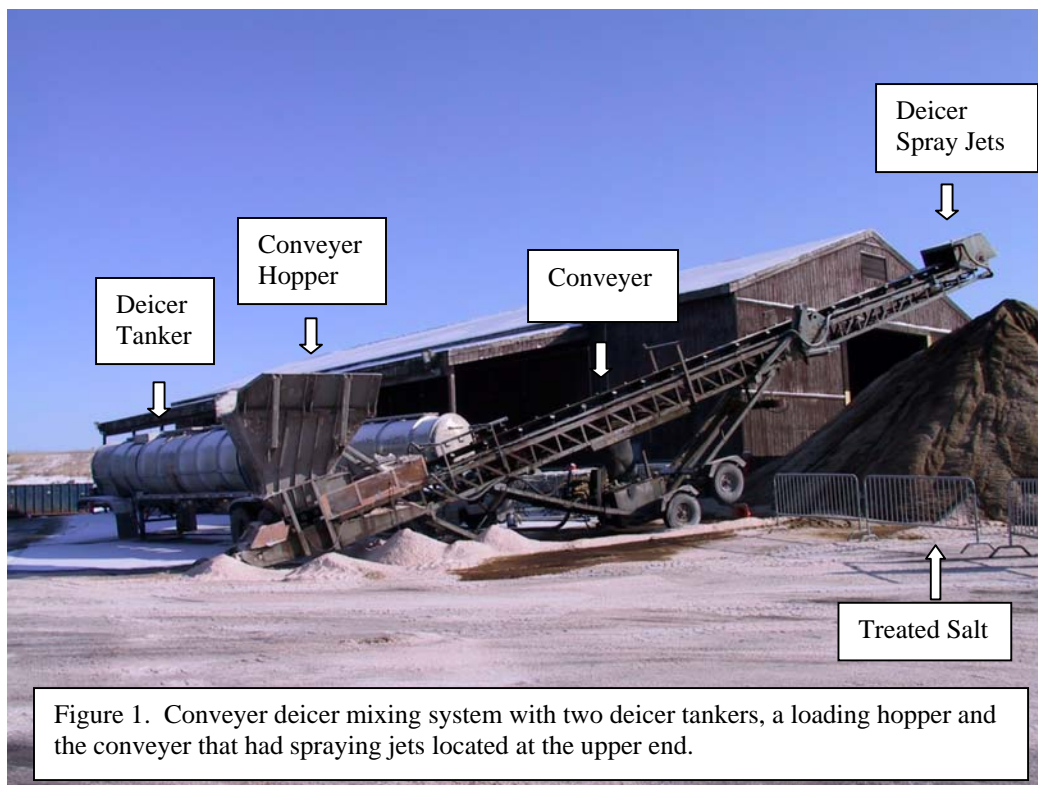
The stacking conveyer (Figure 1) was capable of processing approximately 300 tons of salt per hour. The mixing system had a set of six jets located at the top of the conveyer. The deicer was injected through the jets and sprayed onto the salt right before the salt fell off the belt. The conveyer mixer was equipped with a filtration system that was designed to prevent the jets from clogging up. The controls of the mixing system were located at the north side of the conveyer (Appendix A). When operating the conveyer, the victim stood between the deicer tankers and the conveyer where there was no loader traffic. However, according to the EOs, the spray jets kept clogging that day and the victim had to walk around the salt piles and enter the loader working area to perform maintenance.

Discussion: On the day of the incident, the deicer spray jets that were located on top of the conveyer clogged numerous times and the victim had to perform frequent maintenance that required him to walk in an area with busy loader traffic. The victim was witnessed working on the spraying jets while the conveyer was running. The conveyer mixing system should be evaluated and the following should be considered if feasible:

- 1) Improve the filtering system to prevent the jets from clogging;
- 2) Relocate the jets so that they are easier to access from an area without loader traffic; and
- 3) Install remote controls so operators can turn off equipment while testing and working on the spray jets.

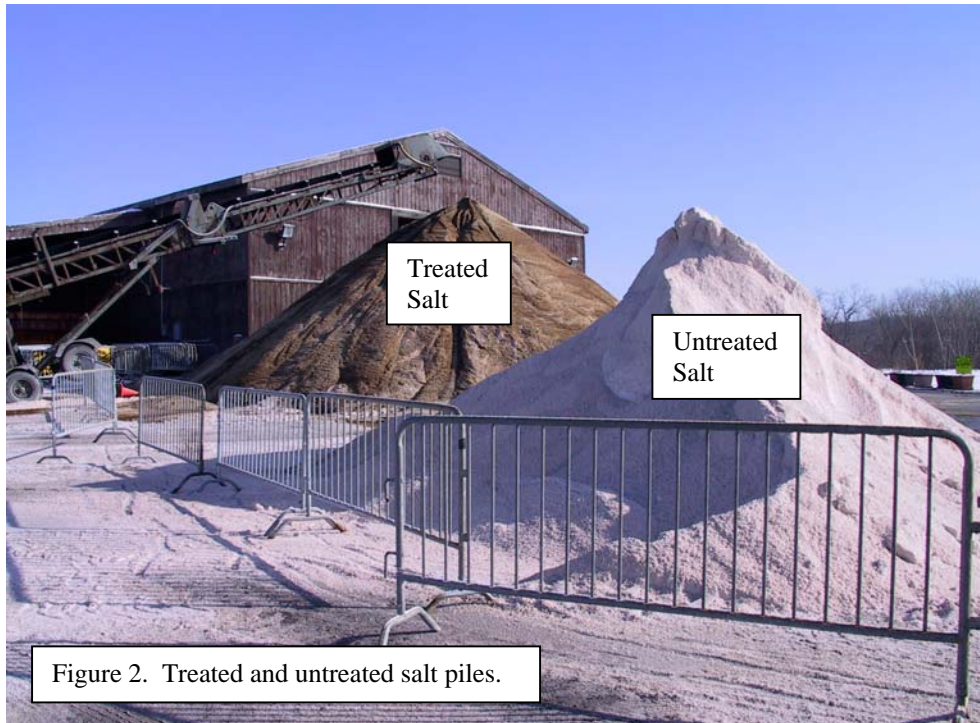
On the day of the incident, the victim wore an earth-tone Carhart suit and a dark blue canvas jacket; he was not wearing a high visibility safety vest. He also wore a hat and a pair of wrap-around safety glasses. In order to communicate with the EOs, who had two-way radios to communicate within the cabs, the victim had to catch the EOs' attention by gesturing or making eye contact. Witnesses reported seeing the victim walking in the areas between the two salt piles, behind the loaders, and near the salt shed entrance numerous times. According to the EOs, at least four times during that day, the victim climbed up to the top of the 25-foot high treated salt pile (Figures 1 and 2) to clear the clogged jets with a wire while the conveyer was running.

Discussion: High visibility safety vests are much easier to spot than tan or dark red uniforms in the earth-colored background of the treated salt pile. The DGS should require that all employees and on-site contractors wear high visibility safety vests while working in the salt yard.

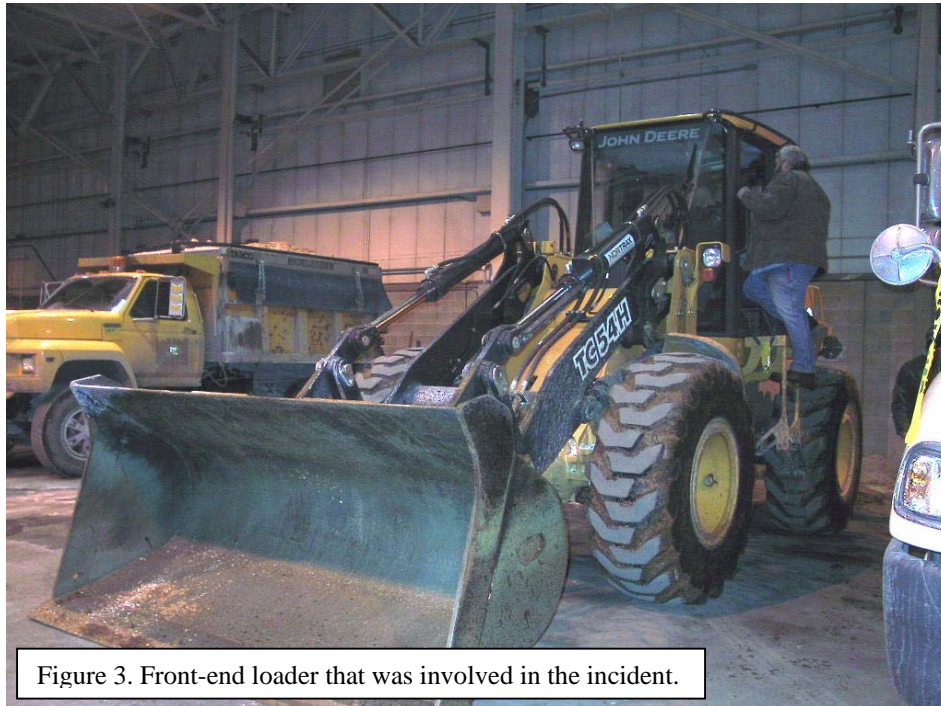
Figure 3. Front-end loader that was involved in the incident.

Operator A used a 2003 John Deere TC 54H wheel loader (Figure 3) that had been purchased by the DGS the previous year. The articulated four-wheel drive loader weighed about thirteen tons. It was equipped with an audible backup alarm and strobe lights that flashed during backing. At the time of the incident, both the audible alarm and the strobe lights were working properly. The loader had a right rearview mirror inside the cabin, and originally had exterior side-rear view mirrors on both sides. The two exterior mirrors had been broken off by tree branches during a snowstorm in December 2003 and had not been replaced. On the right side, the operator had virtually no blind spot due to a right interior rear view mirror. However, with the left exterior mirror missing, the

operator's blind spot on the left side extended back from the left rear of the vehicle approximately nine feet.

Discussion: If a piece of equipment becomes damaged or malfunctions, it should be removed from service until it is repaired. In this case the rear view mirrors that were broken off during a December snowstorm were not replaced until January 23rd, ten days after the incident. Although the missing mirrors in this case may or may not have directly contributed to the incident, they did create a blind spot for the driver on the left side of the vehicle.

Recommendation #2: *DGS facilities should repair damaged equipment in a timely manner.*

Recommendation #3: *DGS facilities should consider installing additional backup safety devices on heavy equipment to warn operators when someone is in their blind spot.*

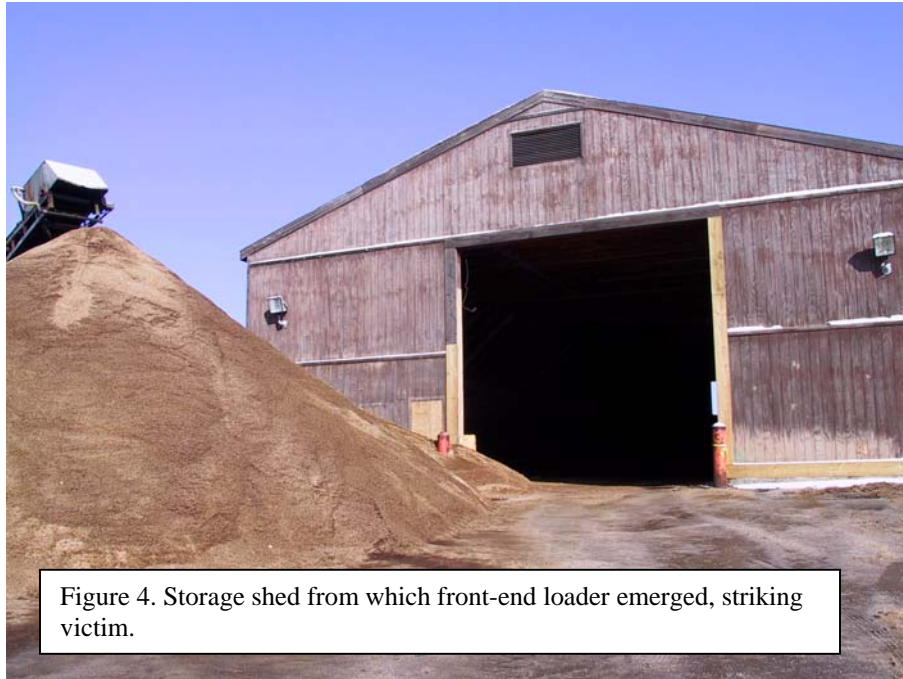
Figure 4. Storage shed from which front-end loader emerged, striking victim.

When Operator A began working at the salt yard at approximately 3:00 p.m., the area in front of the entrance and two-thirds of the shed entrance, which was approximately 20 feet wide, were piled with treated salt. The salt pile in the pathway of the loader created a potential roll-over concern. Operator A tried to shave some of the salt off the salt pile and clear the entrance area. He backed the loader out of the shed (Figure 4), stopped the loader, set the bucket facing the shed entrance, scooped up the salt on the path, drove to the shed, and dumped the salt, then backed out again to pick up another load.

Just prior to the incident, one EO was working at the in-feed end of the mixer and another was fueling his loader at a gas pump at the other end of the salt yard. Neither of these EOs saw the incident. At approximately 3:50 p.m., Operator A began backing his loader out of the shed after dumping a load of salt (Appendix A). The loader backed 48 feet inside the shed to the shed entrance and then proceeded to back 41 feet outside the shed. Operator A stated that he looked back, left and right before and during backing, but did not see the victim in his path. As he backed along the side of the salt pile, Operator A felt the loader rocking as if it had run over a pile of salt. Realizing that he had just cleared the area and there should not have been any obstruction, Operator A immediately stopped the loader. He looked down at the left side and saw the victim's legs under the left front tire. It appeared that the victim was struck from behind while he was walking south around the treated salt pile. Operator A pulled the loader forward to get the front tire off the victim, set the brake on the loader, got out and called 911 on his cell phone immediately. He then ran to the other two operators to draw their attention. Both operators jumped out of their loaders, ran to the victim and stayed with him. EMT arrived on the scene within five minutes. The victim was transported to a local hospital where he was pronounced dead.
