STATE OF NEW YORK DEPARTMENT OF HEALTH

FATALITY ASSESSMENT AND CONTROL EVALUATION

Millwright Killed When Aerial Work Platform Tipped Over Case Report: 03NY034

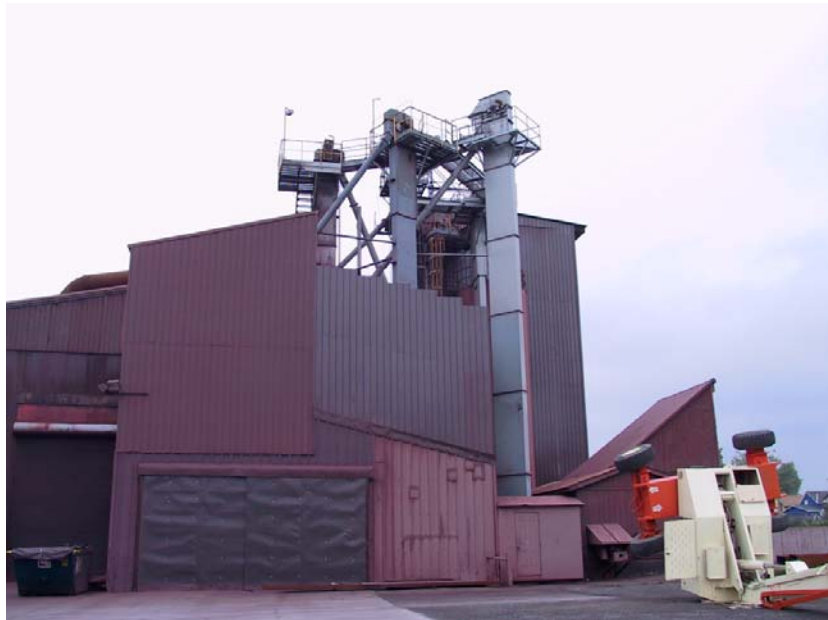
Figure 1. Bucket elevator that was being inspected by the victim during the fatal incident.

At approximately 3:30PM, the maintenance crew finished removing the fiberglass stacks. The supervisor and the victim discussed doing a visual inspection of the exterior of a bucket elevator (see Figure 1). The supervisor left after the discussion and the victim proceeded to perform the inspection. The bucket elevator was approximately 70 feet high and was used to transport iron oxide powder into the plant. The maintenance department inspected the elevator and looked for wear and rust spots approximately once every six months. The unpaved ground around the elevator was solid with grades less than 4 degrees ($^{\circ}$). The manufacturer required that the platform should be leveled within 5 $^{\circ}$. The tires of the platform appeared properly inflated and had good treads based on the post incident examination.

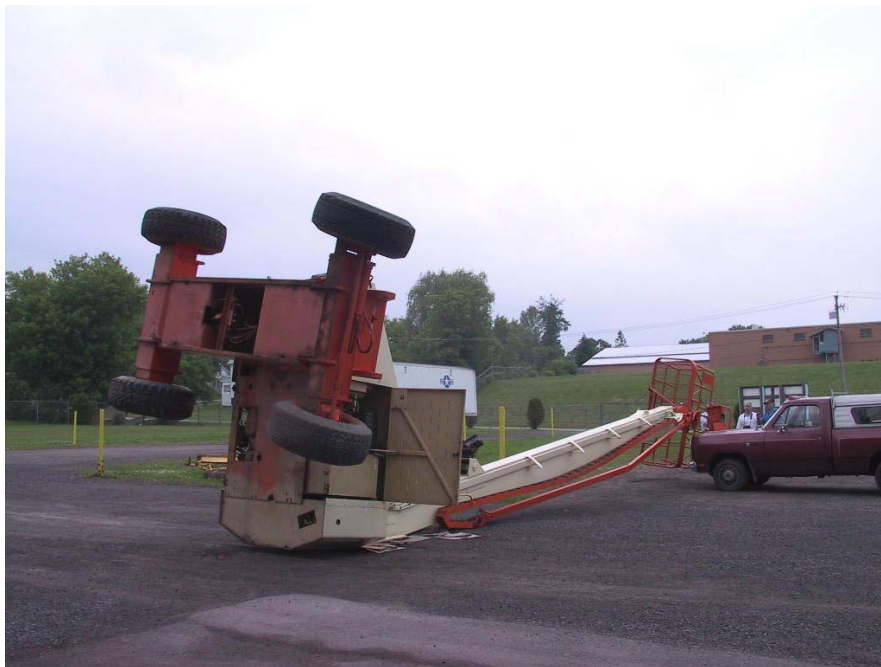
Figure 2. The aerial work platform tipped over during the incident and hit a pickup truck that was parked near by.

Just prior to the 3:45PM incident, the co-worker saw the victim in the platform directly underneath the elevator's catwalk, approximately 54 feet high. A few minutes later the co-worker and a swing shift millwright who had just arrived at the plant heard and saw the lift falling (see Figure 2). According to the post-incident investigation, the boom was extended to 38 feet when the lift tipped. The platform hit a pickup truck parked nearby, resulting in the victim, who was still attached to the platform by the intact lanyard, being bounced out of the platform. The two millwrights ran to the

Recommendation #1: *Employers should ensure that their employees receive proper training and are qualified to operate an aerial work platform before allowing the employees to operate the equipment.*

Recommendation #2: *Employers should require that the operators inspect the aerial lift and test critical safety features before each use and perform safety checkups each time the platform is repositioned during operation.*

Each time when the aerial lift is repositioned during operation, the operators should ensure that the platform is operated on a surface within the limits specified by the manufacturer, and the outriggers, stabilizers, extendible axles, or other stability enhancing means, are used as required by the manufacturer. Employers should ensure that the operators follow the requirement through close supervision and work site inspection performed by a qualified person.
