# STATE OF NEW YORK DEPARTMENT OF HEALTH

## FATALITY ASSESSMENT AND CONTROL EVALUATION

### Worker Dies after Falling through a Steel Grid Plate into an Underground Frozen Coal Cracker Case Report: 03NY006

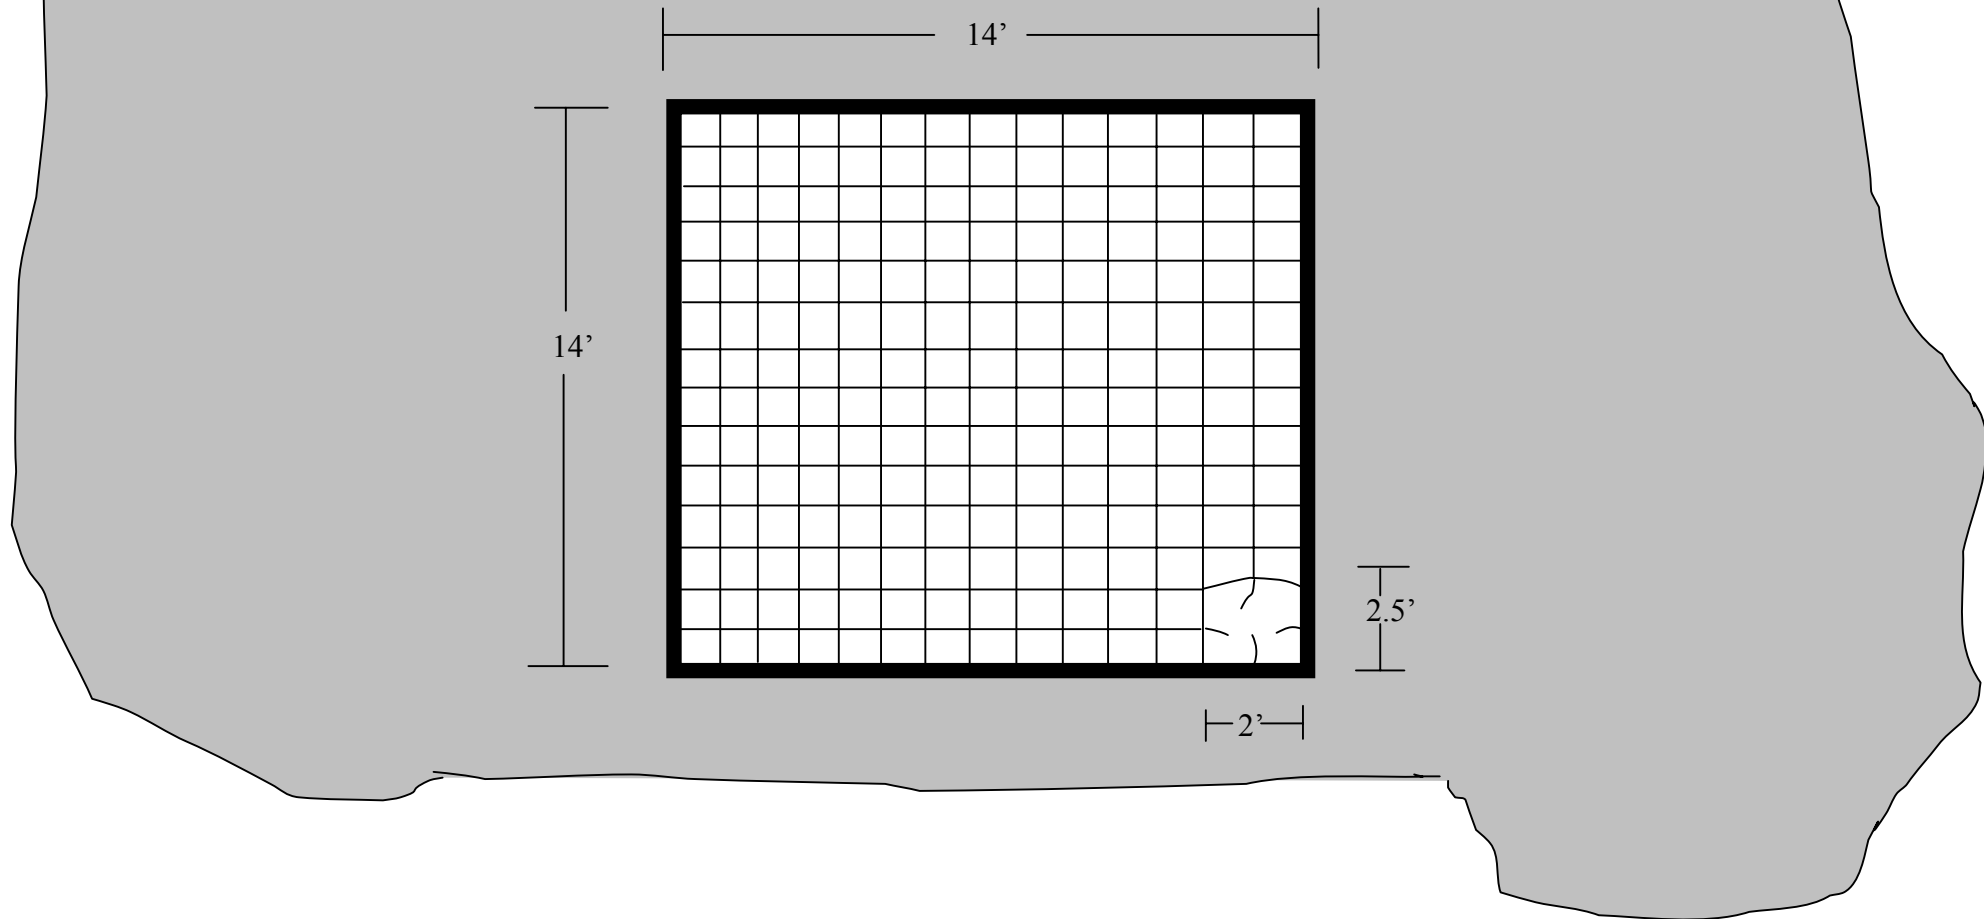
Figure 2. Overhead view of grizzly. (Drawing not to scale).

The last time the emergency stockpile had been used before the fatal incident was on January 22nd. On that day, damage to the grizzly was recorded in the team's daily log. The steel bars (1"X10") that formed the grids were broken and bent in one corner of the grizzly, resulting in a 2' by 2.5' hole. The team leader and the maintenance crew assessed the damage and decided to delay repairing the grizzly until spring, when the weather became warmer. According to the union steward, the majority of the team, including the victim, was verbally informed of the damage and the decision to delay the repair job.

**Recommendation #1:** *Employers should repair damaged equipment in a timely manner, and place warning signs and guards immediately on and around the damaged equipment to warn workers of the safety hazard.*

**Discussion:** In the event a piece of equipment becomes damaged or malfunctions, the equipment should be removed from service and repairs should be done immediately if the damaged equipment presents a safety hazard to the operator or other employees who work in the same area. If the damaged equipment cannot be removed from service or the repairs cannot be done immediately,

guardrails should be placed around the equipment, covers over fall hazards, and warning signs posted to warn workers of the safety hazards.
