# STATE OF NEW YORK DEPARTMENT OF HEALTH

## FATALITY ASSESSMENT AND CONTROL EVALUATION

### Truck Driver Killed when Struck by Laminated Veneer Beams Falling from a Forklift Case Report: 02NY027

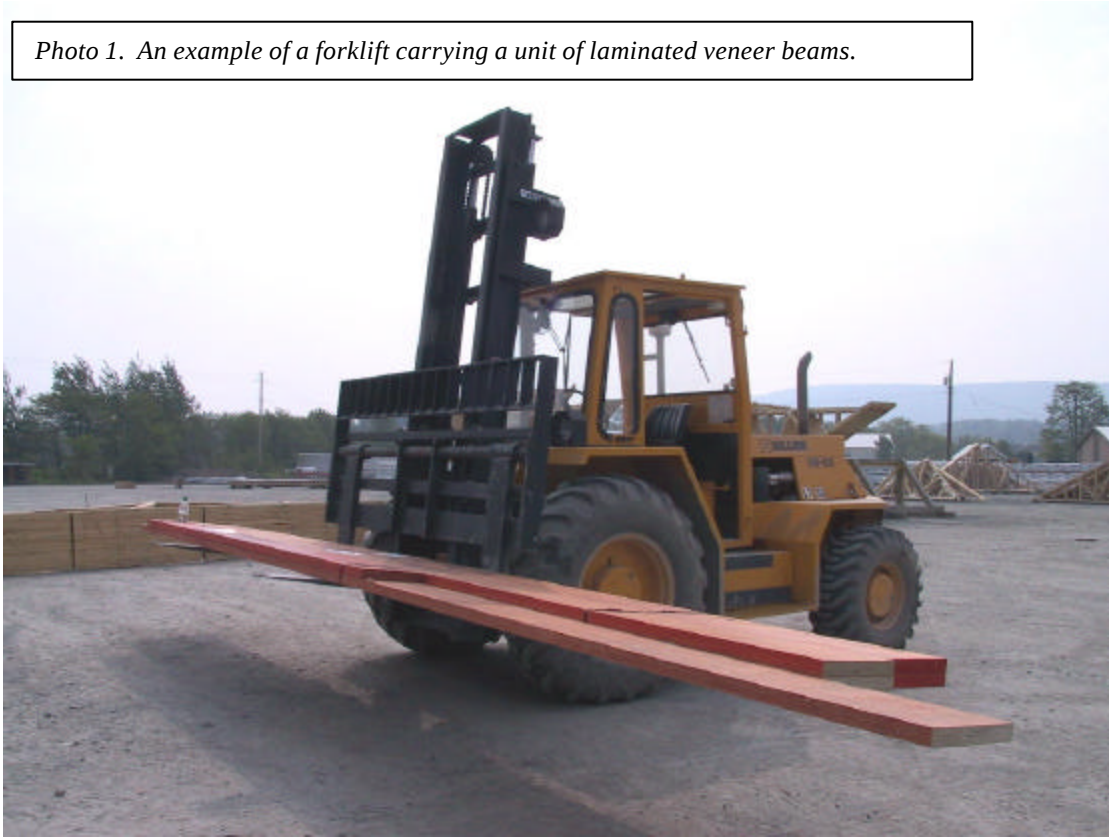
*Photo 1. An example of a forklift carrying a unit of laminated veneer beams.*

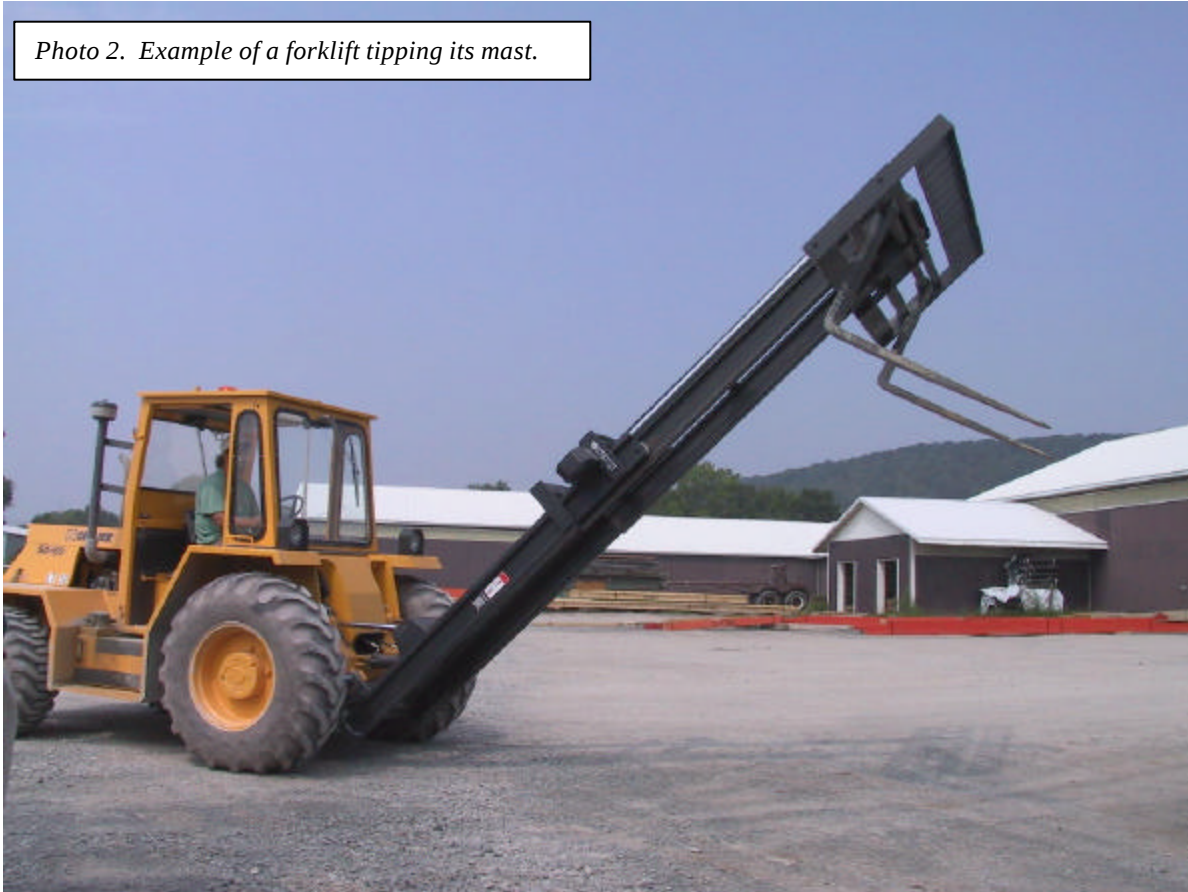
Because the load had to be placed in the middle of the trailer and there were no spacers for the forklift to set the forks in, the forklift operator had to tip the mast to slide the unit into position. While the unit was being lifted and tipped, the end that was close to the rear of the trailer started to slide off the forks first. The victim tried to get away from the sliding beams by running toward the front end of the trailer. The unit quickly hit the previously loaded beams on the trailer. The impact

*Photo 2. Example of a forklift tipping its mast.*

**Recommendation #1:** *Employers should develop and implement standard safe loading procedures for forklifts and ensure that all workers follow the procedures.*

- Only stable or safely arranged loads should be handled;
- Always use spacers in between orders or units to avoid forklift tipping and sliding loads;
- No spotter/helper should ever stand under, in front of, or near a moving load;
- Always keep the spotter/helper in the forklift operator's sight.

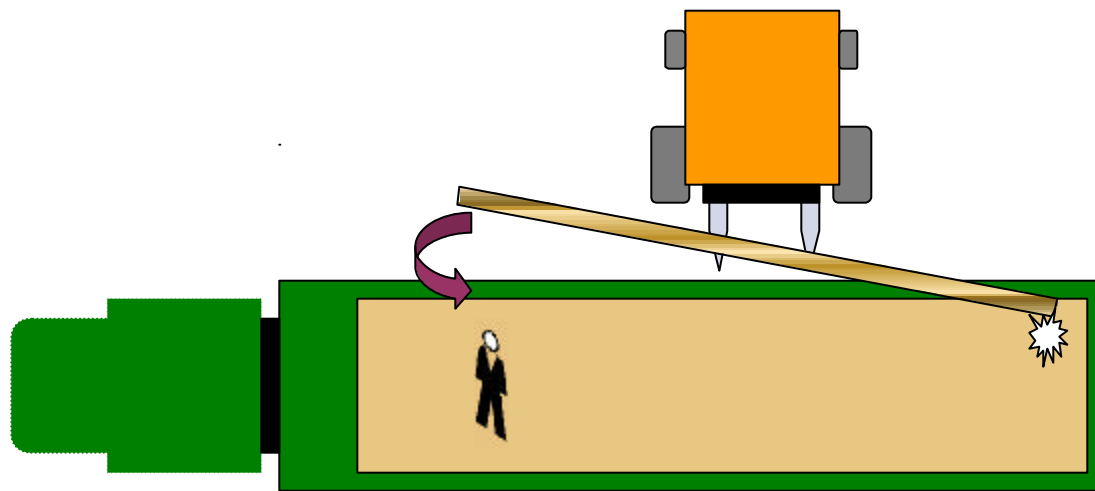
Figure 1. Top View of Incident Scene

caused the unit to bounce and swing rapidly toward the victim (Figure 1). The unit then slid off the forks and struck the victim. The victim fell off the trailer, and his head was crushed by the load. The forklift operator immediately stopped the forklift and ran to the victim who was on the ground next to the driver's side of the trailer. The victim, who was not wearing a hard hat, was found unresponsive with a massive head injury. The forklift operator immediately called for an ambulance. EMS and the local police department responded within minutes and secured the accident site. The victim died instantly. The medical examiner was called, arrived at the site, and pronounced the victim dead at the scene. The victim was transported from the accident site to a local funeral home.
