# STATE OF NEW YORK DEPARTMENT OF HEALTH

## FATALITY ASSESSMENT AND CONTROL EVALUATION

### Truck Driver Run Over by Trash Compactor at Municipal Landfill Case Report: 02NY007

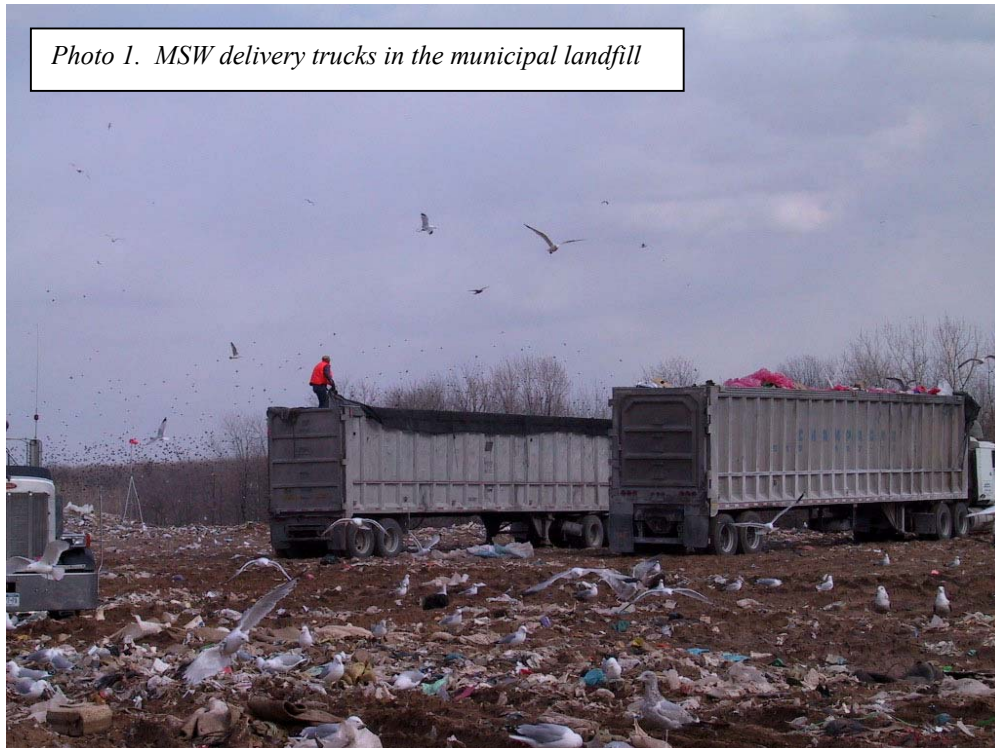
The MSW trucking company that employed the victim was located approximately 180 miles east of the landfill. The trucking company had 35 semi-trucks and employed 40 workers and 35 sub-contractors delivering waste from local transfer stations to landfills (Photo 1). This was the first fatality the trucking company had since beginning business 15 years ago. The decedent was a licensed commercial truck driver and had been employed by this trucking company for five years. At the time of the FACE investigation, the trucking company did not have a full time safety person, nor had it developed a comprehensive health and safety program. The trucking company provided the drivers with high visibility orange vests, but did not require them to be worn.

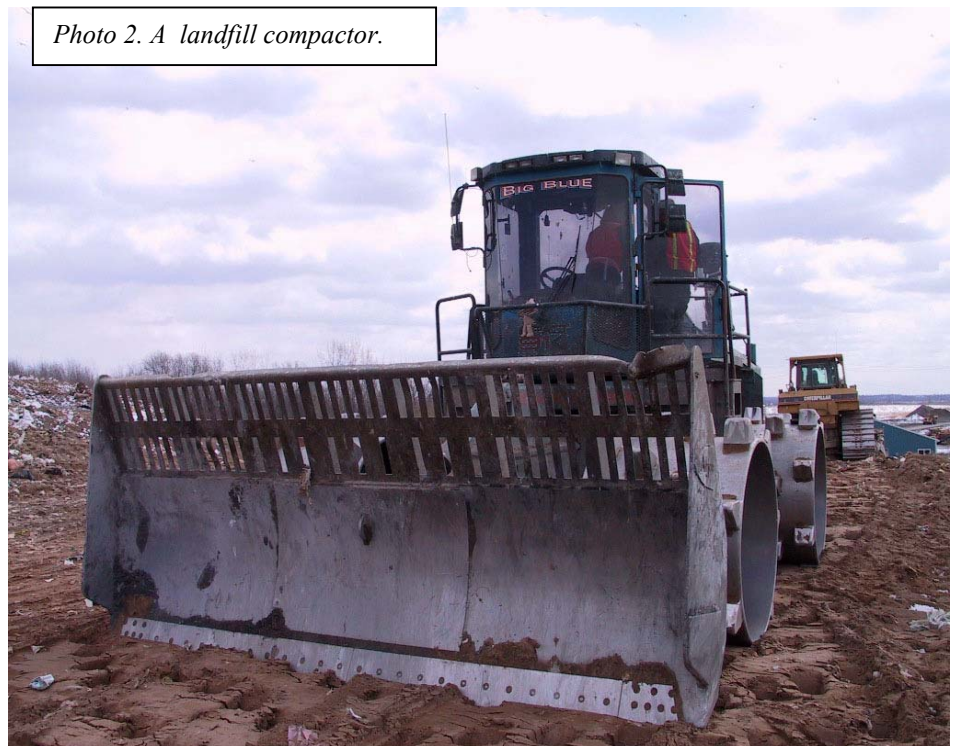
Each landfill compactor used at the time of the incident was about 30 feet long and 15 feet wide and weighed about 100,000 lbs. (Photo 2). It was an articulated vehicle with a front plow to push and spread the waste and sand, and with two sets of double metal wheels to crush and compact the waste. Each metal wheel was six feet in diameter and had 28 evenly staggered triangular metal cleats that were eight inches in height (Photo 3). The compactor moved at a speed of five to six miles per hour. The vehicle had an audible backup alarm, a rearview mirror in the cab and four side mirrors, two on each side.

Because of the length and height of the vehicle, the operator's blind spot extended from the rear of the vehicle up to 35 feet behind; the operator could not see a person unless he or she stood further than 35 feet away from the rear of the compactor.

***Recommendation #3: Landfill employers should consider using additional safety devices for landfill equipment, to warn drivers when someone is in their blind spot.***

- Readily available devices include video cameras that can be mounted on the vehicle to monitor blind spots on the front, rear and side of the vehicle. A video monitor in the cab provides the equipment views.
- Other types of devices may also be available including electromagnetic signal detection, infrared detection, and ultrasonic systems.

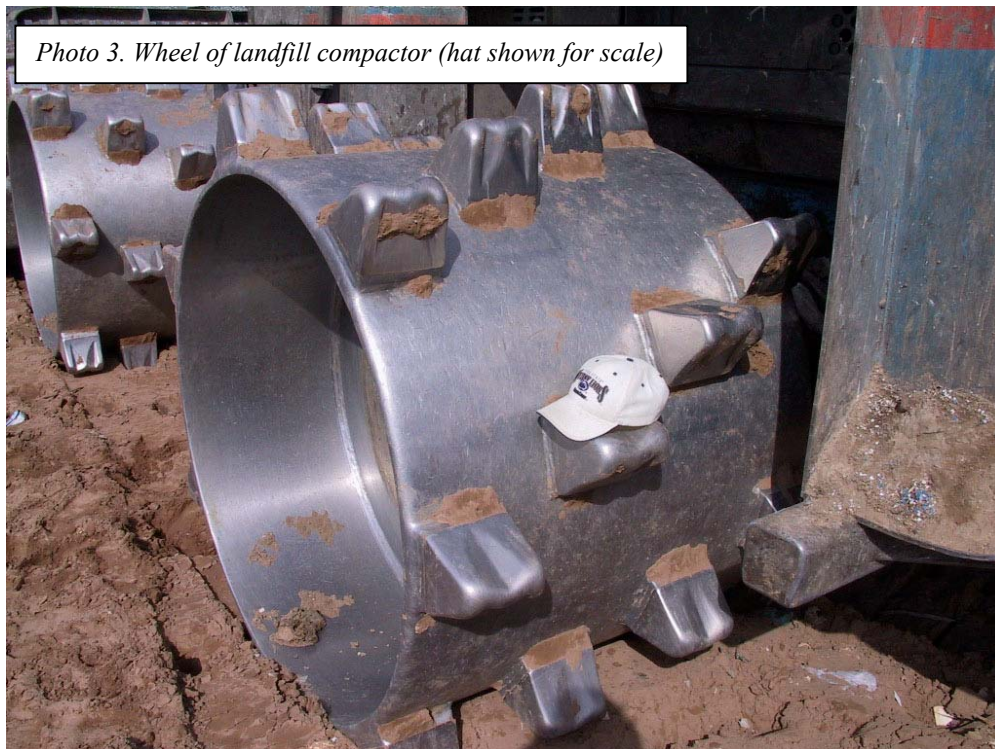
*Photo 3. Wheel of landfill compactor (hat shown for scale)*

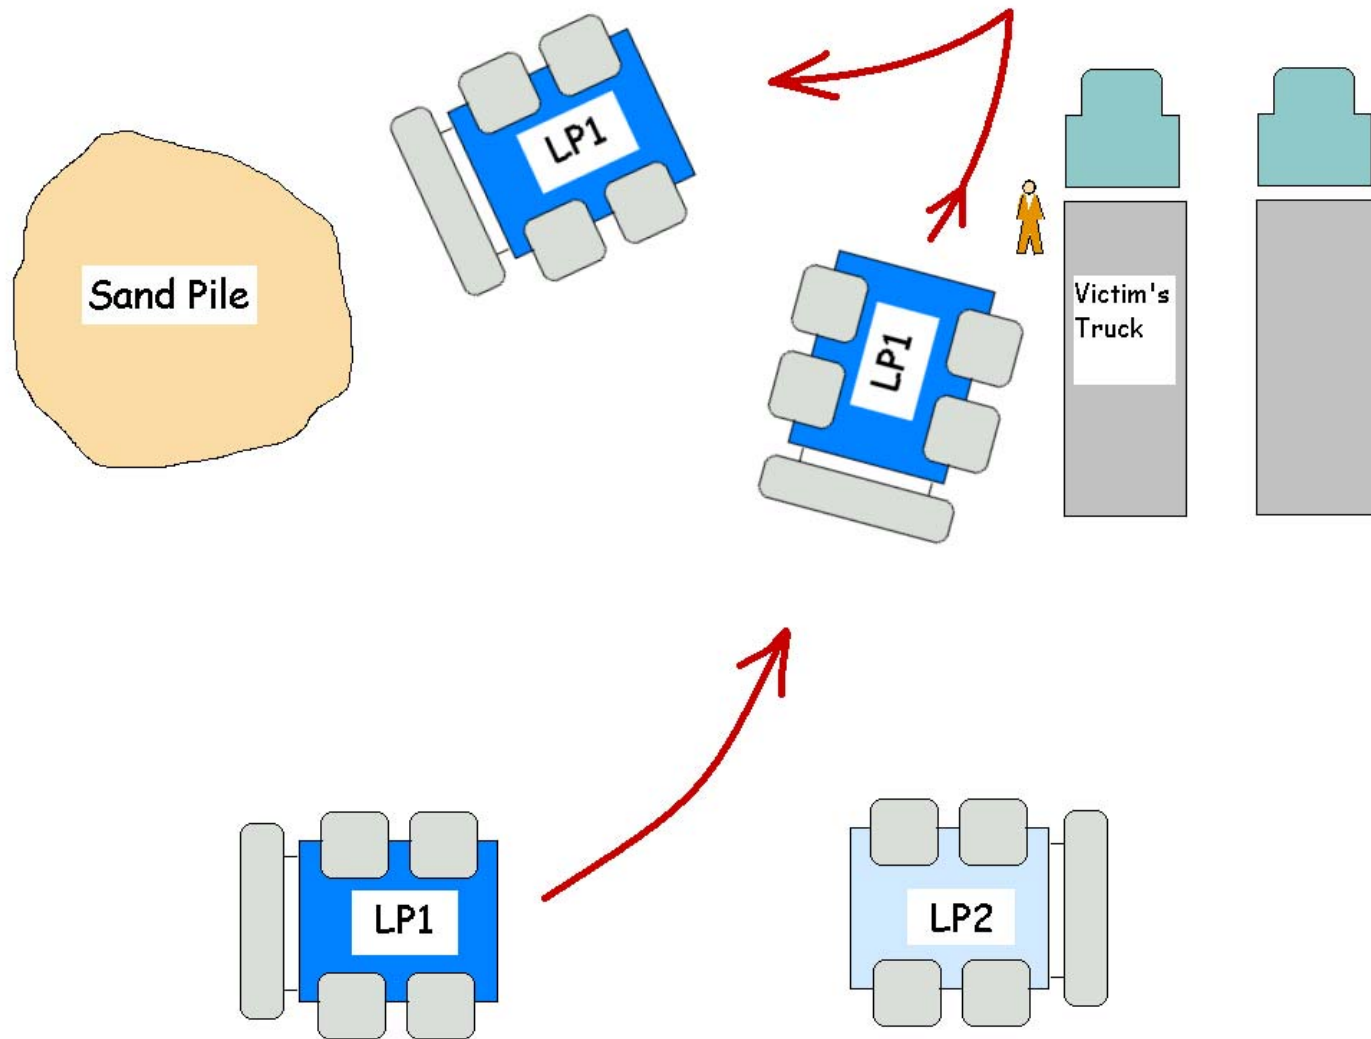
Figure 1 - Illustration of Accident

Just prior to the incident, LP1 moved to the left (southwest) side of the victim's truck and LP2 remained at the rear (south) of the two trucks (see Figure 1). At approximately 2:20 p.m. the trailer was completely unloaded and swept. The LP2 operator stated that he saw the driver jump off the rear of the trailer and walk along the west side of the trailer toward the cab carrying his broom. At the same time, LP1 was backing up next to the victim's truck to get sand from a sand pile located at the left (west) side of the trucks. According to the landfill company representative, the back up alarm of LP1 was working properly at the time of the incident. The LP1 operator stated that he looked through both the back and side mirrors before backing up, and did not see the victim in his path. When LP1 curved to the left (west), away from the side of the victim's truck, to approach the

sand pile, the LP2 operator, whose view of the victim was temporarily blocked by LP1, saw the victim lying on the ground next to his semi-truck, waving his hands. The LP2 operator radioed the LP1 operator to check on the victim. The LP1 operator stopped the compactor immediately and ran over to the victim, who was lying on his back approximately five feet from the driver's side of the truck next to the platform behind the cab, with his broom lying next to him. The victim had massive crushing wounds on his left torso (pelvic area) and left leg. It appeared that at the time of the incident, the victim was walking to the front of the truck to put the broom back when he was struck by the LP1 compactor as it was backing up. The LP1 operator immediately radioed the landfill superintendent for daily operations and summoned the local emergency rescue crew, who arrived within minutes. The victim was transported by helicopter to a hospital trauma center 50 miles away, where he died six days later as a result of the injuries.

***Recommendation #1: Landfill employers should develop a landfill traffic control plan that can be used to coordinate the movements of personnel on foot, landfill mobile equipment and delivery trucks on a working face or on any other landfill operations that involve multiple mobile equipment.***

***Recommendation #2: Landfill employers should develop and enforce a policy that requires delivery drivers to remain in the truck cab during unloading.***
