STATE OF NEW YORK DEPARTMENT OF HEALTH

FATALITY ASSESSMENT AND CONTROL EVALUATION

City Employee Killed when Clothing became Entangled around an Unguarded PTO Shaft on a Salt Truck Case Report: 05NY007

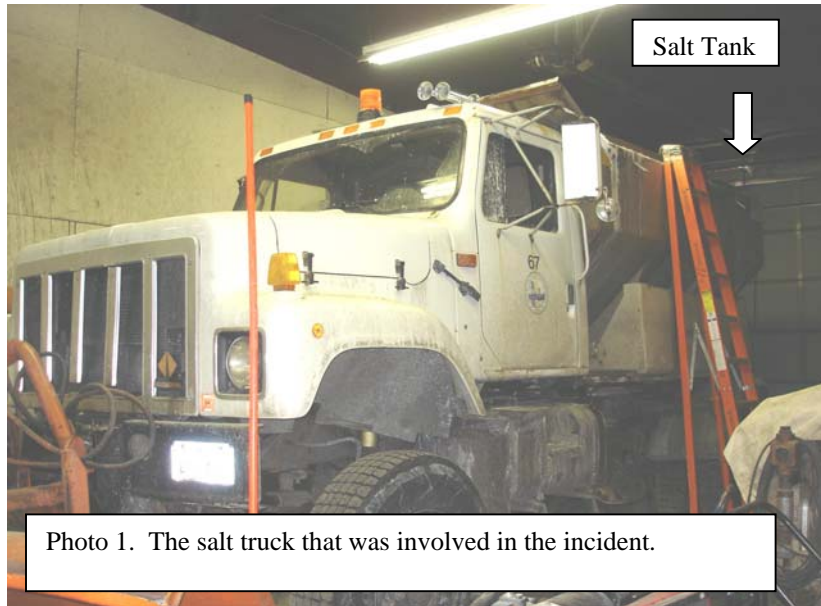
The DPW had two salt trucks, both purchased new in 1993. Each truck had a snow plow in front, a seven cubic-yard salt tank in the back (Photo 1), and a salt spreader at the rear end of the truck. There was a conveyer bed chain on the bottom of the salt tank to transport the salt to the spreader (Photo 2). The conveyer chain was driven by a hydraulic motor through a PTO shaft or a worm gear assembly (Photo 3). The PTO shaft operated between 800 and 1200 RPM with a torque of 1150 inch-pounds. The shaft stub was one inch in diameter and two inches long. Under normal circumstances, the stub was enclosed and guarded by a metal cap (the shaft guard) that was secured to the gear casing with two screws (Photo 4). The PTO assembly was located on the driver's side of the truck towards the back end, approximately five feet and three inches above ground level.

Photo 1. The salt truck that was involved in the incident.

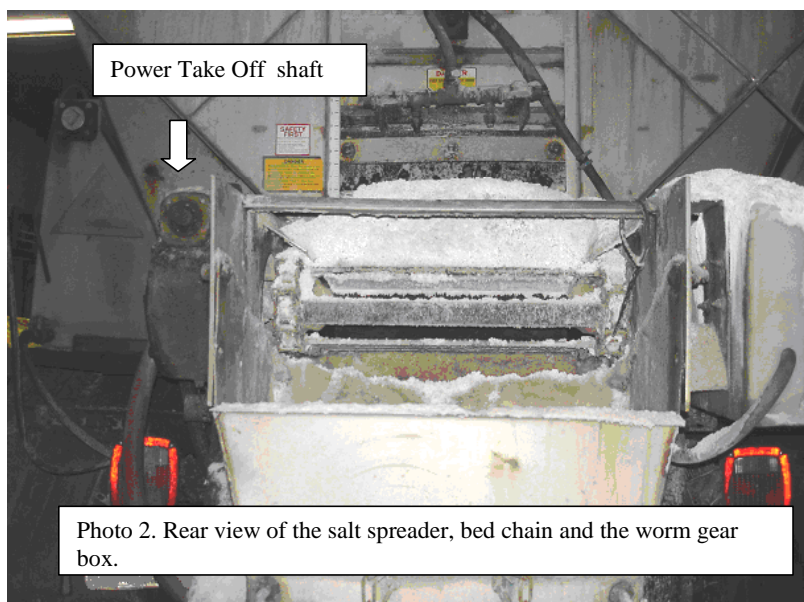
Photo 2. Rear view of the salt spreader, bed chain and the worm gear box.

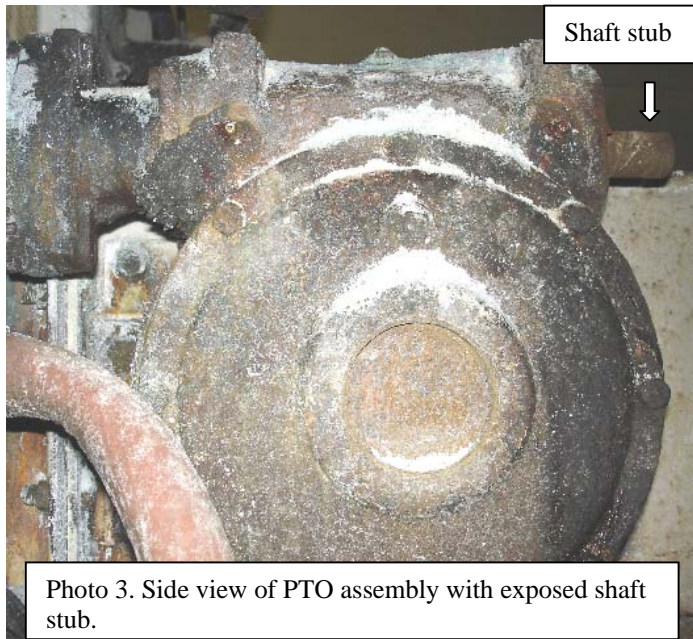
The victim finished plowing and salting the roads and returned to the salt shed at approximately 3:30 p.m. He was seen by one of the workers who was at the salt shed as he backed his truck into the shed to empty the salt. The salt tank had to be emptied at the end of each day so the salt would not freeze and obstruct the bed chain. The salt often stuck to the bed chain and had to be dislodged while the truck was being emptied. This was frequently done by an operator using a stick and without turning off the machine.

Recommendation #3: *Employers should develop a salt truck standard operating procedure that requires operators to turn off the machine before working on the bed chain.*

Discussion: When operating the salt truck, one of the problems frequently encountered by the DPW workers was the clogging of the bed chain. At the time of the incident, the operators often cleaned or unclogged the bed chain without turning off the machine. A standard operating procedure that requires operators to turn off the machine prior to working on the bed chain should be developed and implemented. Workers should receive training and the DPW should increase supervision to ensure that the workers strictly follow the standard operating procedure and do not take short cuts.

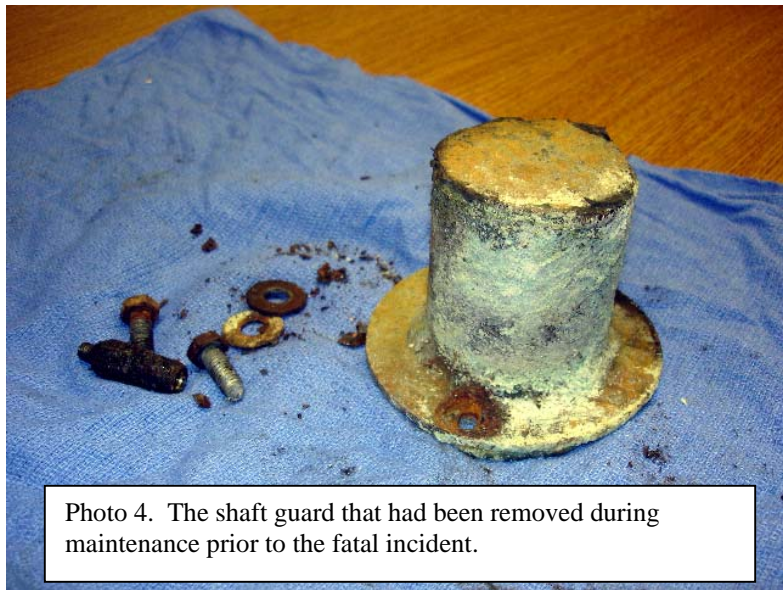
The manufacturer of the salt spreading system specified that all shields be kept in place and the machine stopped when adjusting or oiling. There was a warning sign posted next to the PTO on the salt tank stating that the power to the machine should be disconnected before cleaning a clogged machine. The DPW did not have a standard operating procedure that required an operator to turn off the machine prior to working on the bed chain.

Recommendation #1: *Employers should require maintenance staff to inspect and certify each piece of equipment before releasing it back into service after maintenance or repair.*

Discussion: Each piece of equipment that has undergone maintenance or major repair should be inspected and certified by DPW maintenance staff before it is released back into service. The DPW maintenance staff should verify and certify that the equipment is safe to operate and that all safety features, including machine guards, are in satisfactory condition and have been replaced after repairs. A fill-in inspection checklist may be developed to assist with the inspection. The inspection should be documented and records retained.

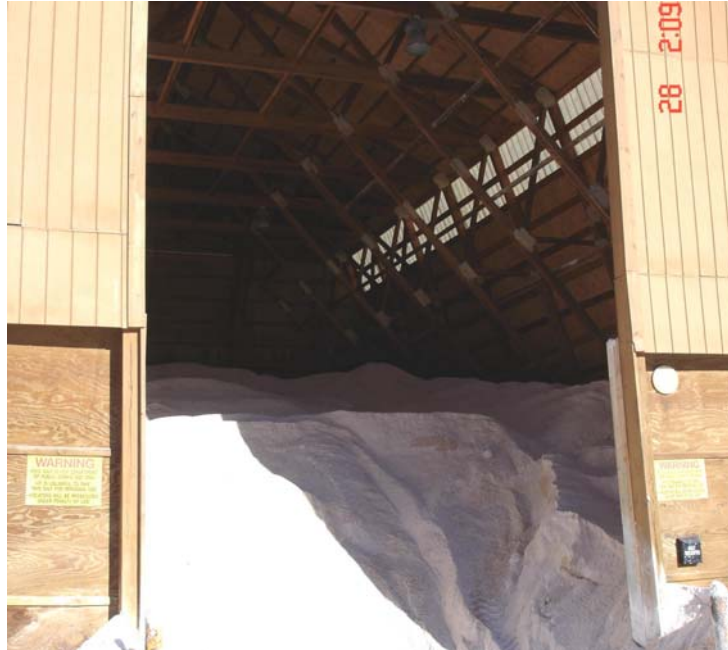
Photo 5. The entrance to the salt shed where the victim parked his truck at the time of the incident.

A potential contributing factor to the incident was the access space inside the shed (Photo 5). At the time of the incident, the victim walked on the piled salt around the rear end of the truck. This unstable footing may have contributed to his contact with the shaft.
