SUBJECT: A machine operator died when he was caught between a conveyor belt and tension roller underneath an industrial machine

SUMMARY
California FACE Report #04CA011

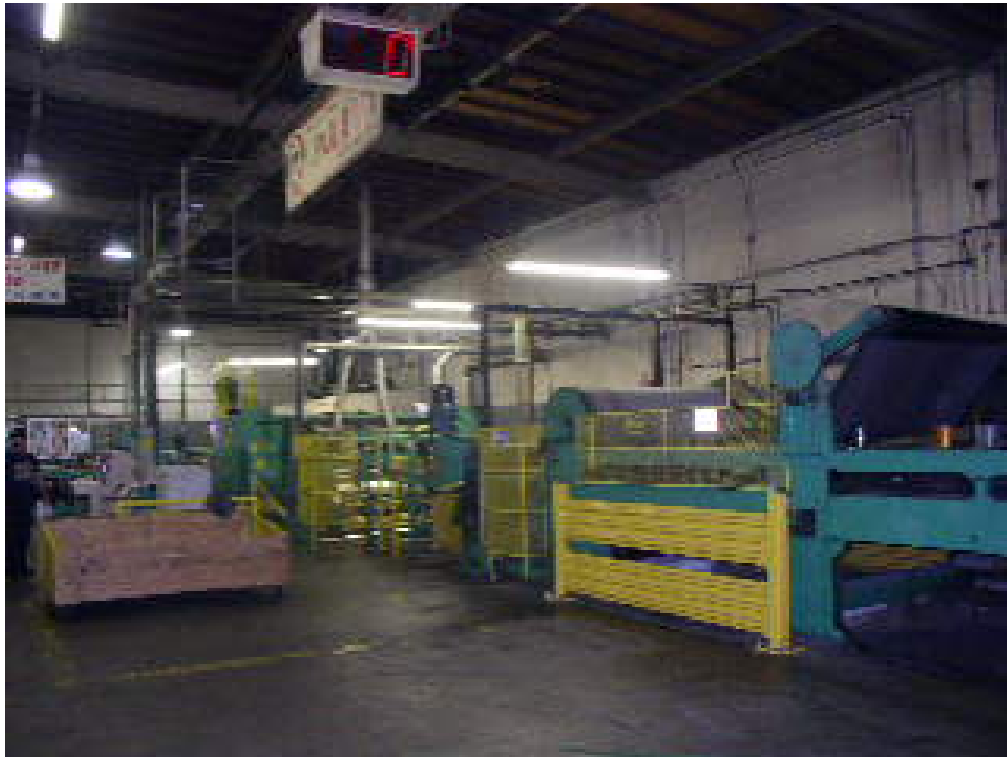
The site of the incident was a manufacturing plant of cardboard sheets and boxes. The machine involved in the incident was an industrial roller assembly used to make corrugated cardboard sheets. The assembly takes sheets of cardboard and, with the application of heat and an adhesive compound, compresses them together making different arrays of regular and specialty cardboard sheets.

Exhibit 1. The machine involved in the incident.

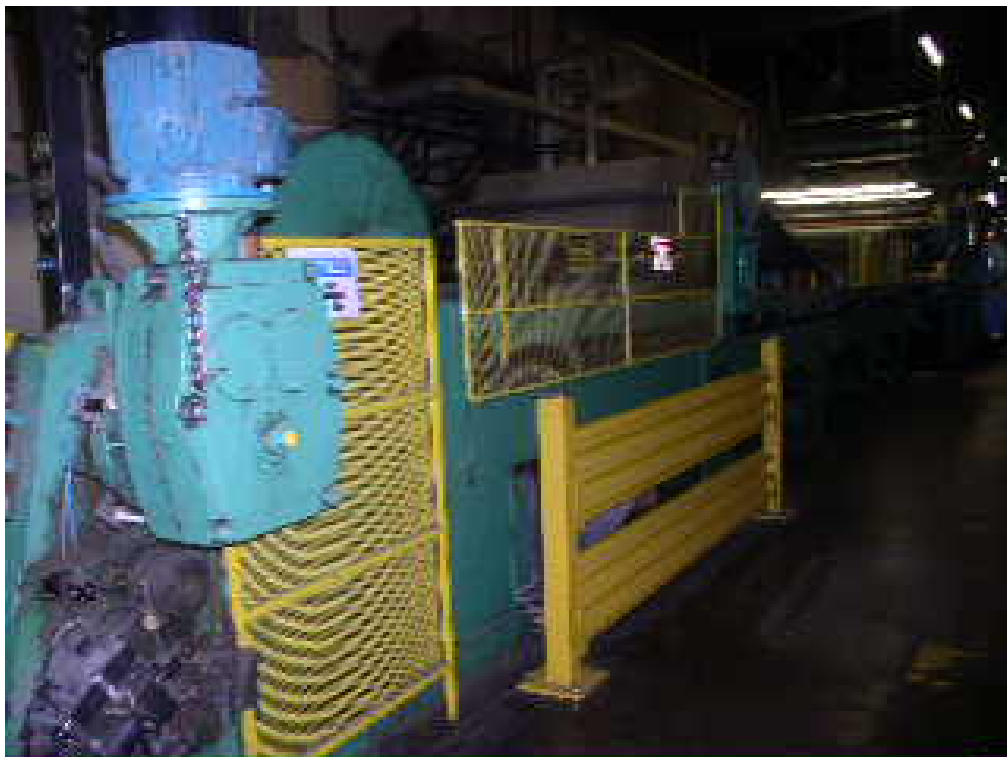
The supervisor immediately shut down the machine and found the victim underneath the machine, stuck between the conveyor belt and the roller. The supervisor and co-worker both stated that they did not see the victim go underneath the machine after he cleared it the first time. The company's lockout/tagout procedure was not being used at the time of the incident. The co-workers removed the victim from underneath the machine as the paramedics were called. The victim was treated at the scene and then transported to the hospital where his treatment continued until he expired later that morning.

Discussion: In this incident the victim was performing service on the conveyor system. During servicing, it is a frequent occurrence for guarding to be removed for access. This is permissible as long as the machine has been de-energized and lockout/tagout is used. When the machinery is to be restarted, the guarding must be replaced. If there had been guarding for this machine, and if it had been replaced after the cardboard had been removed from the conveyor system but before the system was restarted, the victim would not have been able to re-enter the incident site with the conveyor running.

Exhibit 2. The location where the victim went underneath the machine with guards in place after the incident.

Recommendation #3: Ensure all machines are properly guarded to protect employees from moving parts.
