**SUBJECT:** A construction laborer died when he was struck by a fast moving vehicle as he crossed the roadway in a street construction work zone

**SUMMARY**  
**California FACE Report #04CA008**

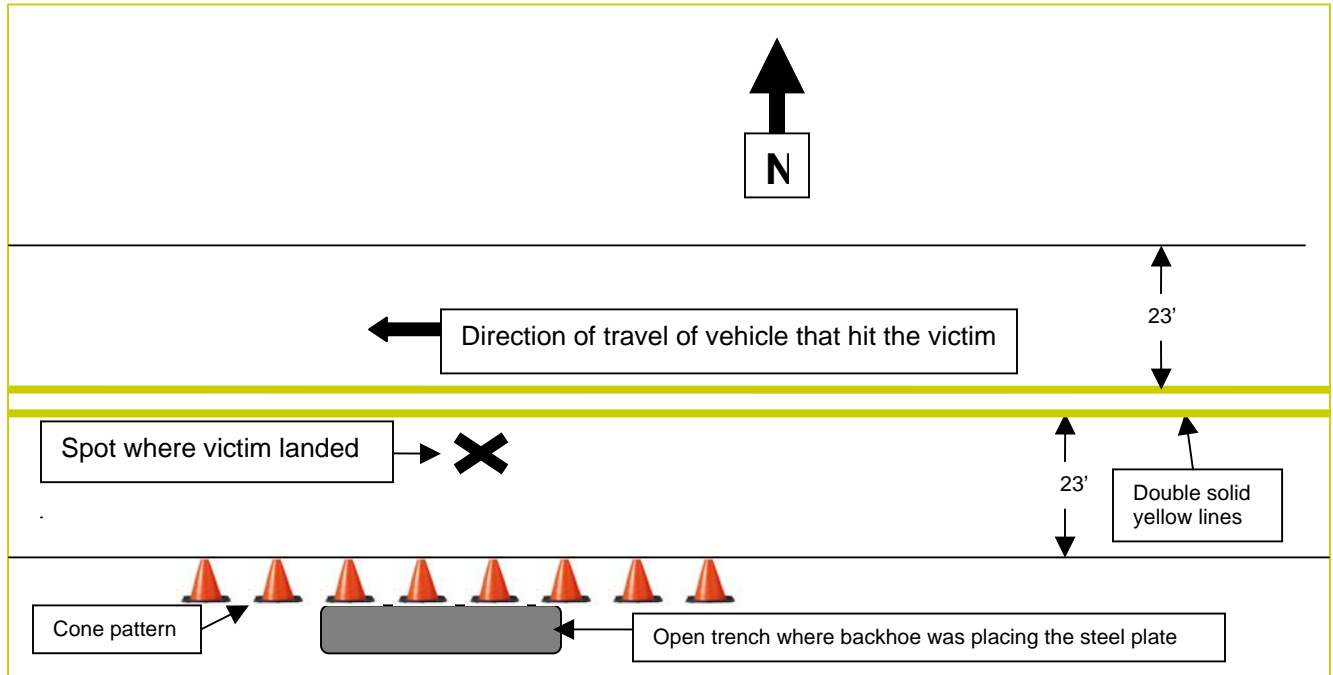
Drawing of Incident Scene

The site of the incident was an asphalt paved avenue that ran in an east-west direction. The company was contracted to replace a water line three feet deep that connected to a main water line. The water main lay on the south side of the avenue, and most of the work was done on the southern shoulder of the eastbound lane. On the day of the incident, sunset was at 5:50 p.m., and the weather was wet with a light rain falling all day. There were two streetlights on the north side of the avenue which were not operating. The avenue had one non-illuminated sign at each end of the work zone stating that there was a construction work zone ahead. It did not warn that traffic may come to a halt. It did not announce a reduced speed for the work zone. The posted speed for the area was 40 mph. There were traffic cones along the southern edge of the eastbound lane. A flag person stood at each end of the work zone to slow traffic, and to stop it when necessary.

The job had taken longer than anticipated and it was dusk by the time the crew began to finish up by placing steel plates over the open trench using a backhoe. The foreman on the job told the victim he was through for the day and that he could go home. The victim began to walk north across the avenue to get to his vehicle. He was entering the westbound lane within the still active work zone when he was struck by a westbound sports utility vehicle (SUV). The victim's co-worker, who was the flag person at the east end of the work zone, saw the SUV coming down the avenue from the east. He stated he waved the stop sign and whistled at the SUV but it did not stop. Another laborer working as a flag person on the west end of the avenue heard the yell and whistle and saw the SUV hit the victim. The backhoe operator, who was bringing a steel plate to the open trench, called 911. The foreman who was also on the west end of the job saw the incident occur and immediately drove his truck into the path of the SUV. He stopped the SUV approximately 200 feet west of the impact area. The police, fire department, and paramedics arrived within minutes and took control of the scene. The victim was transported to a local hospital. He was later transferred to a convalescent hospital where he died as a result of his injuries on August 2, 2004.

According to the police report, the driver of the SUV stated that he was traveling approximately 40 mph in the westbound lane of the avenue when he heard somebody yelling but did not see anyone. He stated that about a second later he felt an impact, pulled over to the side of the road, and saw a work crew. He told police that he saw the work crew dragging somebody over to the south side of the street, at which point he realized he hit someone. He also told police that his windshield wipers were on because it was raining, his front window was slightly fogged-up, and his dome light was stuck in the on position causing a glare on his windshield. He told police he was having some trouble seeing the roadway in front of him, but saw nothing that indicated to him there was construction work in the area.

### **Recommendation #1: Ensure street construction work zones are set up in accordance with the Manual on Uniform Traffic Control Devices (MUTCD).**

Discussion: The MUTCD is a publication of the Federal Highway Administration. It was developed to standardize the design and use of traffic signs, signals, and pavement markings. The MUTCD defines the standards used by road managers nationwide to install and maintain traffic control devices, both permanent and temporary, on all streets and highways. It is the primary reference for all highway and street construction work zone traffic control plans. For a work zone such as the one in this incident, the MUTCD calls for at least four warning signs: two signs at each end of the work zone, one to alert oncoming traffic that there is a work zone ahead, and another sign to alert drivers that flaggers are present. The MUTCD also suggests as an option that there be another sign at each end of the work zone that would alert drivers that they may need to stop. In this incident there were only two warning signs used. There was one sign at each end of the work zone warning of road work ahead. If the additional signs as designated in the MUTCD had been used, there would have been additional warning for the driver of the SUV.
