SUBJECT: An elevator operator was killed when he fell from a manlift.

SUMMARY

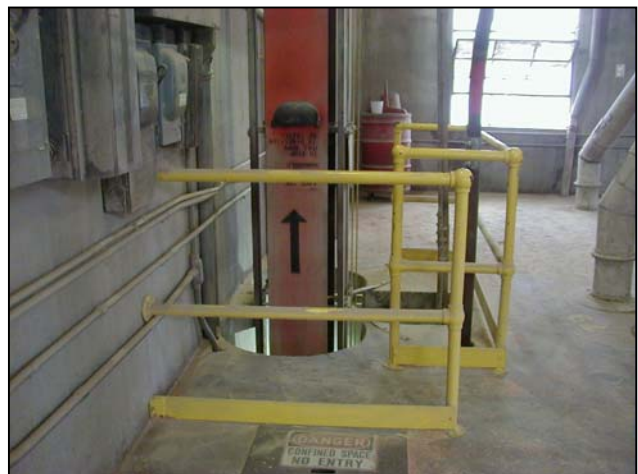
Figure 1. Manlift -- Ascending Side

The decedent arrived to work at 7:00 a.m., his first day back from a vacation. His first duty of the day was to ride up the manlift and turn on the equipment (Figure 1). The decedent was working alone and was using the manlift to come back down when the incident occurred (Figure 2). A co-worker reported using the same manlift two minutes prior to the victim and noted all safety devices to be functioning properly. He stated that the safety stop ropes, which could be used by the rider to cut off power, apply the brake, and stop the manlift, were working because he used them on the way down. The manlift was the only way to get around in the elevator area and was one of three in the mill area.

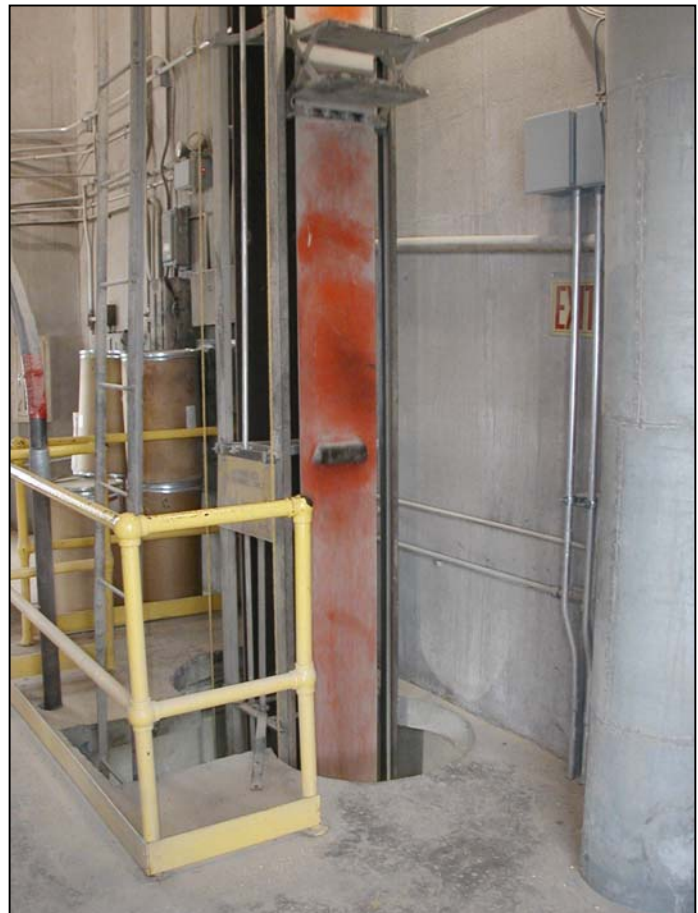
Figure 2. Manlift -- Descending Side

To use the manlift properly, a worker stepped onto one of the step platforms that were 14 to 16 inches wide and 12 to 14 inches deep, and were attached to the belt at a 90-degree angle from the belt surface. At the same time, the worker grasped the handhold, which was located 48 to 54 inches above the step. The worker then rode the manlift up or down, depending on which side of the lift he had mounted, until arriving at the floor level needed. When the step met the appropriate floor level, the worker then stepped off the manlift onto the concrete floor surface. The manlift belt ran continuously straight up from the bottom level to the top level through 28- to 38-inch holes in the different floor levels. The belt then turned over the top pulley and returned to the bottom through a second set of holes in each floor level. The speed at which the belt moved did not exceed 80 feet per minute. The manlift involved in the incident was equipped with an emergency safety stop rope, which ran along the side of the lift. To stop the lift in an emergency, the operator would grab and pull the stop rope, automatically halting all movement of the lift. There was also a safety stop switch at the top of the manlift. The manlift was installed in the late 1940s and was exempt from current standards, which only apply to manlifts installed on or after August 1971. For instance, it did not have two safety switches nor the funnel shaped (conical) guards used to protect workers during ascent, as required on later models. On the descending side, there was a lack of proper guarding, staggered railing or self-closing gates, but it is unknown if this deficiency was a factor in the incident.

Since the decedent was the only one working on that particular floor, no one witnessed the fall, and the factors that initiated the fall could not be determined. It is believed that the victim fell down the manlift shaft while either boarding or riding the manlift. The exact distance of the fall could not be determined, but was estimated to be between 30 and 60 feet. Co-workers found him lying on the concrete floor next to the manlift without a pulse and summoned emergency medical services (EMS) at 7:49 a.m. EMS responded within five minutes and pronounced the victim dead at the scene.

Discussion: The manlift in use at the time of the incident was installed in the late 1940s. At that time, standards did not require the amounts and types of guarding and safety switches that are now required on later models. As of August 1971, the OSHA manlift standards changed, leaving manlifts installed prior to this date exempt, barring any substantial modifications. However, employers should still eliminate newly identified hazards and consider modifying older model manlifts to meet current guidelines in order to provide employees a work environment free from recognized hazards that are likely to cause death or serious physical injury. Manlifts should be inspected at least monthly, with certain components, such as safety mechanisms and limit switches, inspected even more frequently. Any manlift found to be unsafe or to have defects or malfunctions should be taken out of operation until the necessary repairs can be made. The employer should keep written documentation of all inspections on file.
