Laborer Killed While Inflating a Tire Mounted on a Multi-piece Rim Wheel - Massachusetts

Investigation: # 03-MA-057-01

Release Date: December 22, 2004

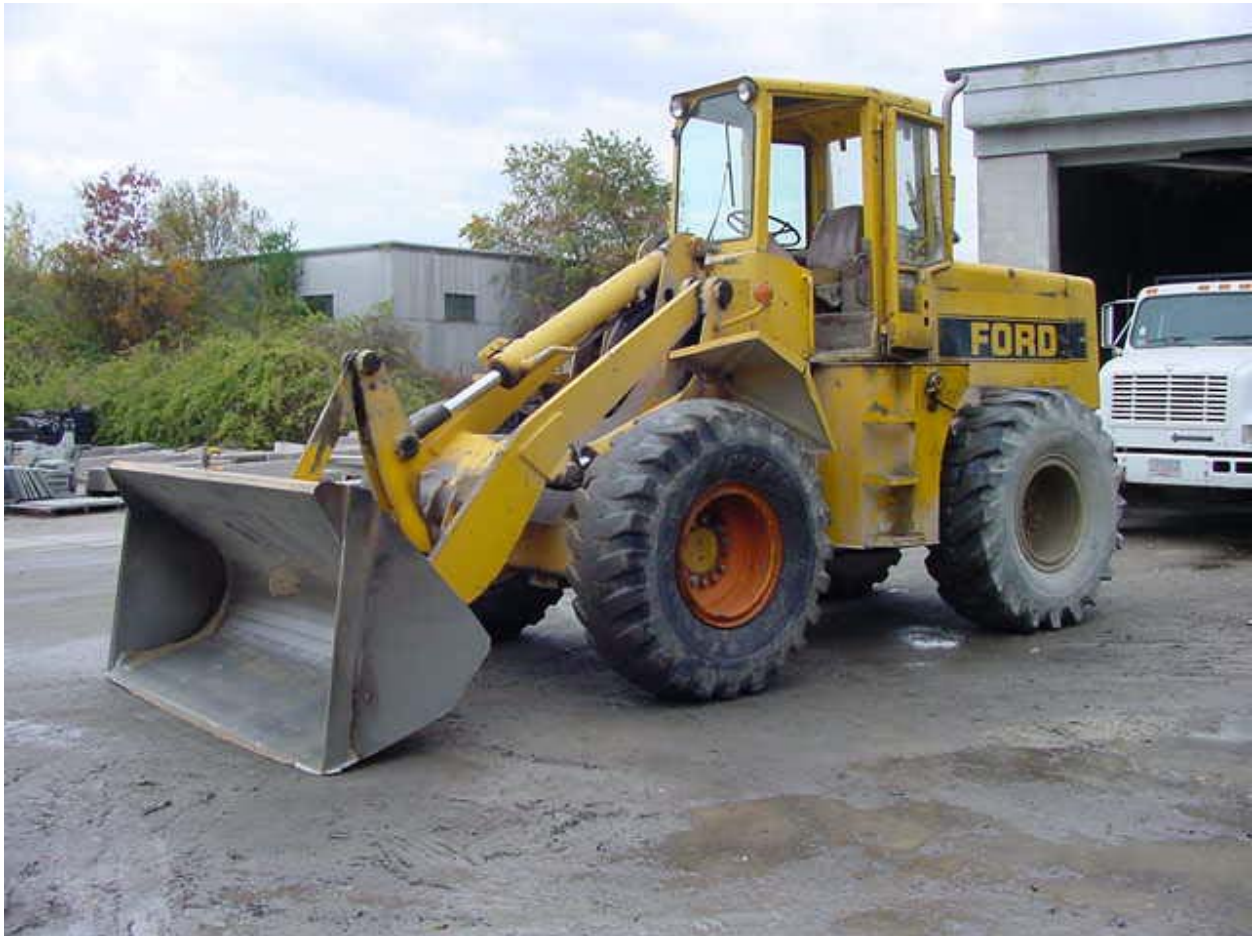
The company's main manufactured product was concrete blocks. The machine involved in the incident was a wheeled front end loader (Figure 1). This was the only front end loader owned by the company. The loader was used to fill the hoppers on the kilns with materials, such as sand and stone, during the cement block manufacturing process. The company had purchased the loader approximately ten years prior to the incident. The employer was unsure of the exact year the loader was manufactured but estimated that it was around 1985. The loader had a diesel engine and was equipped with a two cubic yard bucket. The tires had been originally manufactured as tubeless, but at some point, tubes had been placed inside of them. The loader's wheels were multi-piece rims each consisting of a rim base, a continuous side ring, and a lock ring (Figure 2). The function of the rim base and continuous side ring is to support the tire. The function of the lock ring is to hold the continuous side ring on the rim.

Figure 1 - Front end loader involved in the incident

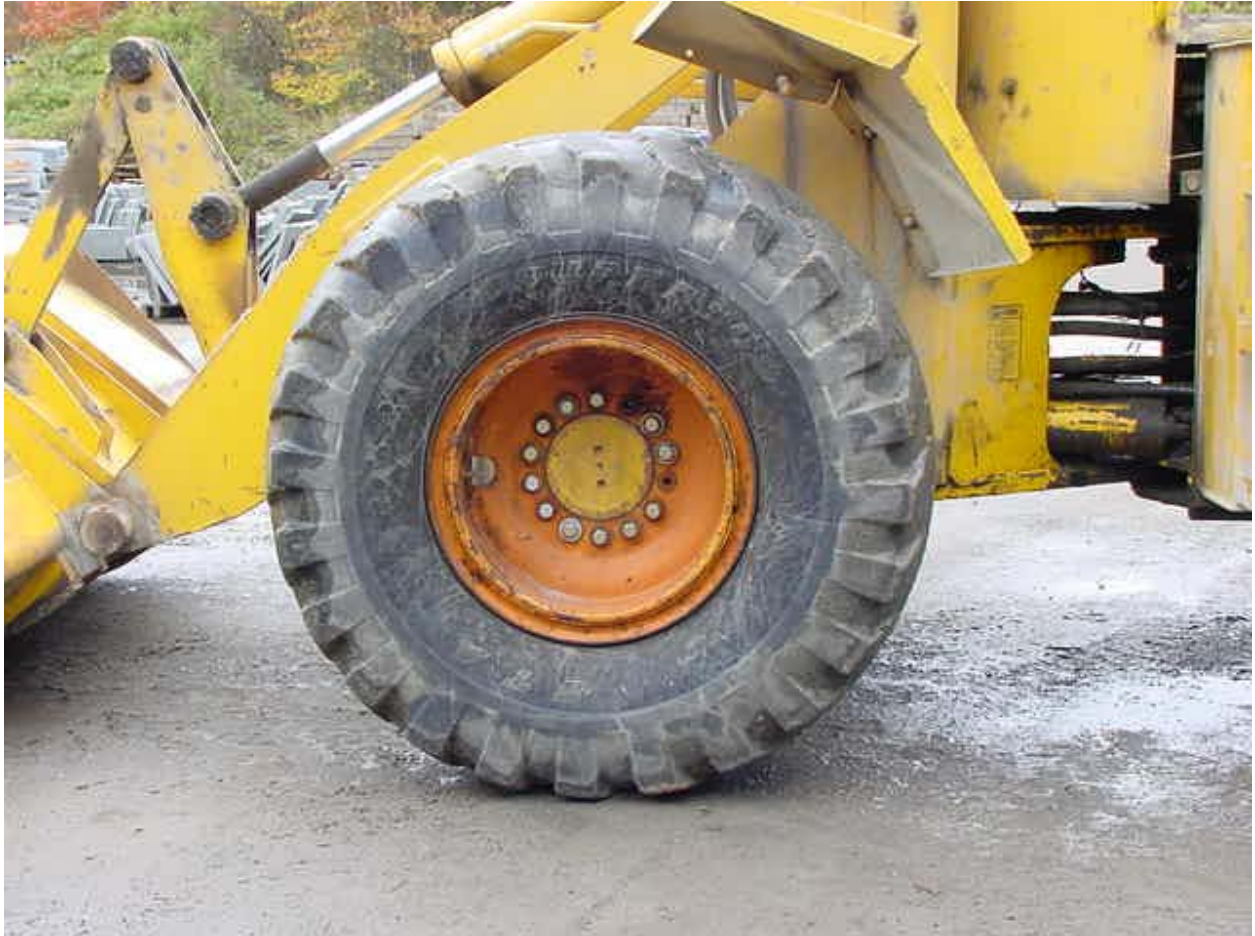
The victim decided to inflate the loader's front left tire (Figure 2) using an air chuck attached to an air line and a compressor. The victim was sitting on a chair that was positioned approximately 12 inches away from, and directly in front of the tire's sidewall during this task. The police report noted that at one point, the victim had asked a coworker about noise made by the tire / wheel during inflation. The coworker responded that to the best of his knowledge, some noise was normal when adding air to a tire.

When the tire had fully deflated, it appears the rim's lock ring had become partially unseated. The air compressor being used by the victim to inflate the tire had a faulty pressure gauge, consequently the victim could not measure the tire's increasing air pressure. Evidence indicates that the increase in air pressure caused the tube to explode, which caused the unseated lock ring and the tire to dislodge from the rim. The release of air pressure when the tube exploded knocked the victim backward with the chair.

It had been reported the loader's front left tire had been partially deflating on a daily basis, and that this was the first time the tire had completely deflated. No defects were found during an inspection of the wheel (rim and tire) after the incident. In addition, one of the company's owners reported that they used a local tire company for servicing the loader's rims and tires.

Figure 2 - Front left multi-piece rim wheel

Recommendation #1: Employers should ensure that tires mounted on multi-piece rims that are flat or underinflated (the tire has less than 80% of recommended pressure) are never re-inflated while the wheel is on the vehicle. Once the wheel is off of the vehicle, the rim should be disassembled, inspected, reassembled, re-inflated and placed back on the vehicle.

Discussion: In this case, the victim attempted to inflate the fully deflated tire while the wheel was still mounted on the vehicle. As required by OSHA, when tires that are mounted on multi-piece rims have less than 80% of the manufacturer's recommended pressure, the tire should be inspected prior to reinflation. First, the tire should be completely deflated by removing the valve core. Then the wheel should be removed from the vehicle, the tire demounted from the rim, the rim disassembled and inspected. If no problems are found, then the rim can be reassembled, the tire remounted on to the rim and reinflated. When reinflating the tire, employees should use a restraining device for the tire such as a safety cage or cable restraints. Only workers trained in servicing multi-piece rim wheels should service these wheels.

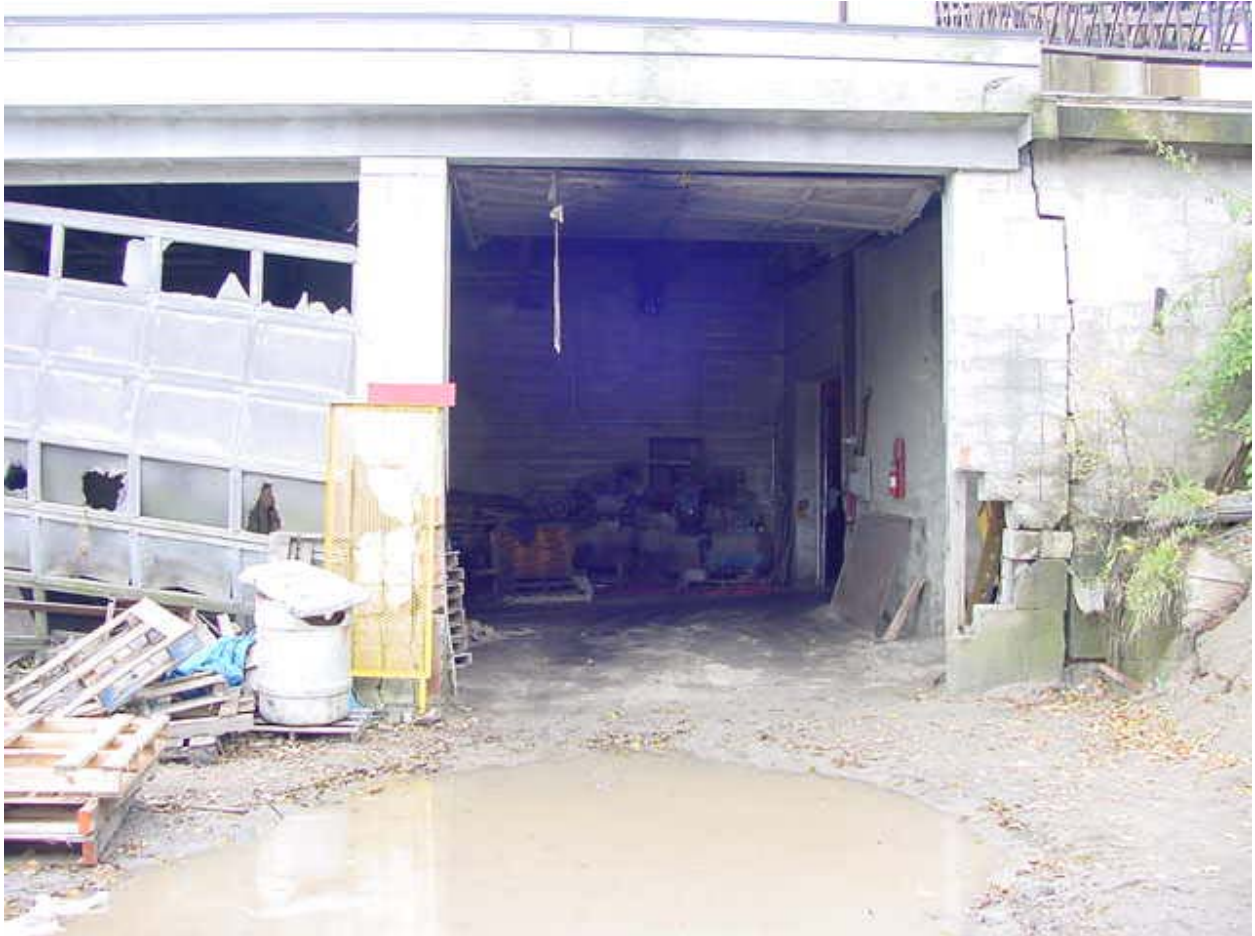
On the day of the incident, the victim had started work at his usual time, 7:00 a.m. The loader involved in the incident had been parked in its normal location inside one of the garage bays (Figure 3). A truck had arrived with a delivery that was to be dropped off inside the garage bay where the loader was parked. The truck driver walked into the garage looking for someone to move the loader and noticed that the front left tire was fully deflated. The truck driver informed the victim that the loader had to be moved and that it had a flat tire. The truck driver went back to the cab of his truck to fill out paperwork.

Figure 3 - Garage where the front end loader was parked

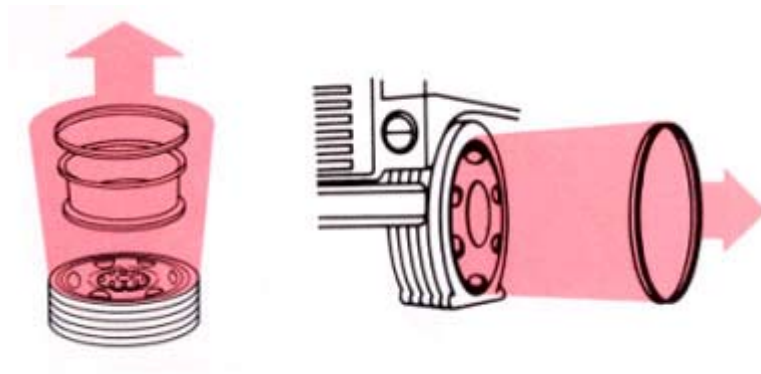
OSHA's definition of trajectory: any potential path or route that a rim wheel component may travel during an explosive separation, or the sudden release of the pressurized air (Figure 4).

Figure 4 - Trajectory of multi-piece rim parts both mounted on a vehicle and placed on the ground

Recommendation #2: Employers should ensure that employees never position themselves in front of or over tires mounted on multi-piece rims during tire inflation.

Discussion: A tire mounted on a multi-piece rim that is underinflated, but has more than 80% of the recommended pressure, can be inflated without an inspection and with the wheel mounted on the vehicle. OSHA requires that the employee inflate the tire from a distance standing behind the tire tread, to be out of the trajectory, using a long air line with a clip-on chuck, and an in-line valve with a pressure gauge. If the same underinflated tire mounted on a multi-piece rim is not mounted on a vehicle, the employee still can inflate the tire without an inspection, but must use a restraining device such as a safety cage or cable restraints while inflating. Only workers trained in servicing multi-piece rims should inflate tires mounted on these rims.
