Hospital Employee Clearing Snow Killed When His Skid-Steer Loader Broke Through a Ventilation Grate Located in a Sidewalk - Massachusetts

Investigation: # 03-MA-001-01

Release Date: December 16, 2004

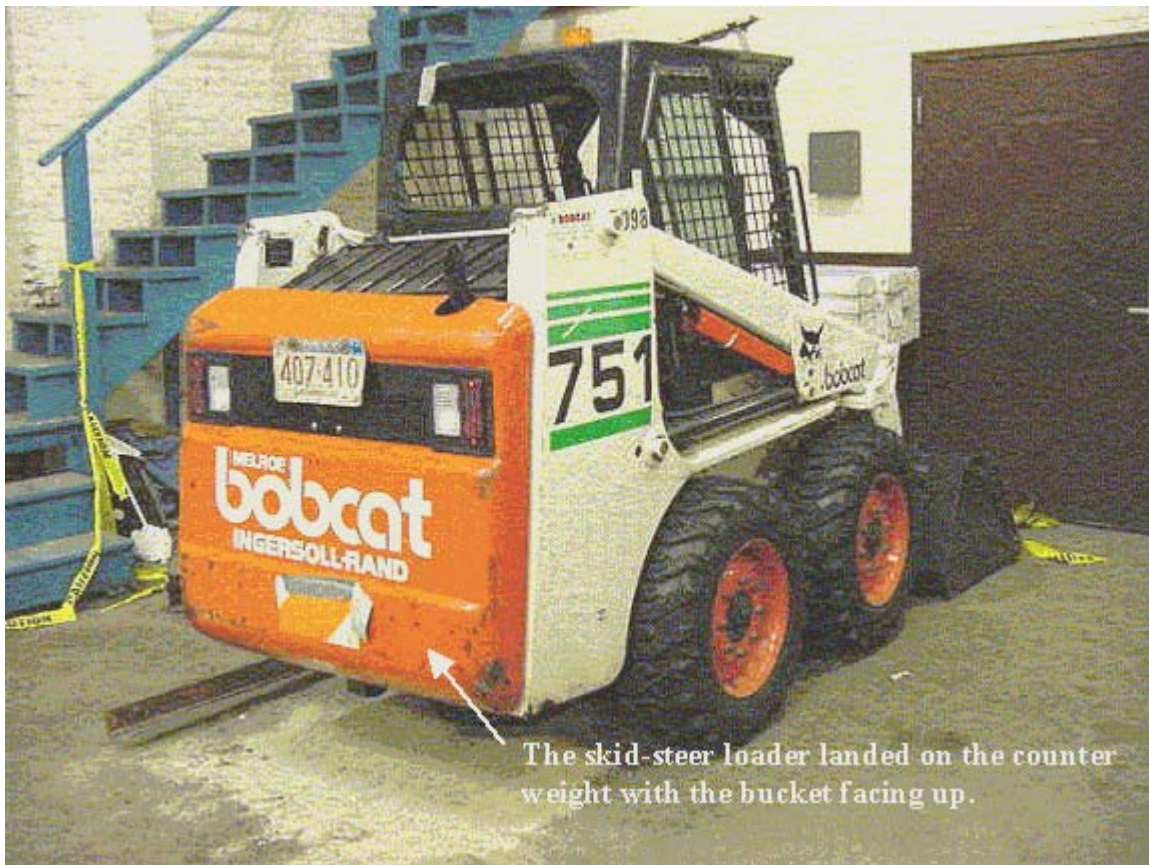
The machine involved in the incident, a skid-steer loader, was manufactured and purchased by the hospital in 1998. The skid-steer loader had a four-cylinder diesel powered engine and weighed approximately 5,200 pounds. The skid-steer loader was approximately ten feet long, four and a half feet wide and over six feet high (with bucket lowered).

Figure 1 – Skid-steer loader involved in the incident

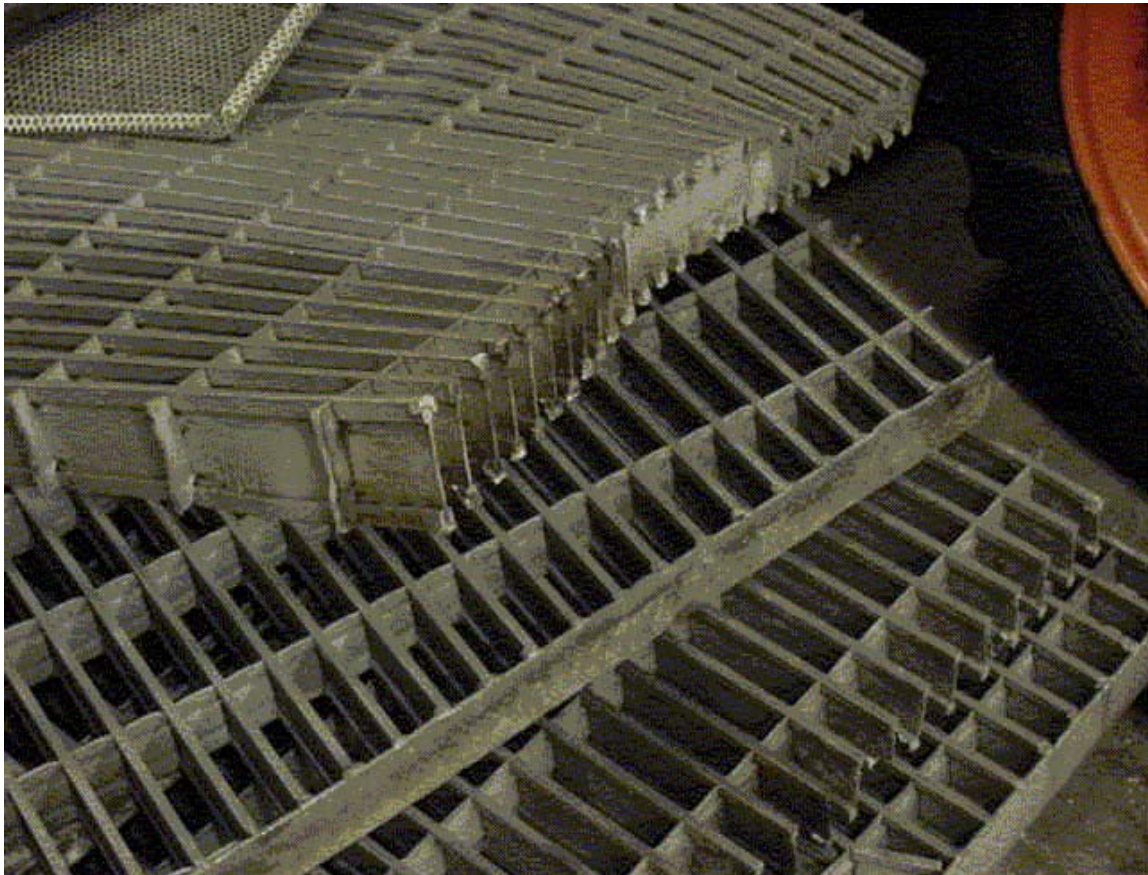
The shaft was poured concrete and approximately 20 feet deep from the sidewalk level. The grate was aluminum and approximately 11 feet eight inches long and 2 ¼ inches thick. One end of the grate was five feet wide and the other end was six feet two inches wide. Steel angle iron, bolted into the top edge of the cement ventilation shaft at the sidewalk level, was used as the grate supporting structure. The side of the steel angle iron that bolted against the ventilation shaft perimeter was approximately three inches wide and the side of the steel angle iron that supported the aluminum grate was approximately 2 ½ inches wide. When in position, the grate was supported only by the bolted angle iron within the shaft opening and was flush with the sidewalk.

Figure 2 – Sections of the grating

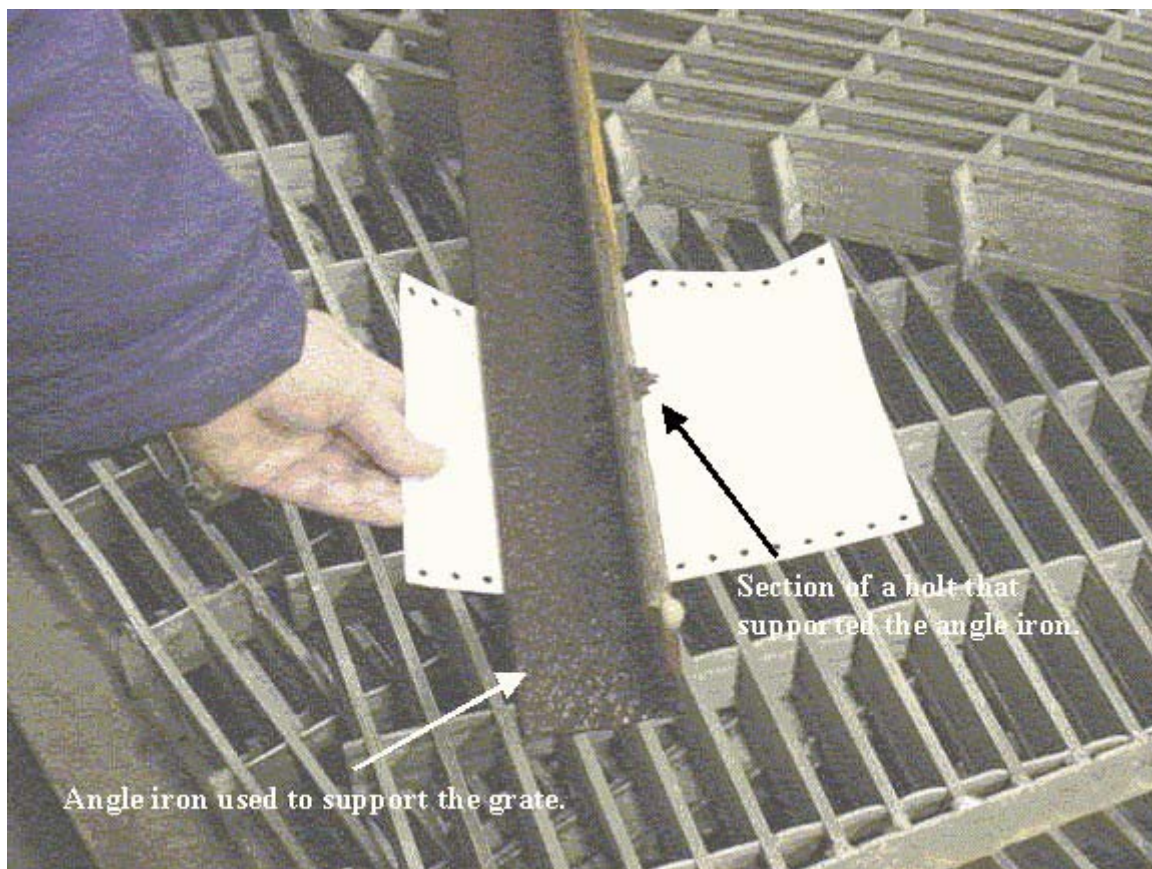
The hospital reported that eight months prior to the incident, one of the bolts supporting a section of the angle iron had been replaced. The hospital also reported that, prior to the incident, they had performed visual inspections of the grate system, but these visual inspections did not detect the corrosion of the bolts. After the incident, the hospital found the engineering drawings for the grate and shaft, but the drawings did not reflect "as built" conditions. In addition, the hospital also placed barriers around the two pedestrian and vehicle accessible grates.

Figure 3 – Section of the angle iron that supported the grate

Recommendation #2:Employers, property owners and municipalities that use skid-steer loaders or other heavy equipment should have engineers conduct routine structural inspections and develop preventive maintenance schedules for all grates located in sidewalks and roadways.

Discussion: In some cases, older grate systems could have corroded structural supports that are not visible or could have been built to lower load capacity requirements. Therefore, registered professional engineers should conduct routine inspections to ensure that the loading capacities of grates are consistent with the engineering drawings and anticipated loads and develop a preventive maintenance schedule for the grates and the supporting structure. In addition, the engineers should be consulted about the possibility of developing redundant supporting mechanisms for the grating system. In this case, a concrete shelf or lip at the top edge of the concrete shaft could be added to provide support for the grating. Grates would be positioned on this shelf or lip and then anchored into the cement shaft.
