A Portuguese Speaking Laborer Working for a Korean Speaking Employer is Fatally Injured After Falling From an Extension Ladder- Massachusetts

Investigation: # 02-MA-042-01

Release Date: October 8, 2004

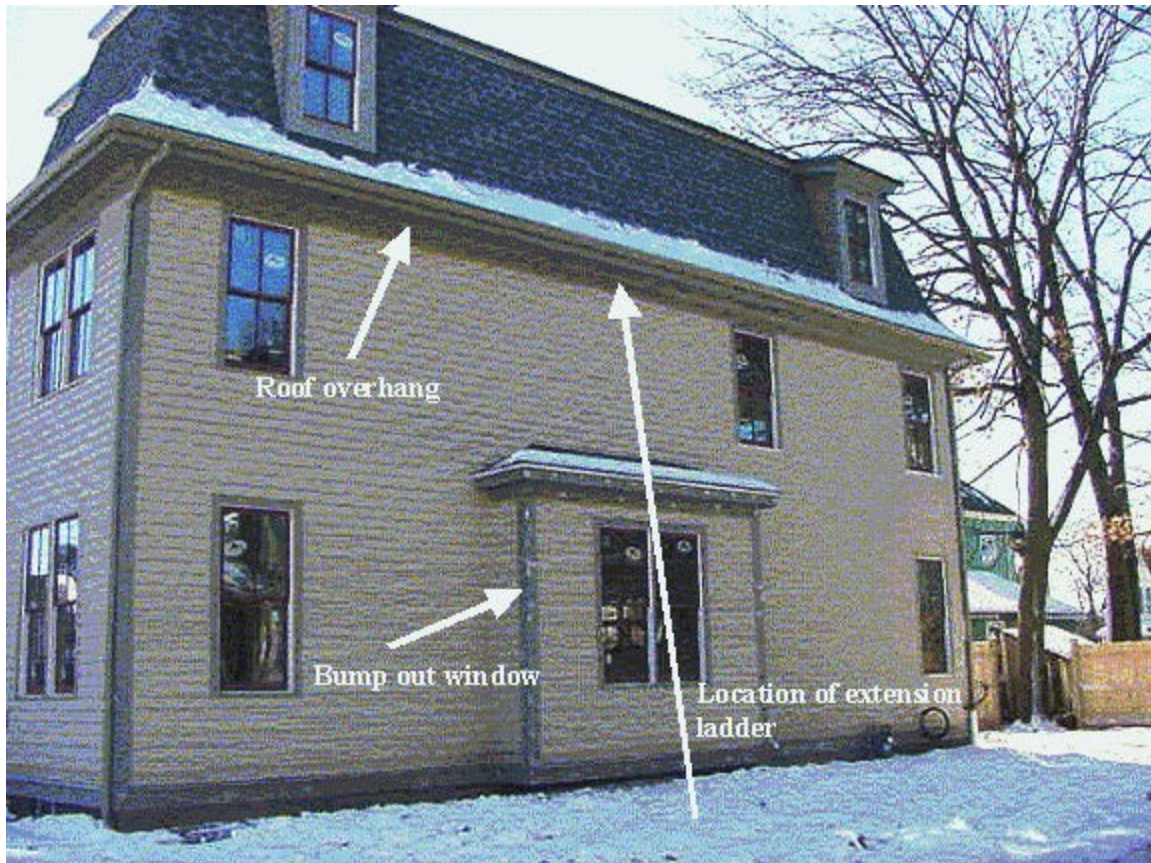
Figure 1 - Incident Location

The work site that the victim and the Korean speaking employee went to was a residential construction site. The project consisted of a new building and an addition to an older house that was being split into townhouses. The structures had mansard style roofs with overhangs at the bottom of the third story (Figure 1). The roof overhang protruded past the side of the building approximately two feet (Figure 2).

The victim and the co-worker located the area on the exterior of the building where the vent hole needed to be drilled. At approximately 4:00 p.m., the victim and the co-worker setup a 30-foot aluminum extension ladder to complete this task. The ground where the extension ladder was positioned consisted of dirt with frozen ruts and mud. The ladder was set up so it extended over a single story bump out window with the top of the ladder below the roof overhang. The bump out window protruded from the main structure approximately two feet and was located directly below where the victim had to drill the hole (Figures 1 and 2).

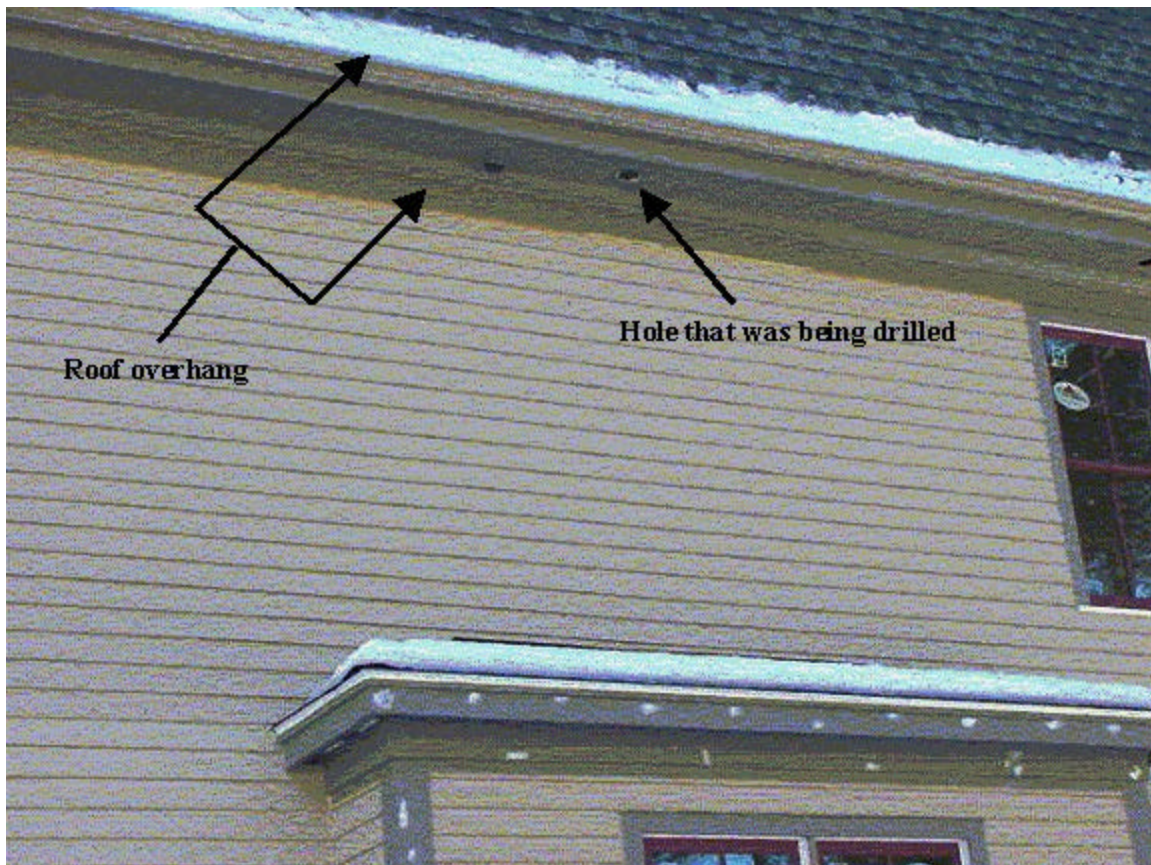
Figure 2 - Roof overhang

The location for the air vent was on the underside of the mansard style roof overhang (Figure 2). The victim, using an electric drill, started to drill in a vertical direction up and over his head. He had been performing the drilling task for approximately 10 seconds when he lost his balance and fell from the ladder. The co-worker, who was holding the base of the ladder at the time of the incident, reported that the victim struck the roof of the single story bump out window while falling and landed on the ground below.

The task being performed when the incident occurred required the victim to access the exterior of the residential structure at the top of the second story (approximately 20 feet high). The victim was using a portable 30-foot aluminum extension ladder to drill a hole into the underside of the roof overhang above him. At the time of the incident, the victim was overreaching directly above and slightly behind him while performing this task. This overreaching most likely was what caused him to lose his balance and fall off the ladder.

Employers should provide training to employees about the recognition and avoidance of unsafe conditions, and the need to control or eliminate these unsafe conditions. Training should include, but not be limited to, when scaffolding should be used instead of ladders to complete tasks, not to overreach when using ladders and scaffolding, always maintaining three-point contact with ladders during use, and never use ladders as work platforms. Training would have provided the victim with the knowledge to

make an educated decision that using an elevating work platform (man lift) and not a ladder would have been safer to use to complete this task. An elevating work platform would have provided the victim with the space needed to take a step back away from the structure and safely complete the task.
