# Temporary Hispanic Laborer Dies After Being Struck by a Turning Device at a Concrete Product Manufacturing Facility - Massachusetts

**Case: 02-MA-016-01**

**Release Date: July 6, 2004**

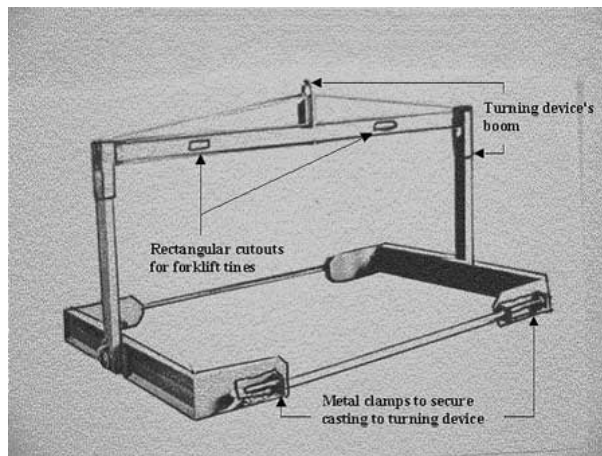
**Figure 1 – Turning device similar to the one used during the incident**

The process of removing the concrete septic system tank from the form and rotating it 180 degrees to right side-up required a laborer, forklift operator, forklift, and a turning device ([Figure 1](#)). The forklift involved in the incident was diesel powered and had a maximum lifting capacity of 17,525 pounds and a maximum lifting height of 13 feet. The turning device, which is used to lift and rotate the septic system tank, attaches to the forklift by inserting the forklift tines into the rectangular cutouts of the turning device's boom ([Figure 1](#)).

When the casting has cured, the sides of the form are unlocked and opened to expose the casting. The turning device is lowered around the concrete casting by lowering the forklift tines. At this point, the laborer secures the turning device around the concrete casting by tightening two metal clamps located at the turning device's base ([Figure 1](#)). The casting is raised out of the form when the forklift operator raises the forklift's tines. The casting is then set onto wooden blocks on the floor to prepare for rotation.

**Discussion:** The turning device involved in the incident attached to forklift by inserting the forklift tines into two rectangular holes in the turning device's boom section. There was no mechanism to keep the turning device securely attached to the forklift tines. Employers should develop a locking mechanism, with input from the original turning device manufacturer, that would prohibit the boom from sliding off of the forklift tines. This could be done by designing a clamp that would attach to the top section of the boom around the rectangular cutouts. When the forklift tines are inserted through the cut outs, the clamps would then be tightened down onto the tines prohibiting the boom from sliding off of the tines.

**Recommendation #1: Employers should develop a locking mechanism to ensure that concrete casting turning devices used with forklifts are securely attached to the tines.**

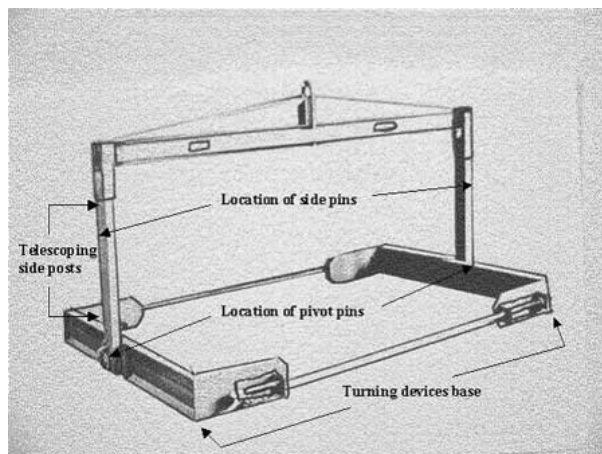
**Figure 2 – Turning device similar to the one used during the incident**

To prepare the turning device for the septic system tank, the laborer removes the side pins on the turning device, located in the telescoping side posts, to increase the height of the turning device's boom. This will give the concrete casting the space needed to rotate ([Figure 2](#)). After the side pins have been removed, the forklift operator raises the tines, which raises the boom section by extending the length of the telescoping side posts. The base section of the turning device remains on the floor during this process. The laborer re-pins the side pins locking the turning device's height.

Next, the laborer removes the pivot pins ([Figure 2](#)) from the turning device's base and stands off to the side of the casting. This unlocks the base from the rest of the turning device allowing the base to rotate, keeping the rest of the turning device stationary. The entire turning device, including the concrete casting, is raised off the floor as the forklift operator raises the forklift's tines allowing the base and casting to rotate 180 degrees placing the casting in the upright position.

In this incident, the victim had pulled out the pivot pins from the turning device's base and stepped back a couple feet facing the casting. The concrete product manufacturer reported that the victim's location would have been out of the forklift operator's line of sight. Before the forklift operator started to raise the entire turning device and casting to rotate it, the boom slipped off the forklift tines, pivoting at the unlocked base pivot area, where the side posts attach to the clamping section. The boom fell away from the forklift, over the victim, striking him in the head causing him to fall to the floor. The victim landed on his buttock with his upper body bent forward and the boom against his upper back and head.
