Vessel Mechanic Drowns after Falling from a Ladder Between a Tugboat and the Dock - Massachusetts

Case: 02-MA-010-01

Release Date: May 26, 2004

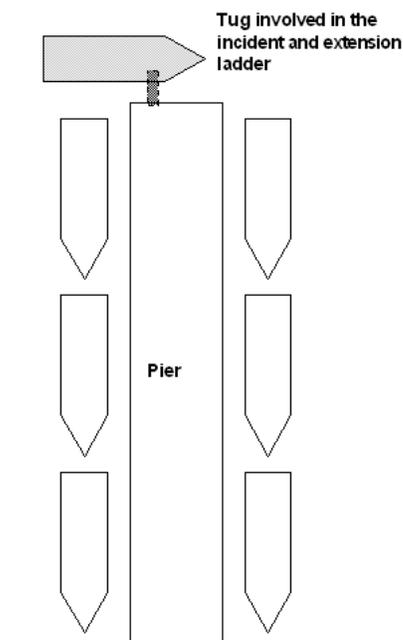
Figure 1 – Diagram of the incident site.

When the tug arrived at the Massachusetts location, it was docked across the end of one pier with the tug's front starboard side (right side) against the dock. Boarding and disembarking the vessel was performed using an aluminum extension ladder that was kept with the vessel. The ladder was 12 feet long and both the top and bottom rungs were damaged. The sides of an ATB are higher than a conventional tugboat; therefore, a ladder placed against the side of

an ATB is typically pitched on an incline from the dock up to the boat's side creating an awkward walking/climbing surface. It was reported that one end of the ladder was lashed down, but it was unknown if it was the end on the dock or the tug.

Approximately three hours into the repair, a truck located on land had to be moved. The victim volunteered to move the truck and disembarked the tug alone. While re-boarding the tug one end of the ladder slipped off of either the dock or the tug causing the victim to fall approximately 13 feet from the aluminum extension ladder into the water. A co-worker found the victim head down in the water between the tug and a large wooden bumper that was against the dock. A call for emergency assistance was placed and personnel from fire and police departments responded within minutes. Emergency Medical Service (EMS) personnel arrived at the incident site and the victim was transported by a fireboat with EMS personnel to a local Coast Guard base where an ambulance was waiting to take the victim to a hospital. The victim was pronounced dead at the hospital.

Recommendation #1: Employers should ensure that all articulated tug barge (ATB) unit's tugs are outfitted with gangways.

All ATB style tugs should be outfitted with gangways and the gangways should be used whenever boarding and disembarking ATB tugs. If the ATB involved in the incident had been outfitted with a gangway the victim would have had a solid no slip walking surface with guardrails, reducing the possibility of the victim falling in between the vessel and the dock.

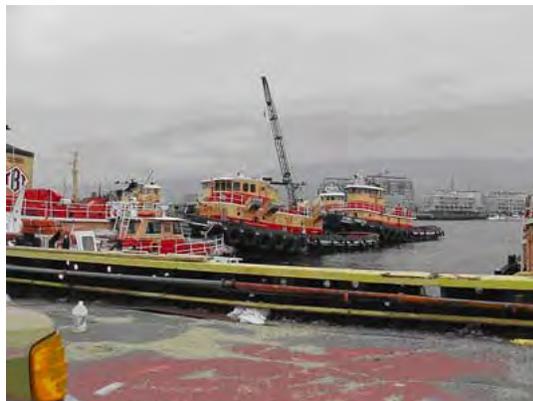
Figure 2 – Massachusetts location

It was estimated that the Massachusetts location had approximately three hours notice that the tug was going to arrive for repairs. Because the Massachusetts location had not been notified about the repair, the docking slips at the Massachusetts pier were occupied with Massachusetts based tugs. It was reported by the company representative that they were unable to free up a docking slip for the arriving tug because few Massachusetts tug operators were onsite at that time. The majority of the tug operators (at the Massachusetts location) were on call as fulltime employees.

Recommendation #2: Employers should ensure that vessels are only docked at designated docking locations.

Discussion: The day of the incident, no docking slips were available at the Massachusetts pier. It was reported that this location had approximately three hours notice that the tug was arriving for repairs. Arrangements should have been made by the employer to have a docking location available by the time the vessel arrived. If the employer was unable to free up a docking location then the repair should have been postponed until the tug was back at its home port, approximately one week later. If the tug's repairs were urgent then the tug should have been pulled out of service for the repairs.
