Vehicle Mounted Work Platform Tips Killing Bridge Inspector - Massachusetts

Case: 01-MA-041-01

Release Date: February 6, 2004

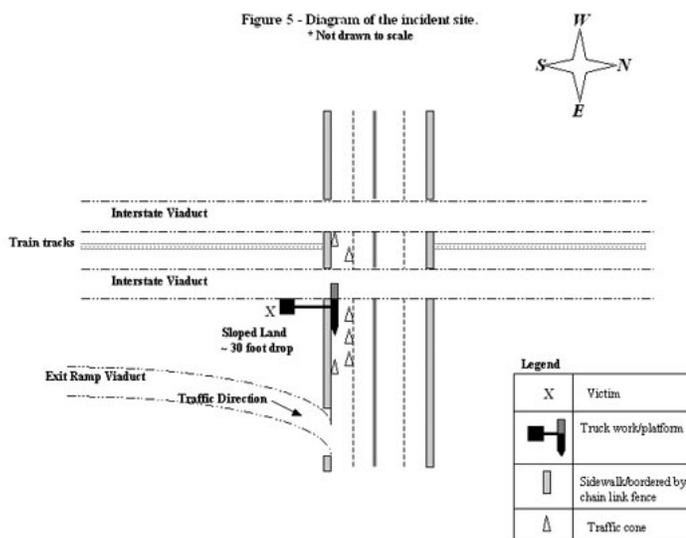
The truck was parked approximately 25 inches north of the curb. The sidewalk located to the south of the truck contained a cement barrier at the roadway edge that was approximately 19 inches high ([Figure 3](#)). This barrier made it impossible to fully extend the outrigger on the passenger side of the truck causing this outrigger's articulating foot to be angled against the granite curbing and cement barrier. The barrier ended approximately 17 inches east of the spot where the passenger side outrigger articulating foot was located.

Approximately one hour into the viaduct inspection, the inspection switched from the west to the east side of the viaduct, which did not require moving the truck. This was the first time, during the inspection, that the work platform had been extended over the south side of the truck (passenger side), the side with the outrigger that was not fully extended. The work platform was extended approximately 50 feet at an angle of approximately 45 degrees. During the FACE investigation, the employer reported that while the work platform was extended out to this location, the victim and his co-worker felt as if the platform was sinking. The co-worker engaged the control and raised the work platform up. The workers felt the work platform sink again, and this time the work platform continued to accelerate. The platform descended to the ground with the workers, striking a section of chain link fence ([Figure 4](#) and [5](#)). The victim struck a metal fence post and was bounced out of the platform.

**Figure 5 – Diagram of the incident site.
* Not drawn to scale**

In this case, the victim and the co-worker arrived at the work site, positioned the truck and extended the outriggers. The truck's location prohibited the passenger side outrigger from being fully extended due to a 19-inch high cement barrier at the sidewalk edge. If the truck had been moved approximately 17 inches to the east past the end of the barrier, the outrigger would have had the space to be completely extended, reducing the possibility of the truck tipping during use.
