Police Officer Dies After Being Backed Over by a Dump Truck -Massachusetts

Case: 01-MA-039-01

Release Date: July 30, 2003

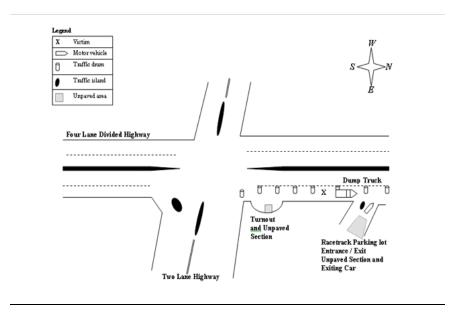
Figure 1. Incident location.

The larger, more traveled state highway ran north and south at the intersection. This highway consisted of four lanes, two lanes traveling north and two lanes traveling south with a divider. On the day of the incident and during the investigation, there were temporary, single dashed white line road markings dividing the travel lanes. The smaller less traveled state highway, which ran east and west, consisted of two travel lanes, one in each direction. The pavement markings for this highway consisted of solid double yellow center lines and white fog lines. The intersection where the two routes crossed contained traffic lights and a turnout located to the east of the right-hand northbound lane of the four lane divided highway. Approximately 1,000 feet north of the intersection, on the same highway as the turnout, was the entrance/exit for a racetrack parking lot. The racetrack parking lot was in use by raceway clientele at the time of the incident and throughout the project. The incident occurred south of this parking lot entrance/exit in the northbound right-hand lane of the four lane divided highway. (Figure #1)
