Massachusetts Mechanic Killed When A 55-Gallon Drum Exploded

Investigation: # 00-MA-042-01

Release Date: July 19, 2001

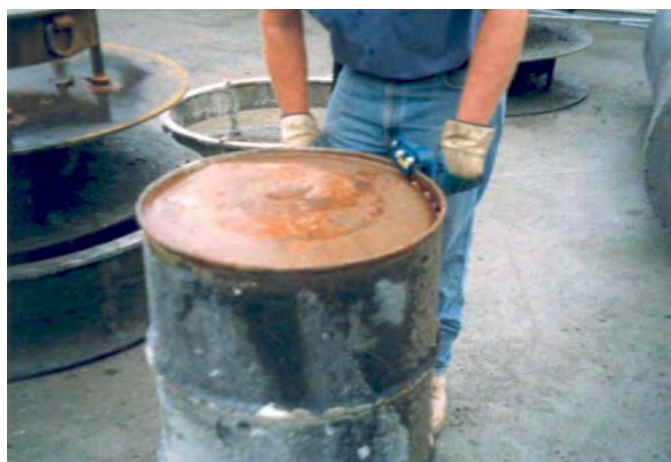
The company had an unwritten procedure for handling and discarding empty drums 55-gallon drums. The lids were cut off using a manual drum cutter that resembled a large can opener. The device was hand held and clipped onto the edge of the drum. Pushing down on the device's long handle made the sharp blade cut into the inside edge, where the lid met the drum. The drum cutter was then moved further around the lid and the procedure repeated. A short section of the lid was left connected to the drum, the lid was bent inside the drum, and then the drum was flattened. The company had previously used a pneumatic drum cutter but management indicated that the victim had thought this device was dangerous because it created sharp edges on both the drum and lid. Apparently, the victim had researched different methods for removing the lids and had selected and implemented the hand held manual device because it did not create sharp edges.

Figure 1 – Employee using hand held drum opener to open a 55-gallon drum.

In addition to providing safe equipment, employers who use large metal containers and drums should develop, implement and enforce standard operating procedures (SOP) for safely removing the lids. A SOP for removing the lid off large metal drums should specify that a manual drum cutter or another safe method should be used and that the use of a torch is not recommended. In addition, SOP should clearly state that if it is absolutely necessary to use a torch on a large metal container or drum for any purpose then the container must be vented and purged thoroughly to make absolutely certain that there are no flammable materials present (29 CFR 1910.252).

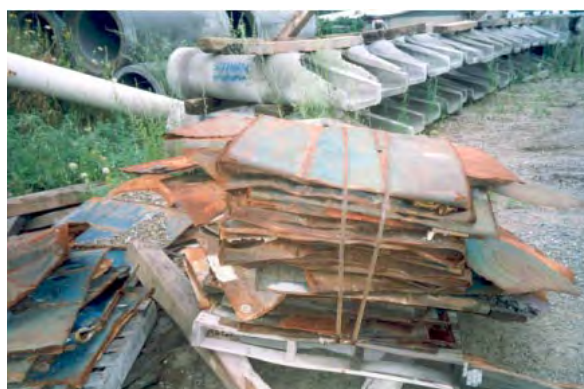
Figure 2 – Stack of 55-gallon drums onsite opened with the hand held opener.
