Massachusetts Stock Clerk Dies from Fall Out of a Tipped Vertical Lift

Investigation: # 00-MA-003-01

Release Date: January 5, 2001

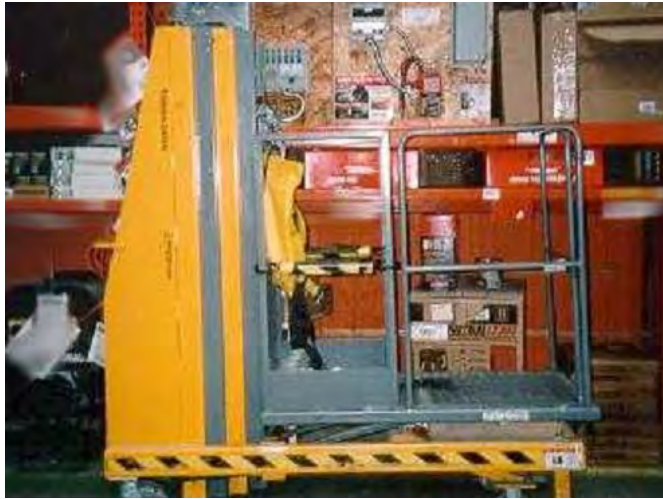
Figure 1 – Manual Electric Vertical Hydraulic Lift (side view)

The base dimensions of the lift were 2 feet 6½ inches wide by 5 feet 11 inches long by 6 feet 5 inches high. The dimensions of the operator's area were 2 feet 5 inches wide by 4 feet 2 inches long. The operator's area was used to temporarily store objects that were being raised. The operator's area was equipped with a safety cage, which consisted of two movable sections that were 3 feet 6 inches high. The control panel located at the front of the operator's area acted as the third side of the safety cage. This design left one side of the operator's safety cage open at all times. The lift had an anchor point located below the control panel for the use of a lanyard.

An uncrated generator that weighed 247 pounds was one of the objects placed on the floor of the hardware section during the previous day. Alone, the victim loaded the generator onto the lift to restock the generator back to the top shelf. Once the generator was loaded onto the lift, only a small area approximately 1 foot long and 2 feet 5 inches wide remained for the victim to operate the lift and maneuver the generator onto the shelf. The victim raised the lift to the maximum lifting height of 14 feet 10 inches with the open side of the operator's cage toward the shelf he was accessing. Although unwitnessed, the evidence indicates that the force being applied against the raised lift while maneuvering the generator up onto the shelf, which was 16 feet high, caused the lift to tip away from the shelf. The victim was not wearing the company required fall protection equipment (body harness and lanyard) fell over the top of the operator's area safety rail and fell approximately 15 feet to the floor below as the lift tipped. The lift landed partially upright against an adjacent shelf.

In this case, the victim was using the lift to raise an object that was too heavy and large to safely maneuver onto the shelf. The size of the object took up most of the operator's area inside the safety cage leaving him with little room to operate the lift and maneuver the generator to the shelf. Although, the weight of the generator and the victim combined was less

than the maximum weight rating provided by the manufacturer, the combination of the lift being fully extended, generator's weight, and maneuvering the generator exceeded the amount of applied vertical force the lift could handle.

Recommendation #1: Employers should develop a standard operating procedure (SOP) for new equipment before introducing the equipment into daily activities.

Discussion: The manufacturer did not make information on the potential tipping hazard of this lift available leaving owners and operators unaware of the hazard. The manufacturer of the lift should include a section on the potential tipping hazard of narrow lifts in the operation and maintenance manual. In addition, by affixing decals on the lift, the manufacturer attempted to inform the operator of other safety hazards. The manufacturer could also attempt to inform the lift owners and operators of the potential tipping hazard by placing an additional decal on the lift in clear view of the operator.
