Massachusetts Foundry Manager Dies When Caught in Die Casting Machine

Investigation: # 99-MA-070-01

Release Date: December 1, 2000

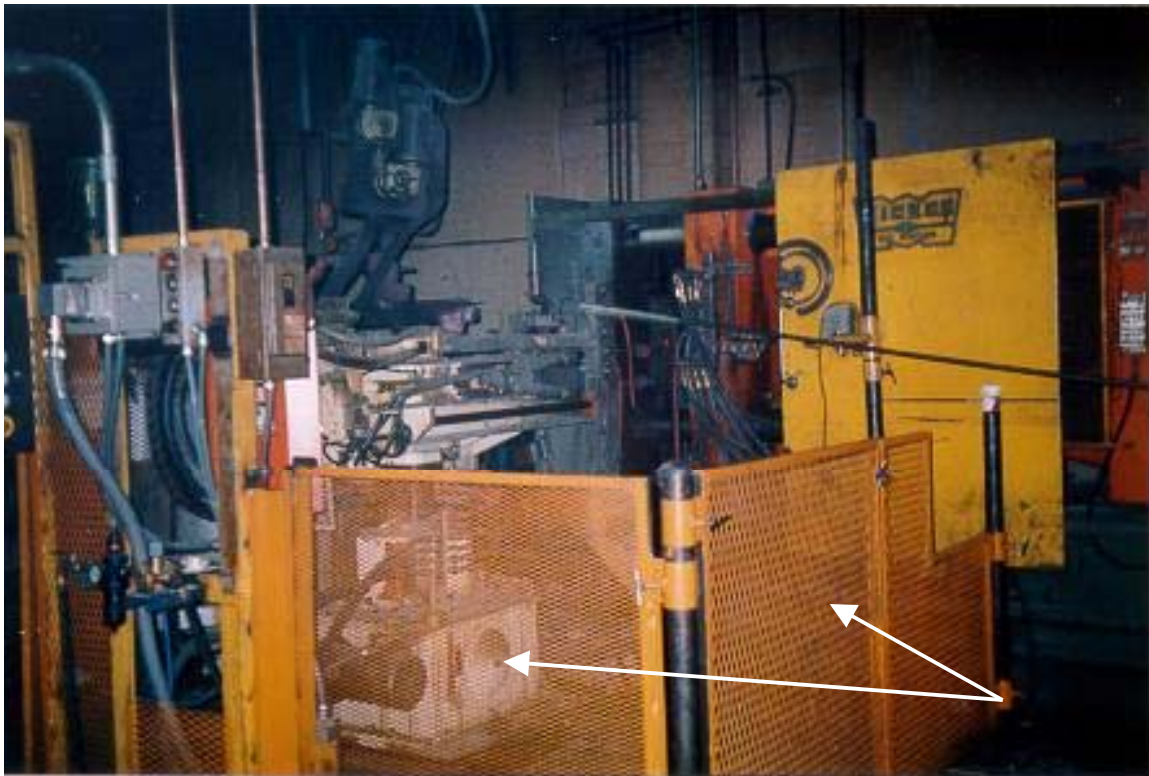
Figure 1 - The Die Casting Machine Perimeter Guarding

A fence type perimeter guard was installed as a replacement for the operator's door, which formerly functioned as a physical guard and part of the interlock system. The perimeter guard consisted of three sections: one gate and two fixed sections all approximately 48 inches high with the machine acting as the fourth side of the barrier. The disabled interlock system was incorporated into the perimeter guard gate, which was kept closed during the operation of the machine. When the gate was open the interlock system was automatically engaged and the machine would not resume operation without manually closing the gate and resetting the interlock system using the control panel. The control panel was located approximately four feet to the left of the perimeter guard gate and five feet high. The location made the control panel inaccessible to employees while inside the perimeter barrier.

At the time of the Massachusetts FACE investigation the employer had welded the two fixed sections of the perimeter guard together eliminating the possibility of entering the machine

Discussion: Approximately, four months prior to the incident an automatic extractor and a perimeter guard which was connected to the already existing interlock were added to the die casting machine. To install the automatic extractor, the operator's door, which was originally connected to the interlock, had been placed permanently in the open position with the interlock disconnected. Before placing the machine back in service a thorough inspection may have identified that the perimeter barrier was not installed properly. The two abutting fixed sections of the perimeter guard were not secured together allowing access to the machine operating area while bypassing the gate and interlock system.

In addition, an inspection may have identified that the 48-inch height of the perimeter guard was not high enough to deter employees from climbing over the guard and bypassing the interlock system. A perimeter guard that is at least 8 feet high or a cage that enclosed the entire machine would be a better safety system. It would prohibit entry to the machine operating area when the interlock system was not engaged.

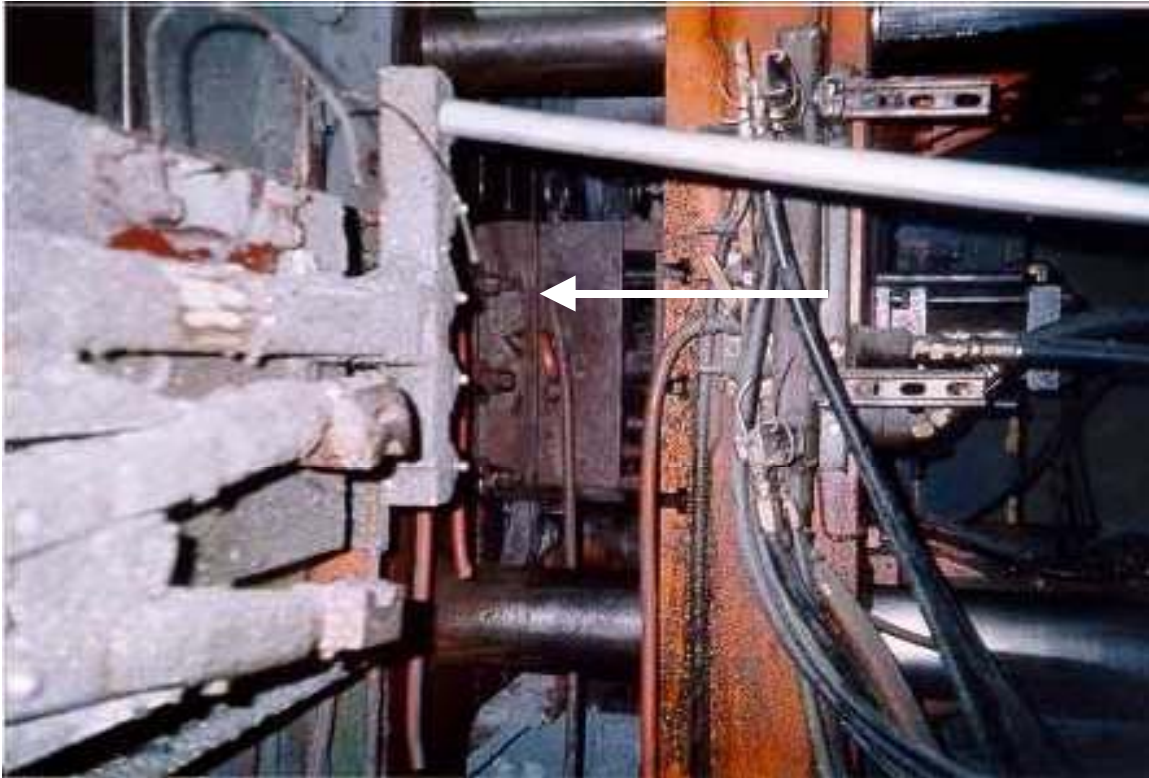
Prior to the incident, the quality control inspector had found a blemish on the exterior surface of the castings being produced by one of the machines and informed the victim of these imperfections. Although the incident was unwitnessed, evidence indicates that the hazardous energy control program including the lockout/tagout procedure had not been followed prior to the victim's entering the machine operating area. The die cast machine's main power shut off switch was not turned off and locked out. Also, the perimeter guard gate of the die casting machine was in the closed position, suggesting that the victim did not access the machine operating area through the gate. The area of the perimeter guard where the two fixed sections abutted were not fastened together. This would have made it easy for the victim to push apart the two fixed sections of the perimeter guard and enter the machine operating area with out opening the perimeter guard gate. If the machine operating area was entered by bypassing the gate, as mentioned above or by climbing over the perimeter guard this would allow the machine to continue to cycle while the victim was inside the machine operating area. Once inside the machine operating area, the victim apparently leaned inside the die space between the two separated sections of the die. He used a handheld abrasive-cleaning tool to remove excess aluminum from the dies. At some point, the die casting machine cycled to the closed position bringing the two sections of the die together while he was still leaning between the two dies.

Figure 2 - The Die Casting Machine's Die.
The arrow points at the location where the two sections of the die come together.
