Separate Rotating Shafts Entanglements Kills Two Massachusetts Fishermen

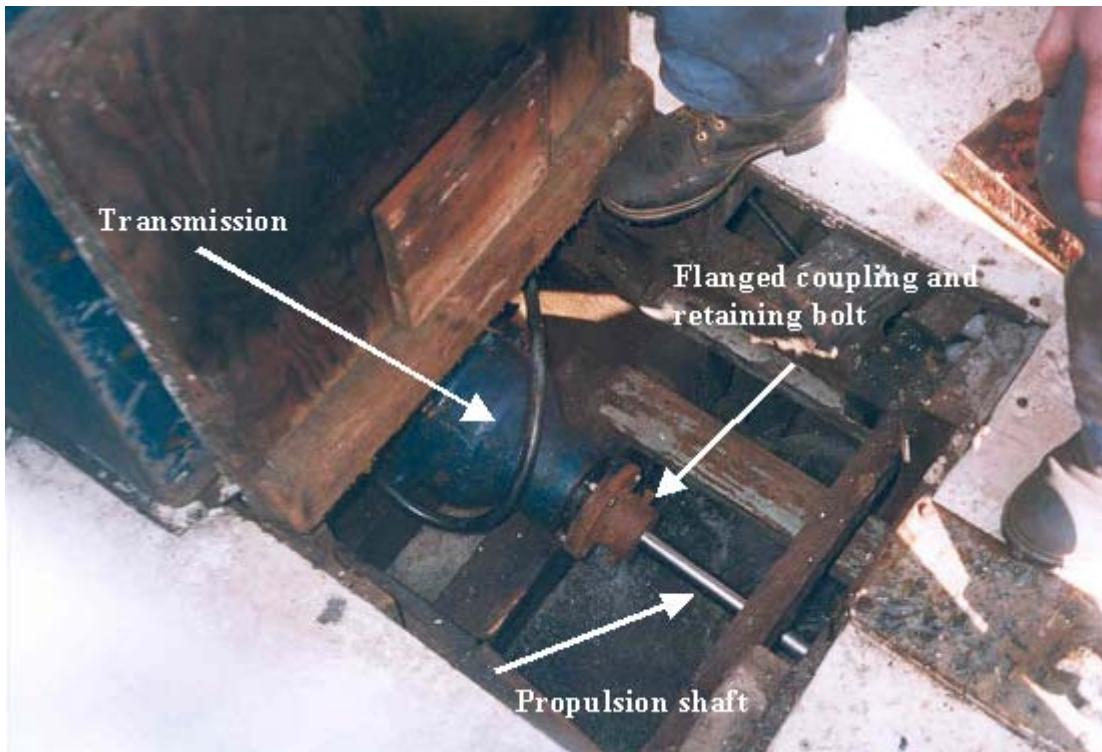
Prior to checking the transmission, the victim had removed the rectangular wooden deck cover exposing approximately 1½ feet of the 1½ inch diameter transmission propulsion shaft and coupling. It was stated in the Coast Guard Report that the son heard a loud clanging sound and then the engine immediately shut down. The son turned around and found his father entangled in the propulsion shaft.

It appeared that while the victim was checking the propulsion shaft and transmission, one or more of the rotating coupling retaining bolts had caught his shirt pulling him into the opening and entangling him with the shaft. The son immediately radioed for emergency assistance. A nearby fishing vessel's Master relayed the call to the Coast Guard and then went to try and assist the victim. The Master of the nearby fishing vessel helped the son cut the father's clothing and freed him from the shaft, then they performed 2-person cardiopulmonary resuscitation (CPR). A Coast Guard utility boat arrived and transported the victim to a waiting ambulance. He was then transported to a local hospital where he was pronounced dead.

Figure 1 - Open deck cover exposing a section of the transmission, flanged coupling and propulsion shaft. (Incident #2)

Recommendation #1: Fishermen should disengage the transmission before attempting to work on or near a propulsion shaft and coupling.

Recommendation #2: Fisherman should guard moving machine parts, such as propulsion shafts and couplings, to avoid contact.
