A Massachusetts Drill Press Operator Strangled after his Shirtsleeve was Caught and Tightened by Rotating Drill Bit

Investigation: # 99-MA-033-01

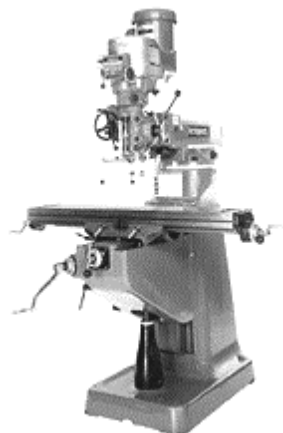
Figure 1. Drill Press

The drill press (Figure 1) involved in the incident had been purchased from another foundry approximately 19 years prior to the incident and had not been modified since its 1960's manufacturing date. It was used infrequently and located away from the main shop area. Drill rotation was controlled by a three-position switch (forward, off, and reverse) located at the top left side of the drill press. The drill press was hard wired with a main power shut-off switch mounted on the wall behind the drill press. Drill bit penetration was controlled by pulling a feed-lever located on the right side of the spindle housing. Various rotational speeds could be selected by moving the drive belt among various size pulleys mounted on the motor and spindle. At the time of the incident, the drill press was operating at 250 revolutions per minute. All of the machines were on a preventive maintenance schedule that was typically performed once a month.

The investigation revealed that the drill press was not equipped with an emergency stop or point of operation guards.

It should be noted that a second possible hazard of clothing or hair being caught in the drill press other than at the point of operation was revealed during the investigation. This location was at the unguarded motor compartment containing the drive belts and pulleys. Exposed rotating belts and pulleys can easily catch baggy clothing or long hair and draw the person into the machine.

Discussion: The main power switch and the spindle switch on the drill press should be located in convenient and accessible locations. In this case, the main power switch was located behind the machine, and the drill press spindle switch was located at the top left side of the machine. Both locations were inconvenient and not readily accessible to the operator. If the spindle switch had been in a more accessible location, the operator may have been more likely to use the switch and eliminate the hazard by stopping the rotation of the spindle before setting up or removing the work clamps. In addition, because both switches were not readily accessible the victim could not turn off the machine while his shirt was caught in the drill press. The locations of the switches were such that it was difficult even for an employee passing by to turn off the drill press.

Recommendation #1: Employers should guard moving machine parts to prevent employee contact with them.

Discussion: Drill presses are included in the OSHA list as machines that usually require point of operation guarding. OSHA regulation, 29 CFR 1910.212 (a)(3) states: (i) Point of operation is the area on a machine where work is actually performed upon the material being processed. (ii) The point of operation of machines whose operation exposes an employee to injury shall be guarded. The guarding device shall be in conformity with any appropriate standards therefore or, in the absence of application specific standards, shall be so designed and constructed as to prevent the operator from having any part of his body in the danger zone during the operating cycle.

In this case, the drill press was an older, used machine, which had not been equipped with a point of operation guard when manufactured. However, the manufacturer could have been contacted for suggestions on appropriate machine guards for the drill press. There are many available guards for drill presses due to their wide use in many manufacturing industries. One type of guard is a tiered guard, which clamps to the quill of the drill press and at all times covers the rotating parts of the press from the quill down. When the operator lowers the manual feed lever, the guard is designed to contact the work piece before the drill bit. The tiered guard then slides up into itself preventing employees from contacting the rotating drill bit as it penetrates the work piece. The guard is designed to give the operator complete visibility of the component being drilled and to be easily swung away for changing the chuck or drill bits. If this type of guarding had been properly used, the operator may not have come in contact with the rotating drill bit.

Recommendation #3: Employers should ensure that drill presses and similar equipment have emergency stops and convenient and accessible switches.

Drill presses and similar style equipment should have an emergency stop, which overrides all other switches on the machine. It should be located close to the operator for emergency situations but not in a place where the switch could accidentally be activated. The emergency stop could be a large red button or paddle mounted on the front of the spindle housing directly above the quill. Another type of emergency stop would be to mount a foot operated on/off switch that would shut down the machine if the operator stepped off of the switch.
