A Self-Employed Welder Fatally Injured during an Explosion while Welding a Rim Wheel to Repair Air Leaks

Investigation: # 99-MA-032-01

Release Date: September 8, 2000

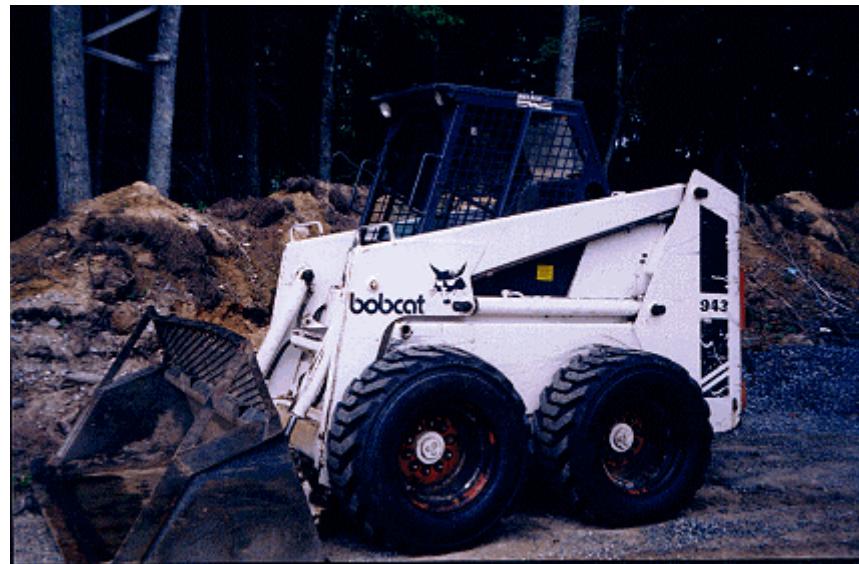
At the time of the incident, the skid-steer loader had a front-end loader attachment connected to it. The front-end loader attachment was positioned down against the ground to lift up the front two wheels of the loader for easier access. The victim was leaning into the right front wheel, which had a pressurized tire on it. He was wearing a welder's mask and gloves and was welding or beginning to weld when the explosion occurred. The tire was blown off the rim wheel and into the victim. The explosion propelled both the tire and victim approximately 15 feet in the air and threw the victim approximately 24 feet west of the loader and into a mailbox by the side of the road.

Figure 1. Skid-steer loader involved in the incident.

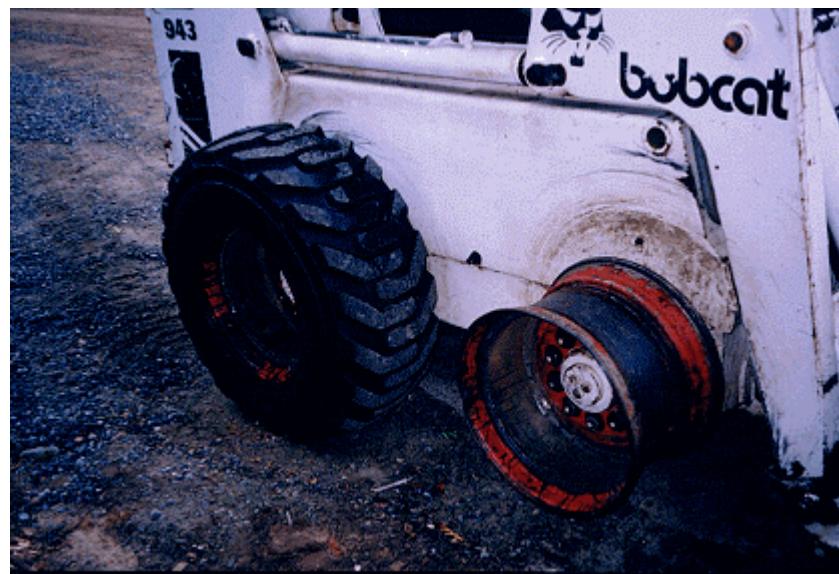
When the tires were mounted and pressurized the modified wheels leaked at the new weld locations. The victim attempted to solve the problem at the incident site by using multiple 12-ounce cans of flammable aerosol tire sealant/inflator purchased at a local automobile parts store. This product was applied to the four tires but the wheels continued to leak. The victim started to mark the leaks along the welds by putting little "dings" in the rim wheels with a hammer at the leaking weld locations. The victim then ground away these sections of weld with a grinder to reveal the holes, and was attempting to seal the holes by welding. The development company

Welding or other hot work should never be performed on rim wheels. Rim wheels manufactured for the use with a pressurized tire have typically gone through a heat treatment process. The heat treatment process for rim wheels would consist of heating and quenching the metal to increase its hardness. This process involves changing the crystalline structure of the metal. Once a heat-treated rim wheel is manufactured if it is reheated or altered using heat, as in this case, this would cause additional changes to the crystalline structure of the metal in the location where the heat was applied. These additional changes in the metal's crystalline structure could cause a structure failure point, weakening the wheel and making it unsafe to use.

Figure 2. Rim wheel of the skid-steer loader after the explosion.

Recommendation #1: Employers including the self-employed should never weld or perform other hot work activities on a rim wheel.
