Self-Employed Residential Contractor Dies in Ten Foot Fall Through Floor Opening on Massachusetts Construction Site

Investigation: # 99-MA-022-01

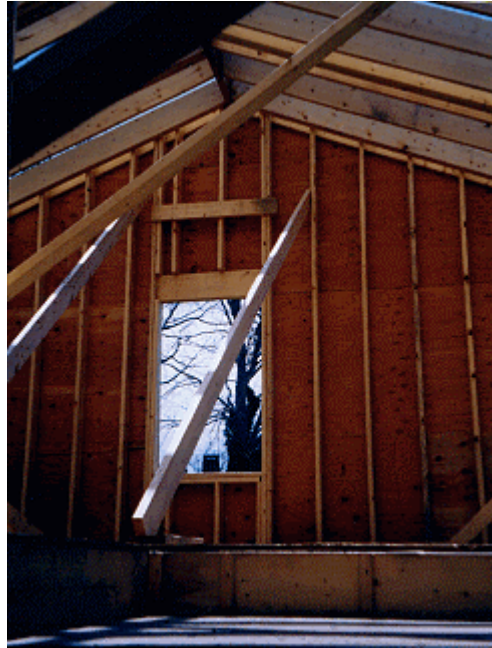
Figure 1 - Gable End 2nd Floor Family Room

On March 30, 1999, a residential construction crew was erecting a new, two-story single family house. The owner of the residential construction company and two laborers were working at the site when the incident occurred. The contractors were framing the second floor and attempting to true up the end gable of the 25 foot by 14 foot second floor master bedroom. The victim apparently stepped back and fell through two uncovered floor openings for the chimney: one in the second floor master bedroom and the other located in the first floor family room. He landed in the ground level crawlspace with his head striking the concrete chimney footing. The two laborers were working with the victim on the second floor of the house at the time of the incident. One of the laborers went down to the crawlspace to check on the victim while the other laborer went to call for emergency assistance. The local fire department, police department, and state police arrived and the victim was transported to a local hospital where he was pronounced dead.

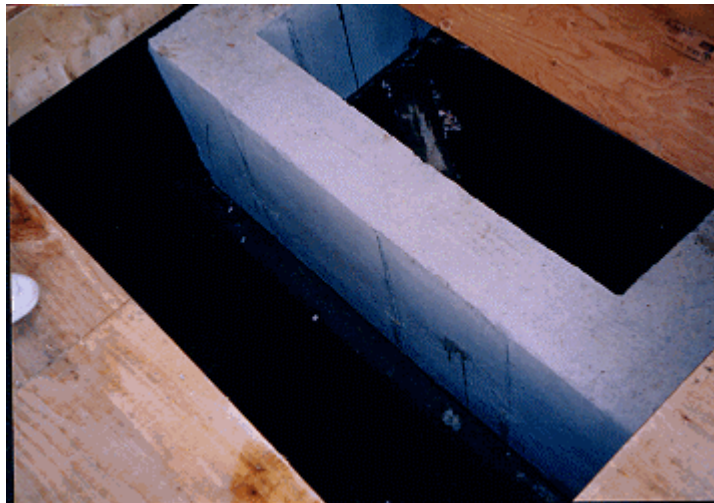
Figure 2 - Floor Opening and Concrete Chimney Footing

Both the second and the first floors were decked with plywood except for the two chimney floor openings, which were uncovered at the time of the incident. Each floor opening for the chimney measured approximately 5 feet 4 inches wide by 4 feet. During the investigation the distance the victim fell before striking his head on the concrete footing was measured at approximately 10 feet.

In this case, there were two unprotected floor openings in the residential structure. The openings were intended for a chimney and were aligned directly over each other on the first and second floors. The simple solution to protect workers from this hazard would be to use a piece of plywood that is at least one-half inch thick as a cover for each opening. Covering the openings with a piece of plywood will eliminate employees from potentially tripping, falling, or stepping into the opening. In addition, the covered openings will eliminate the chance that an object could fall through the opening injuring an employee below.

Recommendation #1: Keep all holes/openings in walking/working surfaces covered throughout all phases of construction.
