Massachusetts Mason Falls When Granite Block Tips Onto Scaffold

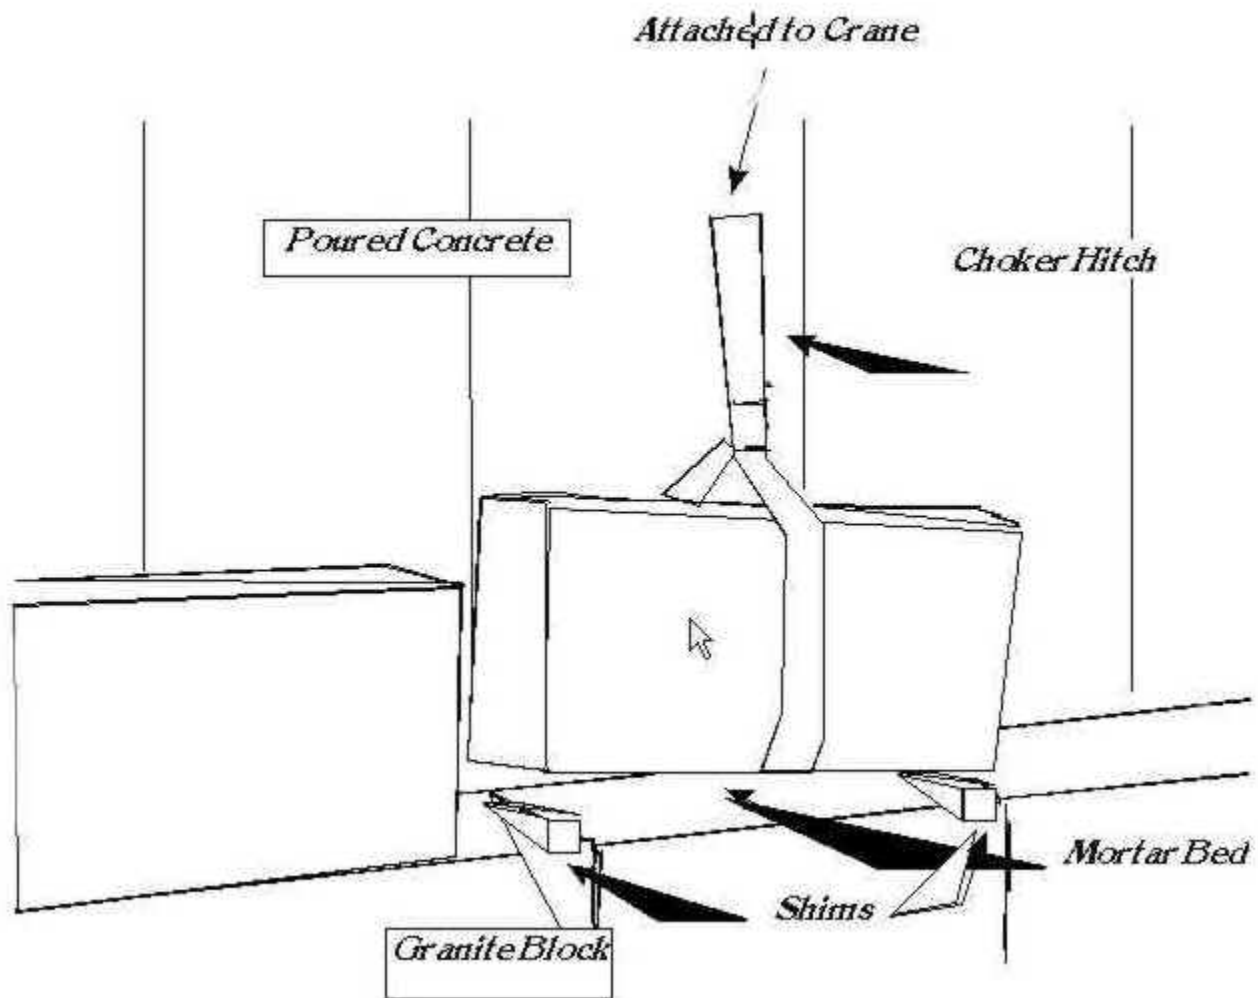
At the time of the incident, the crane was removing the sling from around the block. The sling hung up on the approximately 4 foot long block causing the block to tip onto the scaffold planks. The planks broke and the victim who was standing on them fell through to the concrete below, approximately 22 feet. Two laborers on either side of the victim jumped to adjacent scaffolds and did not fall. The victim suffered severe head injuries in the fall and was assisted in breathing by a trained emergency medical technician on the site until the ambulance arrived. He was then transported to the local city emergency room where he died several hours later.

Figure 1: Placing Granite Blocks With Crane

Recommendation #1: Employers should ensure that slings are removed by hand, not with the use of the crane.

Discussion: Granite block weighs approximately 165 lbs./cu. ft. which meant that the blocks in use at this job ranged from 750 lbs. to 1500 lbs. each. When pulling the sling out from around the block by hand, the sling may catch a bit and then come out with some physical effort. It is therefore easier to let the crane pull the sling out. The crane however is so strong that there is no resistance when the slings is substantially hung up on the block. Therefore, in this case, the crane was able to tip the block over when it pulled out the sling. If the workers had attempted to pull the sling out by hand, they may have realized that the block was resting on the sling and placed another shim under the block to free the sling.
